**Facility Assessment Report
For the City of Biddeford**

City of Biddeford
205 Main Street
Biddeford, Maine 04005

December 30, 2005

OAK POINT
ASSOCIATES

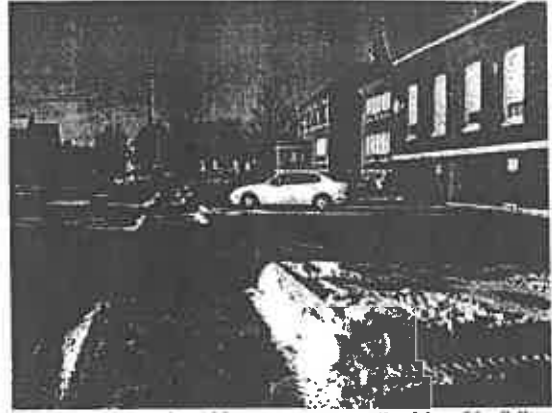
Granite curb and parking area on south side of building

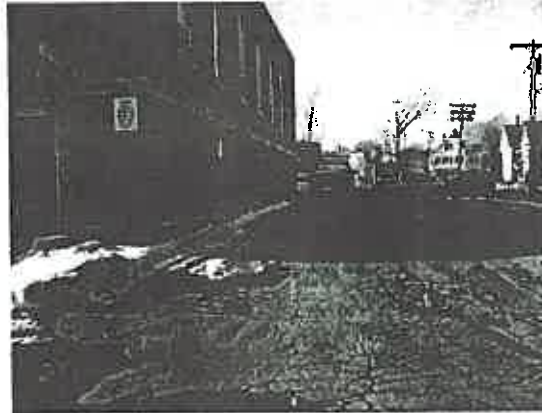
The asphalt concrete pavement surface of the parking areas and drives is in poor condition. Block and alligator cracking is widespread, with some areas of pavement breaking up completely with potholes resulting. Rutting and uneven settlement of the paved surface was also observed in some areas.

Entrance to north parking area showing poor condition of pavement

The paved surface of the parking areas and drives is in poor condition, and reconstruction is recommended. Reclaiming the existing asphalt concrete surface with the underlying base course is the recommended means of reconstruction. Minor grade changes at accessible parking can be accomplished during the reclamation process to ensure the area complies with the slope requirements of the ADA. In addition, removal of the broken up concrete walks crossing vehicular paved areas is recommended at this time. Following fine grading and compaction of the reclaimed base, the area should be resurfaced with new asphalt concrete pavement. The estimated cost to reclaim and repave the parking areas and drives is \$55,000.

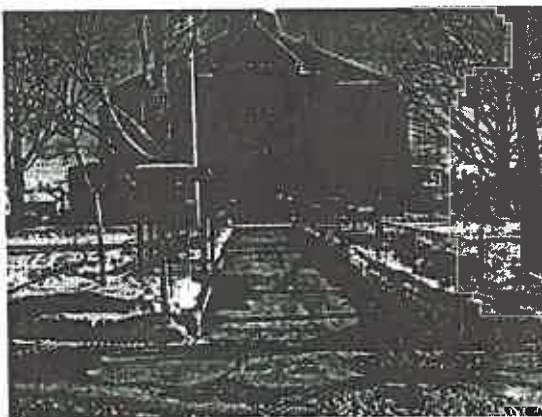
Main entrance and walk to westerly end of building

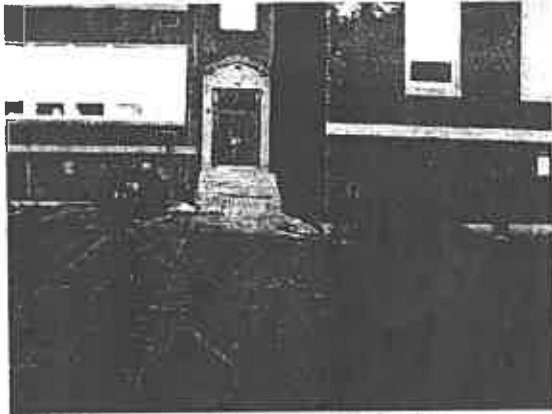
Other concrete walks run from doors on the north and south sides of the building. These walks are generally in poor condition, especially the walks that cross vehicular drives. The handicapped accessible route is via a large concrete ramp to an entrance near the southwest corner of the building. The concrete surface of the ramp is in adequate condition, with the exception of a few failed joints. The ramp is equipped with steel pipe handrails that do not meet the requirements of the ADA.

Typical concrete walk across vehicular drive

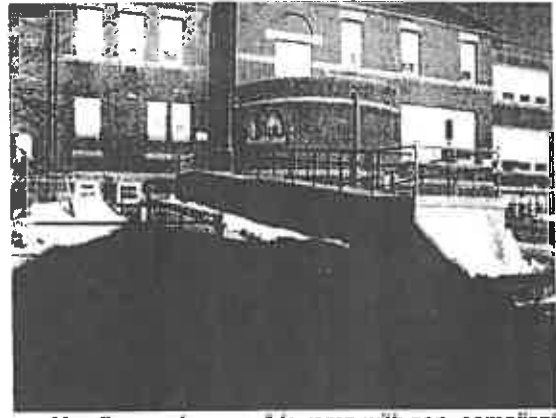
Handicapped accessible ramp with non-compliant handrails

Due to the height of the handicapped accessible ramp, the existing handrails do not meet code and guard rails are required on both sides. The estimated cost to repair the concrete surface and replace the hand rails with guard rails is \$15,000.

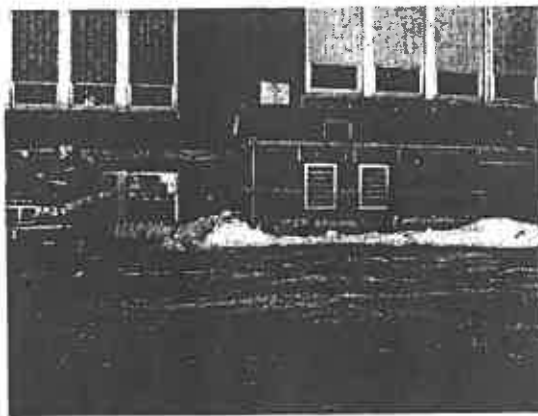
Roof drainage is accomplished by a number of downspouts, some of which run down the outside of the building and some are internal. The internal downspouts discharge through the exterior building wall generally about three feet above grade. Some of the exterior downspouts extend into an existing underground drain system, while others discharge at or above grade. The downspouts that discharge above grade are subject to freezing and result in ice build up on the adjacent parking areas.

Typical roof leader discharge - underground fuel tank is in foreground

Installation of underground piping to collect runoff from the roof leaders is recommended. This project should be undertaken before or during the reconstruction of the pavement. A more intensive evaluation would have to be conducted to determine the most effective way of conveying the drainage to the existing storm drain system. The estimated cost for the drainage improvements is \$20,000.

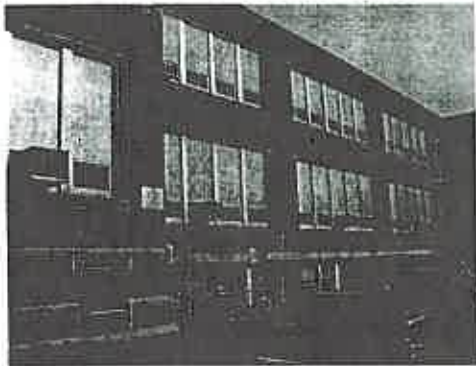
Vertical resisting elements consist of the perimeter unreinforced brick walls, the ground floor brick corridor walls, and the brick stair towers. These elements would only resist lateral forces, assuming there were adequate diaphragms in place. Based on the lack of reinforcing, it is anticipated that the vertical resisting elements would not have sufficient strength to resist the maximum design lateral forces.

Horizontal and vertical brick elements

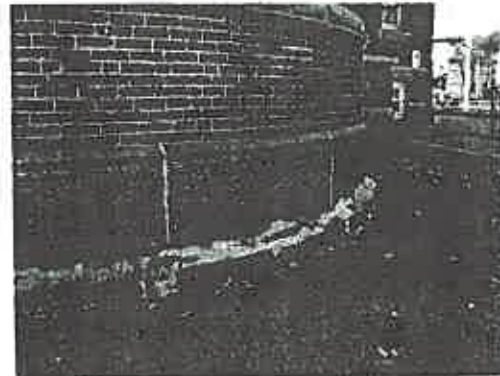
The foundation systems for both the original construction and the addition consist of granite blocks of varying sizes. Visual inspections did not indicate any evidence of failure or differential settlement.

Granite foundation

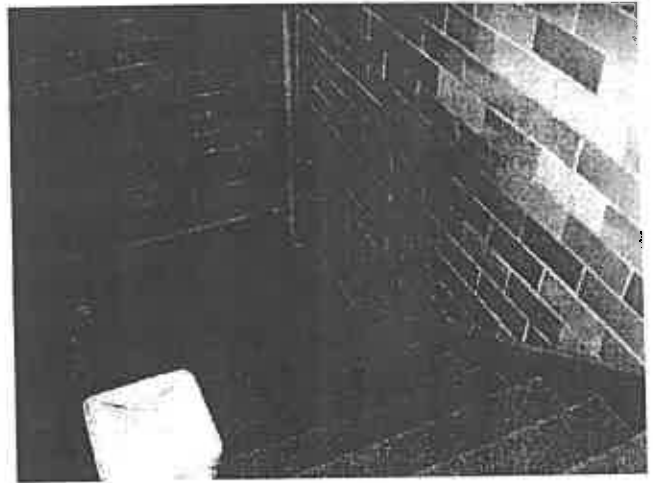
Egress stairs in the building are missing handrails or existing handrails do not meet building code or ADA requirements. Additionally, existing guards are below the 44-inch code requirements. All existing handrails and guards should be replaced or, if missing, be provided on each side of egress stairs: **\$9,000**

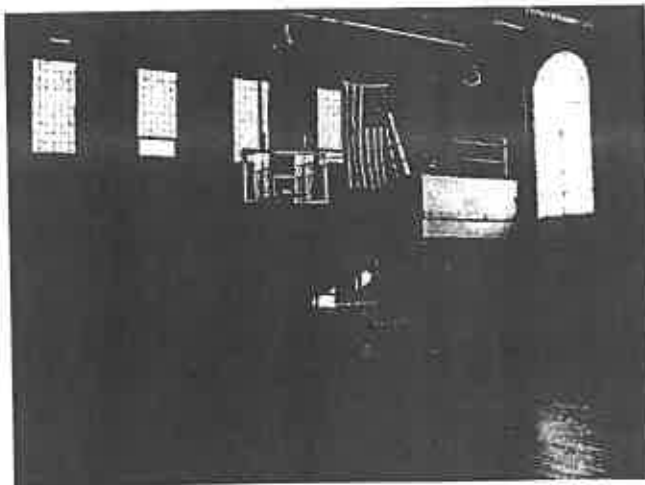
Door knob hardware used in the building does not meet building code or ADA requirements. Knob hardware should be replaced with levers: **\$8,000**

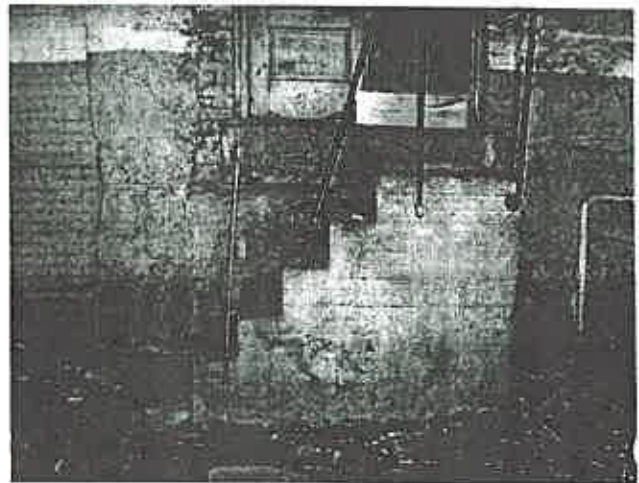
The exterior boiler room door and stair are in a deteriorated condition with plywood added to the door and part of the handrail missing. The door and frame, as well as the handrail, should be replaced: \$3,000

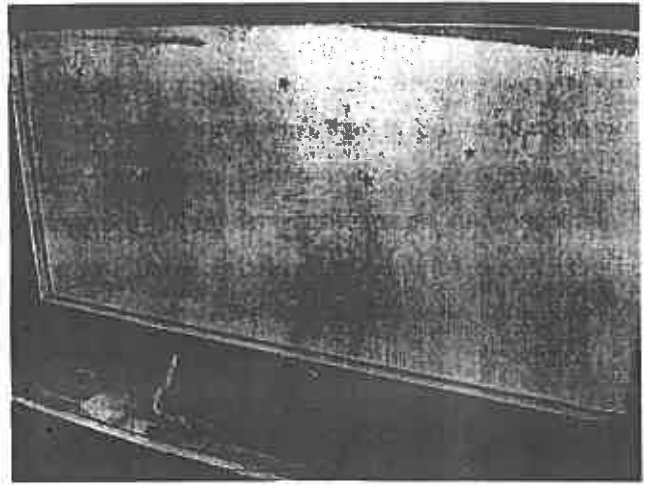
The existing windows are nearing the end of their expected useful life. The glazing used in the awning windows has lost its transparency due to age, and the fiberglass panels have areas of damage.

This existing system is also less energy efficient than current designs. It is recommended that the windows be replaced with units that are energy efficient and with transparent glazing: \$320,000

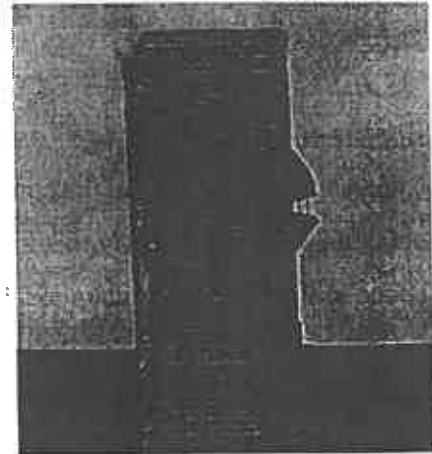
Chimney deterioration

The brick chimney above the original portion of the building is visibly in poor condition where it extends above the sloped roof. The chimney should be repointed in the immediate future to prevent further deterioration: **\$3,500**

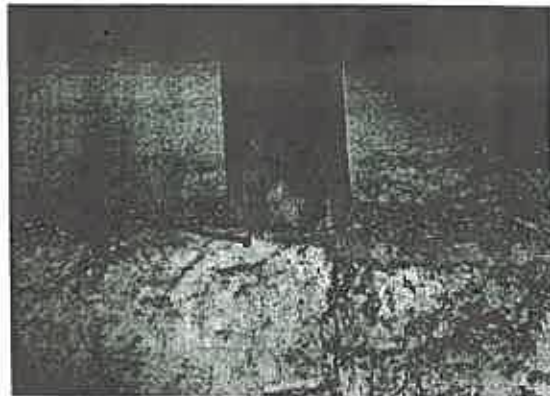
Base of floor joist support

Provide connections of the first floor joist support posts to the first floor framing and the granite foundation: \$3,000

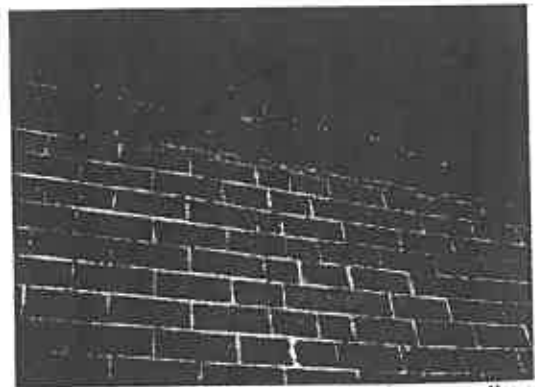
No lateral force transfer connections

Provide connections to transfer lateral forces from wind and seismic loads from the horizontal lateral resisting elements to the vertical lateral resisting elements: \$30,000

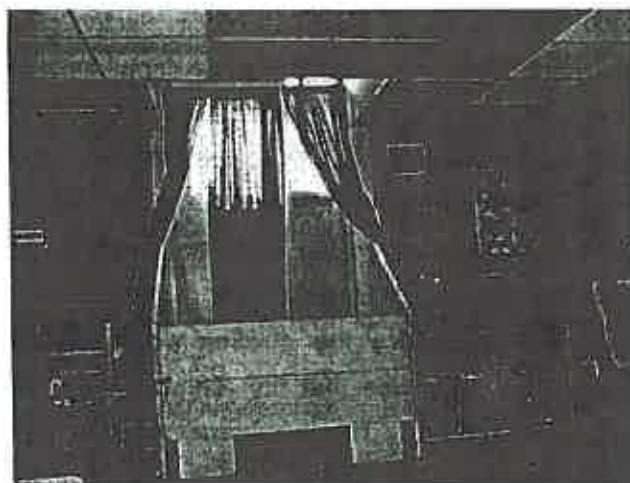
The building's sprinkler system appears to have originally covered the entire building. However, some partitions that have been added since have created spaces which are not protected, or in which sprinkler spacing and distances from walls may not be appropriate. Also, as already noted, some original building sprinklers, which are in excess of 50 years old, remain in use. In order to re-establish a condition of full coverage, a complete building survey by a qualified fire protection professional should be done, followed by work performed to eliminate unprotected and under-protected spaces. The remaining old sprinklers should be replaced with new. Estimate to do a complete building sprinkler inspection, change out remaining old sprinklers, and extend system to spaces currently lacking protection: \$8,000

Typical construction of storage pockets which have no sprinklers
