# **Rapid Reconnaissance Survey of Two Parcels in Western Biddeford, 2022**

submitted to the Biddeford Conservation Commission

September 2022

Mark Ward

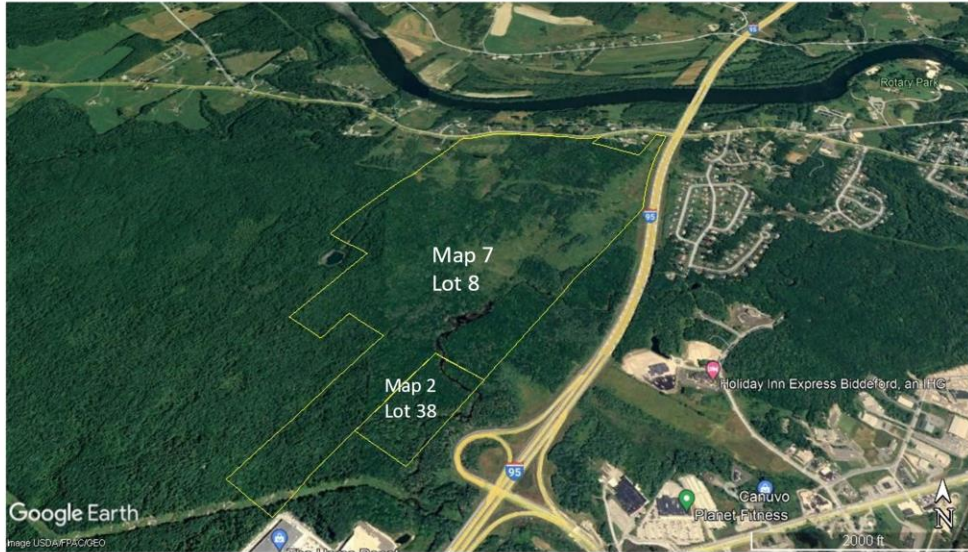
**Figure 1a. Aerial imagery of the subject parcels as they were in 2007.**

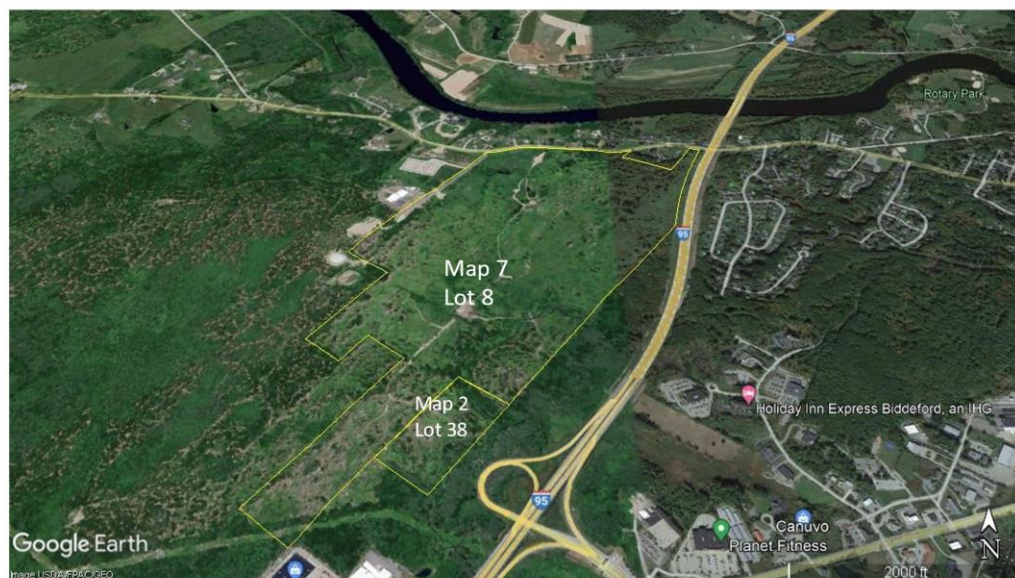
**Figure 1b. Aerial imagery of the subject parcels in 2022.**

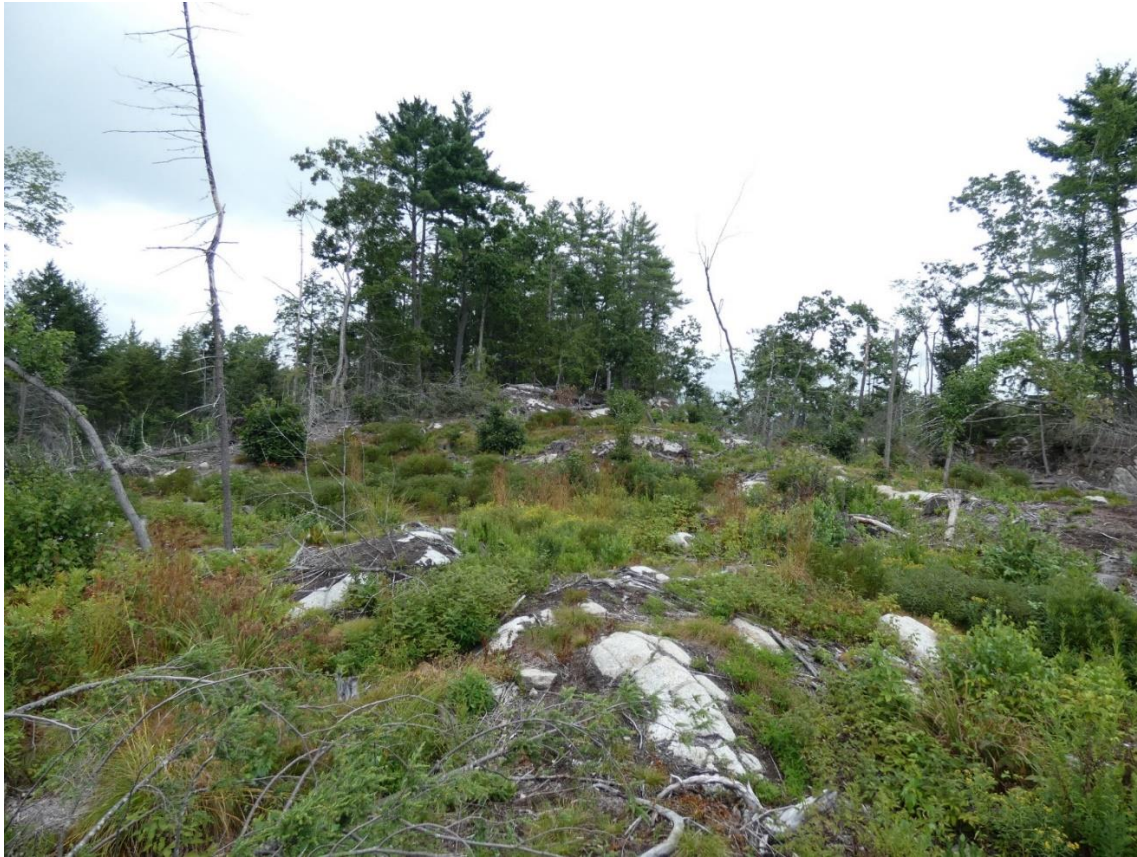
**Figure 3. Sections of exposed bedrock from the logging operation. (Waypoint#966)**

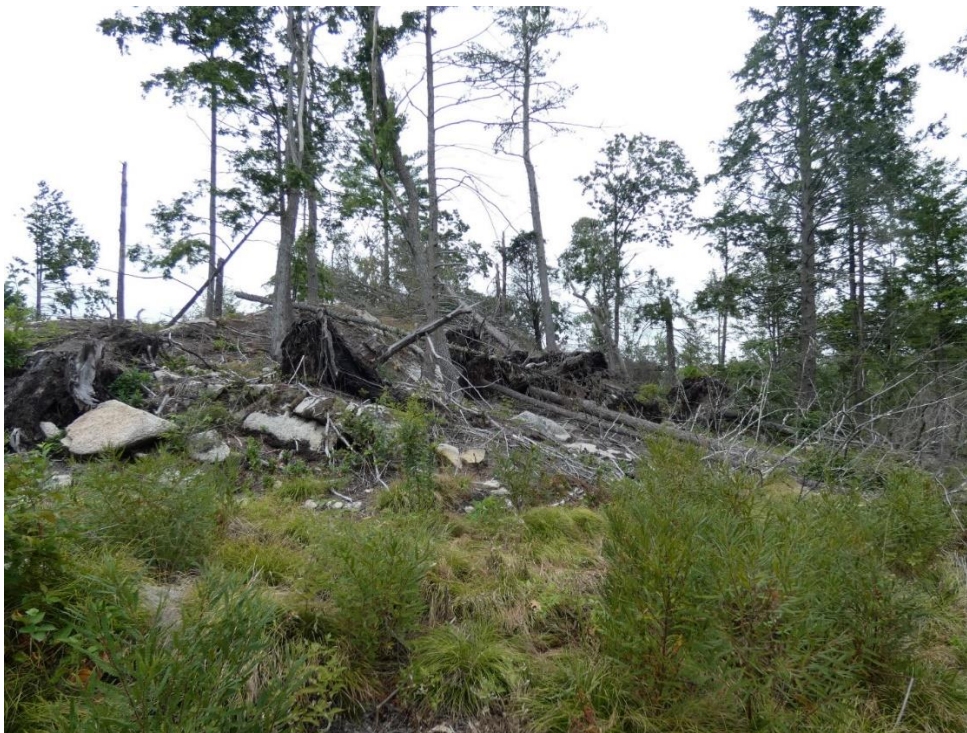
**Figure 4. Windthrown trees uprooted after logging operations. (Waypoint#976)**

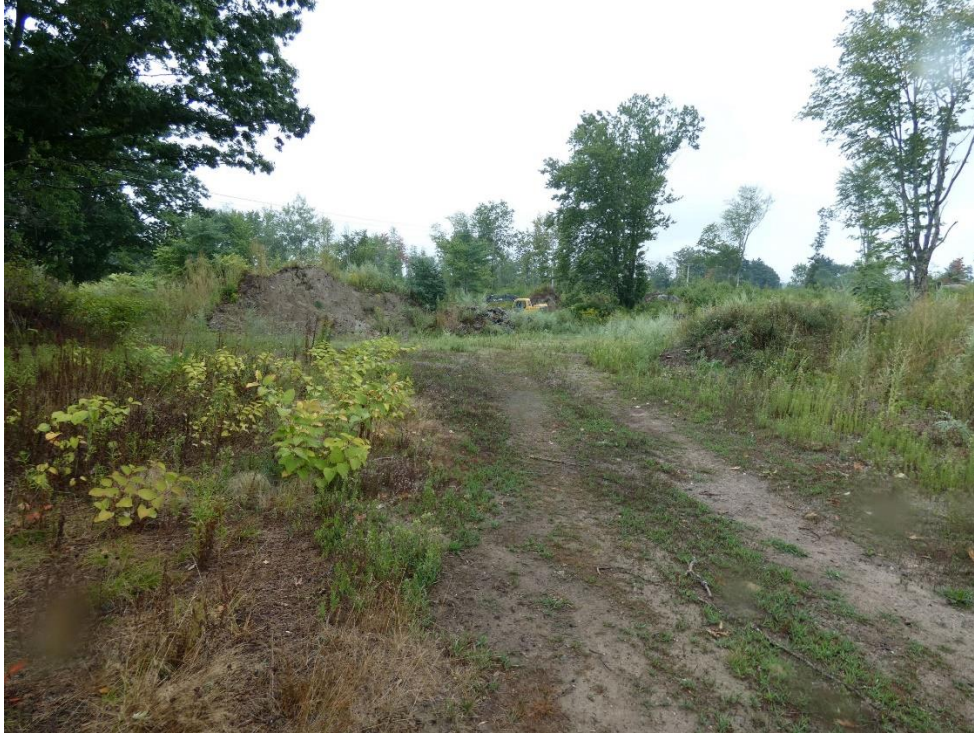
While cutting operations seem largely to have concluded at this site, there was still earth-moving machinery present at site at the time of my visit (Figure 5).

**Figure 5. Earth moving machinery observed at site on Aug. 22, 2022 (Waypoint#085).**

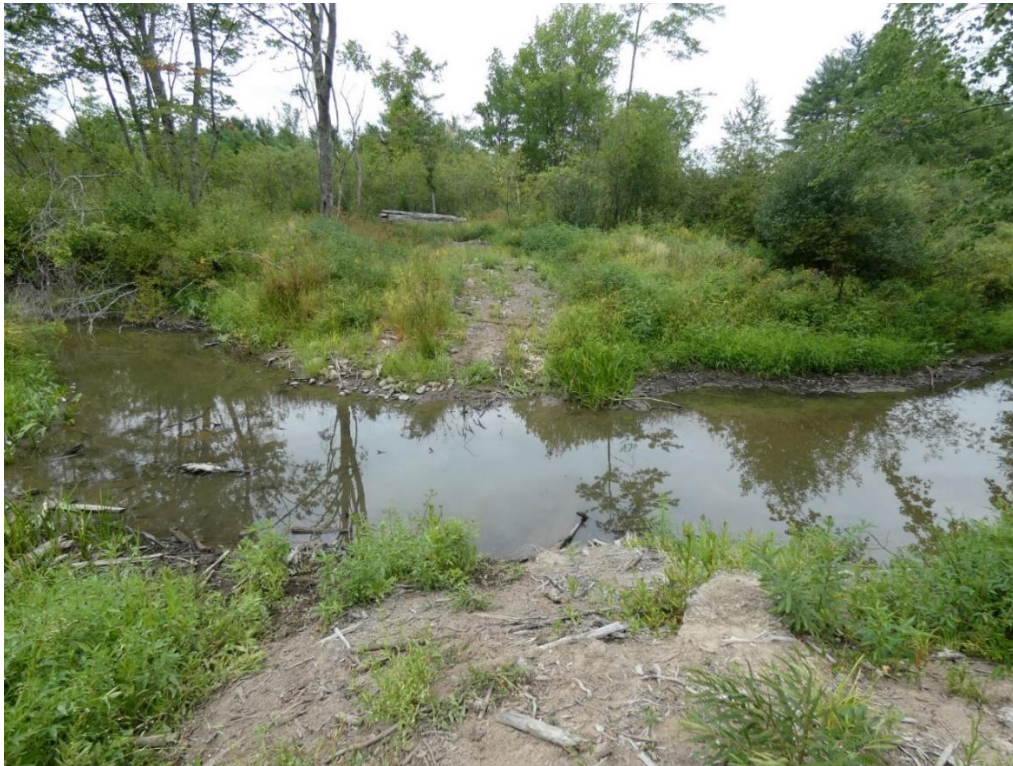
**Figure 6. The location at which a temporary bridge was constructed across Thacher Brook for logging access. The horizontal remains of bridge materials are visible in the distance. (Waypoint#007)**

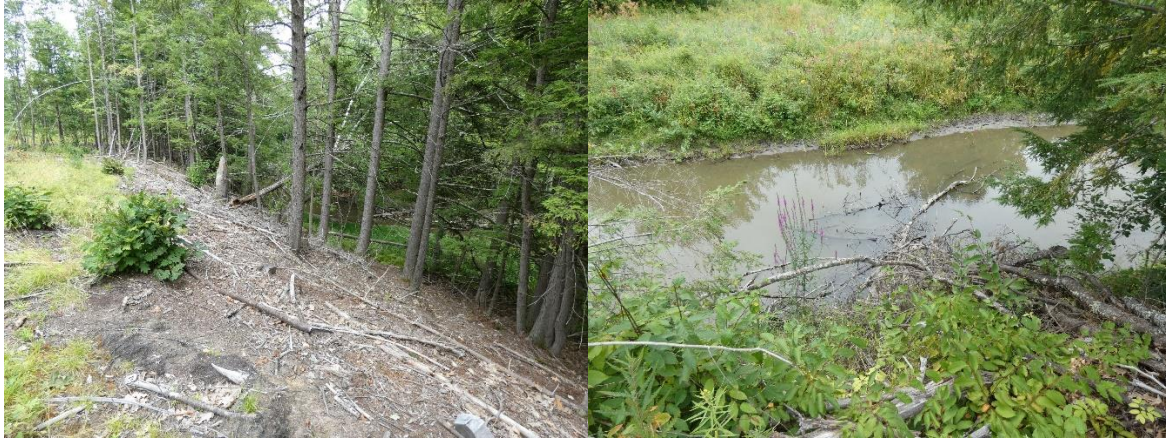
measurements of the forested buffer along Thatcher Brook on these parcels to routinely fall short of this threshold. Measured buffer widths at five different locations ranged from 0-75 ft, with only one measurement approaching 75 feet and most falling in the 35-50 ft range. For an impaired waterway, such as Thatcher Brook, extra caution should have been taken to assure that, at a minimum the required 75-ft forested buffer condition was met. This does not appear to have been the case.

An inadequate forested buffer can subject Thatcher Brook to additional sediment input during heavy rainfall events. Increased solar inputs caused by an inadequate forest buffer can raise water temperatures, which can in turn reduce dissolved oxygen levels and further the cycle of impairment.

**Figure 7. A narrow, forested buffer along Thacher Brook showing cut stumps on a steep bank (left) and a location where felled trees left no forested buffer at all along Thacher Brook (right). (Waypoints#1000 & #006)**

I recommend against dropping additional trees in the already inadequate forested buffer left along Thacher Brook. If putting downed trees in the stream channel is intended to enhance pool formation, then I would recommend using already downed wind-thrown trees on the property rather than felling additional trees in the insufficient forest buffer.

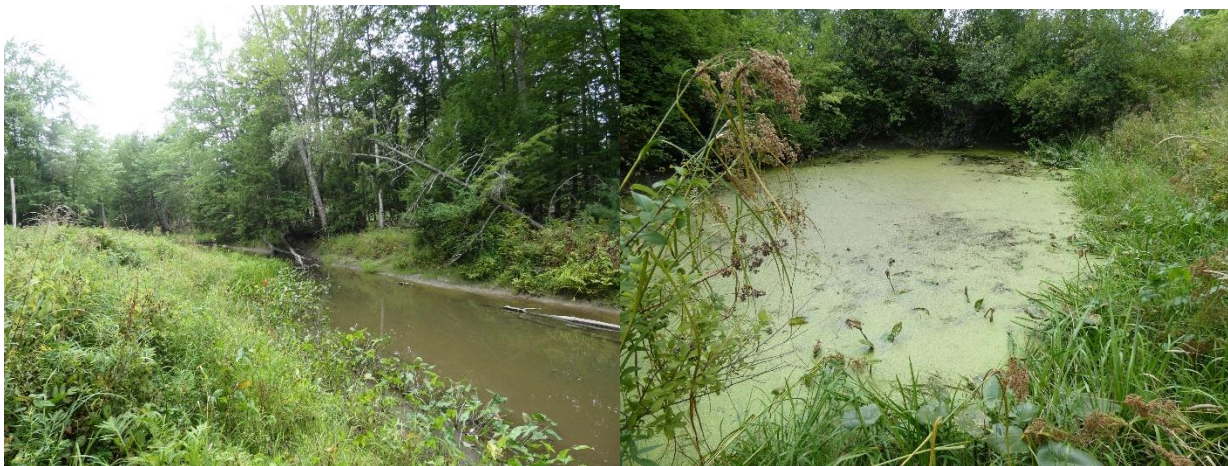
**Figure 8. A typical section of tall herbaceous vegetation in the floodplain along Thacher Brook (left) and a duckweed covered pool in the floodplain of Thacher Brook (right). Waypoints #004 & #008.**

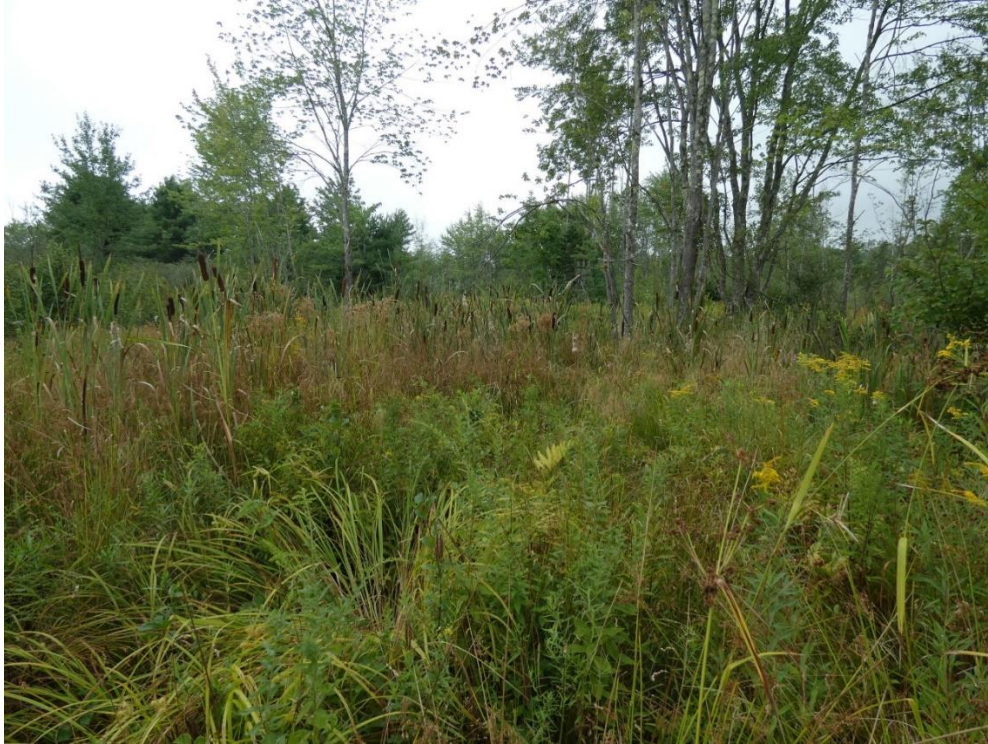
**Figure 9.** An example of cattails (*Typha* sp.), an obligate wetland plant species, suggesting an area that would be delineated as a wetland. (Waypoint#041).

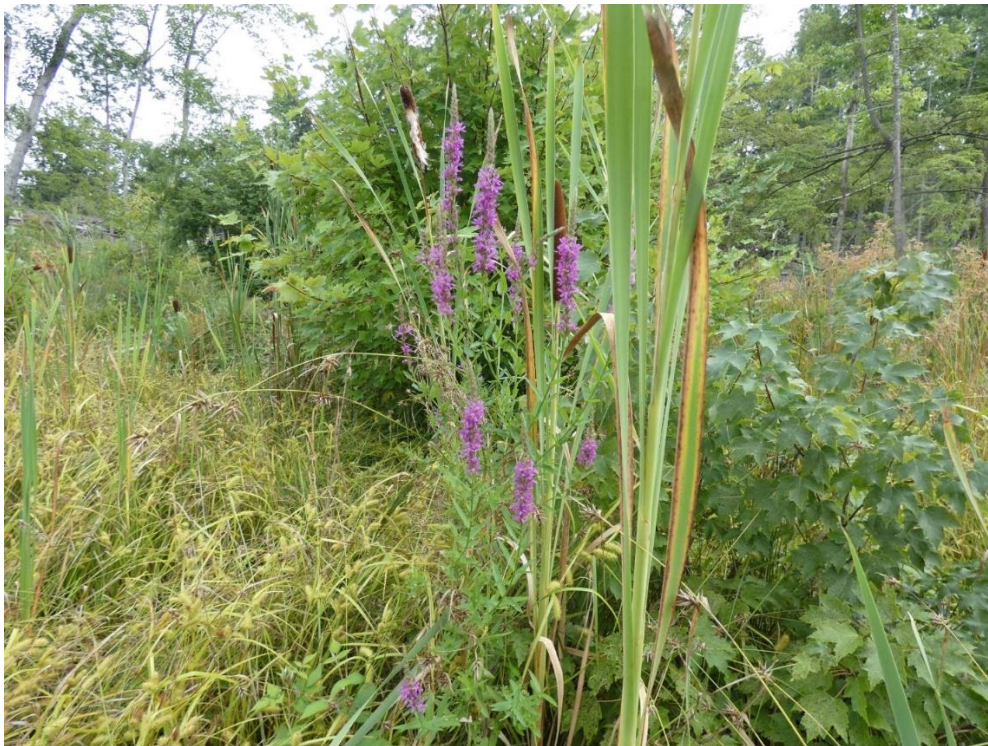
**Figure 10.** Purple loosestrife, an invasive wetland plant species, in front of stump sprouting red maples in a formerly forested wetland. (Waypoint#967)

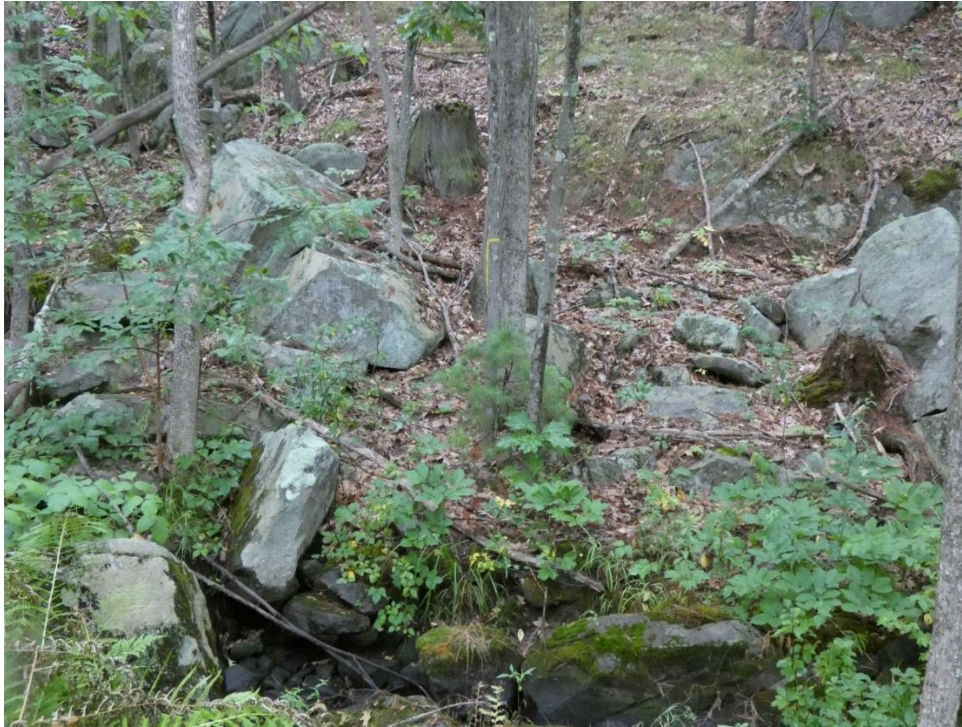
There was little indication at the site (such as extant flagging) that a thorough wetland delineation has been completed on the subject parcels. The only location where we observed any flagging to suggest wetland delineation was along a wooded stream channel at the northern edge of the site (Figure 11).

**Figure 11. Yellow flagging on a tree along a streambed at the northern edge of the property was the only on the ground indication of potential wetland delineation observed at the site. (Waypoint #091)**

I recommend that the Conservation Commission seek details of any wetland delineation work that may have been conducted at this site to find out when the work was done and the extent of the site that it covers. The Maine Natural Areas Program map included in Mr. Lema's report (which includes an "additional NWI wetlands" data layer) can be used as rough guide to assess the quality of any delineation work.

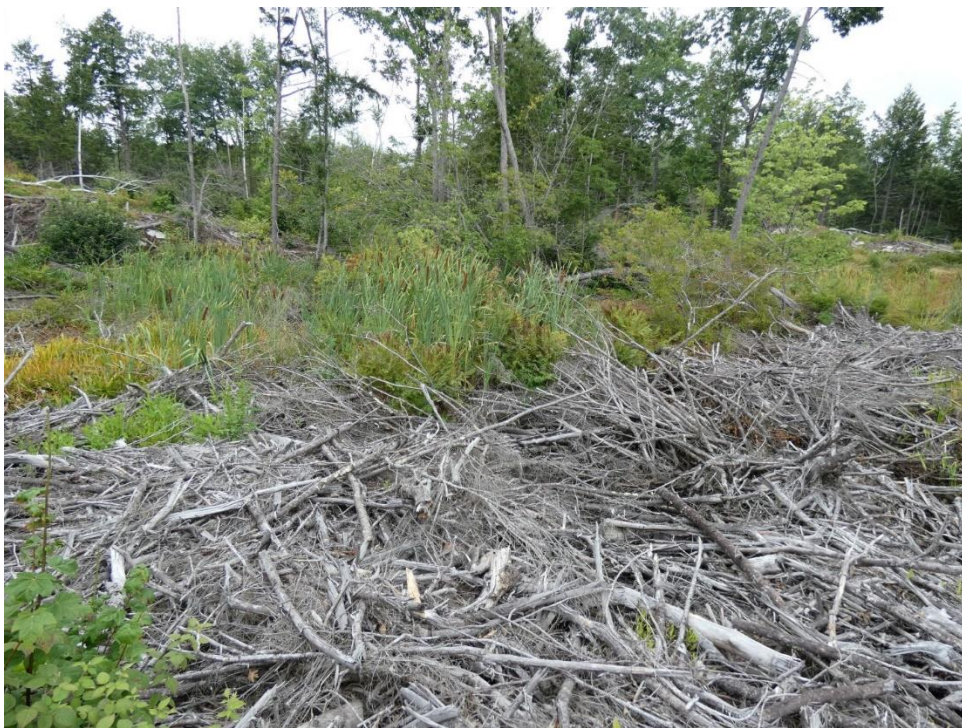
**Figure 12. Logging slash deposited in a deep section of a potential vernal pool at which a critical threshold of egg masses had been counted in 2007 to suggest its designation as significant wildlife habitat. (Waypoint# BWA117)**

I recommend that the Conservation Commission seek additional details of the Vernal Pool Assessment conducted in 2020 to determine the area assessed and to seek any data on potential vernal pools that were visited and/or egg mass counts at assessed pools.

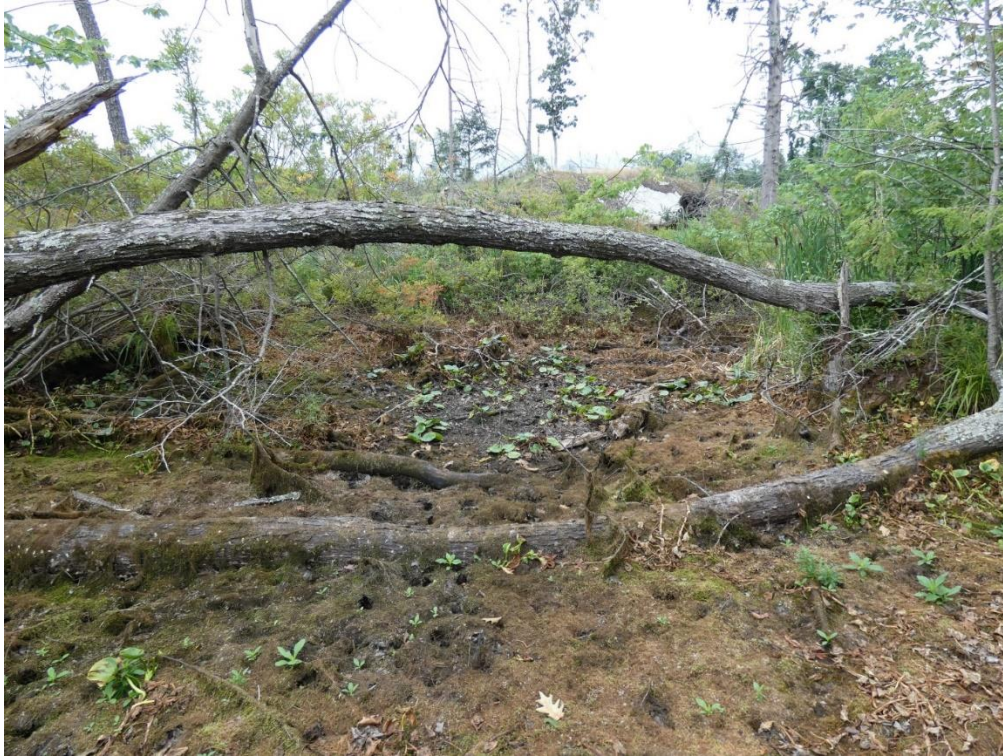
**Figure 13. A relatively unvegetated section of a potential vernal pool with wild calla (*Calla palustris*) suggesting the longer hydroperiod of a semi-permanent pool. (Waypoint #BWA117)**
