JFK-Re-Use

**AD HOC JOHN F KENNEDY SCHOOL BUILDING
RE-USE COMMITTEE**

Appendix A

J. Richard Martin Community Center General Recreation Program Data

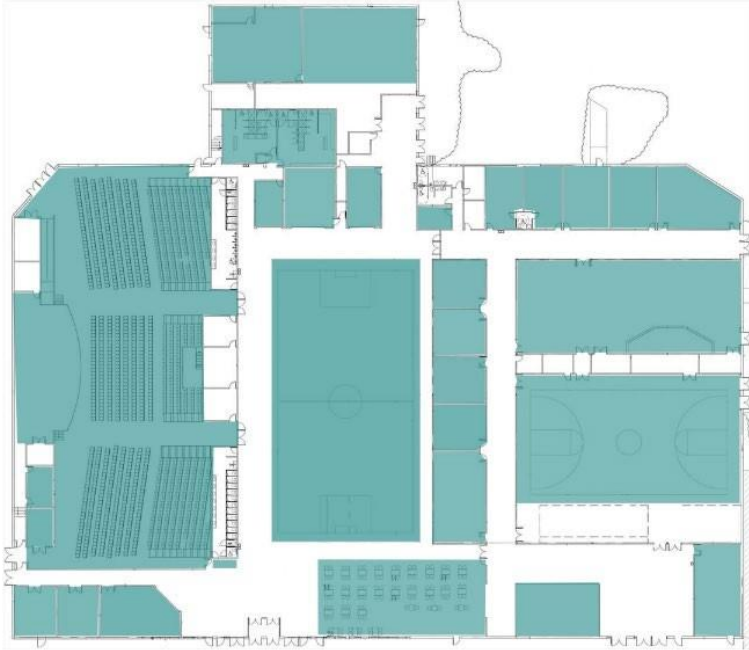
1-Floor Plan for The Point in South Portland

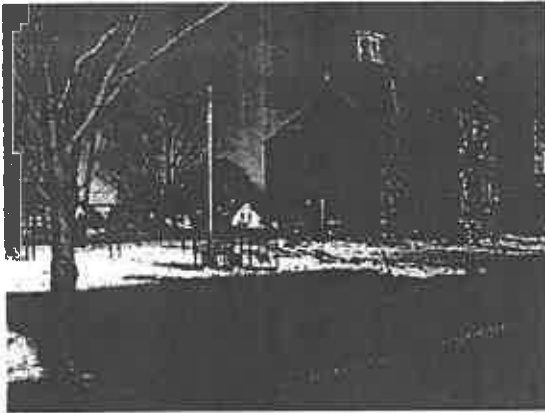
Playground and westerly end of building

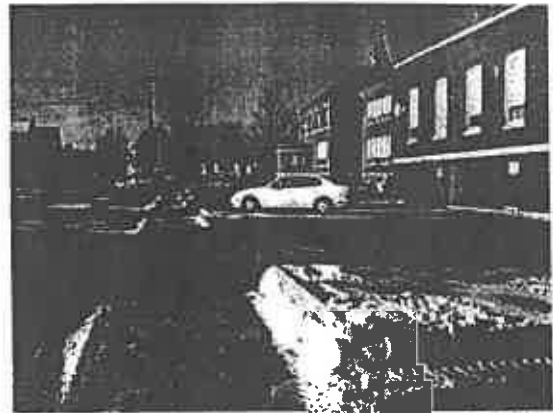
Granite curb and parking area on south side of building

Access to parking on both the north and south sides of the building is via separate drives off Prospect Street. The northerly parking area is marked for approximately 22 spaces, with an egress onto Myrtle Street. The southerly parking area is marked for approximately 23 spaces, including 2 spaces designated as handicapped accessible. The slope of the ground surface in the vicinity of the accessible parking spaces appears to exceed 2 percent, making them non-compliant with the requirements of the Americans with Disabilities Act. Egress from the south parking area is onto Clark Street. A more efficient striping layout would result in additional spaces in both the north and south parking areas.

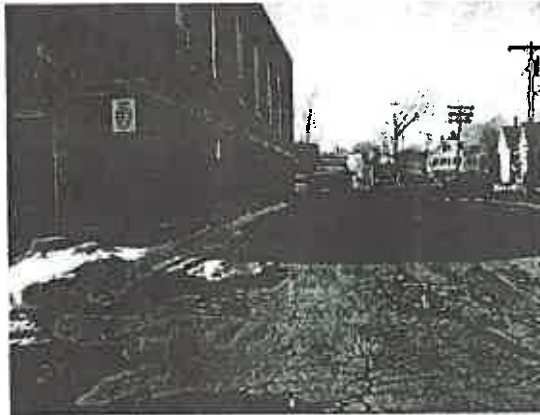
The asphalt concrete pavement surface of the parking areas and drives is in poor condition. Block and alligator cracking is widespread, with some areas of pavement breaking up completely with potholes resulting. Rutting and uneven settlement of the paved surface was also observed in some areas.

Entrance to north parking area showing poor condition of pavement

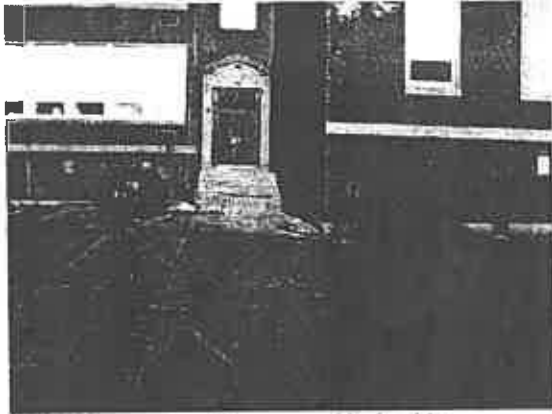
Other concrete walks run from doors on the north and south sides of the building. These walks are generally in poor condition, especially the walks that cross vehicular drives. The handicapped accessible route is via a large concrete ramp to an entrance near the southwest corner of the building. The concrete surface of the ramp is in adequate condition, with the exception of a few failed joints. The ramp is equipped with steel pipe handrails that do not meet the requirements of the ADA.

Typical concrete walk across vehicular drive

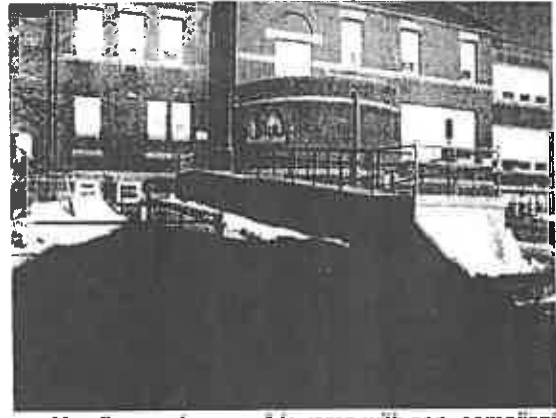
Handicapped accessible ramp with non-compliant handrails

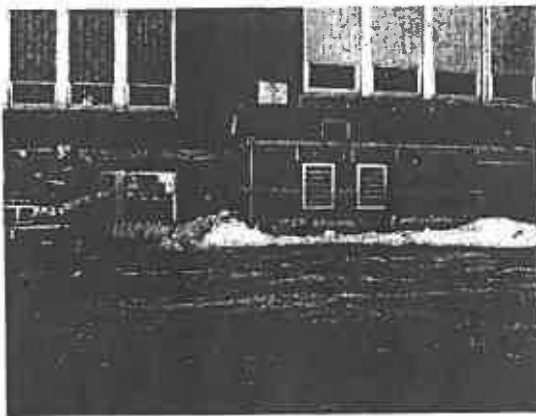
Roof drainage is accomplished by a number of downspouts, some of which run down the outside of the building and some are internal. The internal downspouts discharge through the exterior building wall generally about three feet above grade. Some of the exterior downspouts extend into an existing underground drain system, while others discharge at or above grade. The downspouts that discharge above grade are subject to freezing and result in ice build up on the adjacent parking areas.

Typical roof leader discharge - underground fuel tank is in foreground

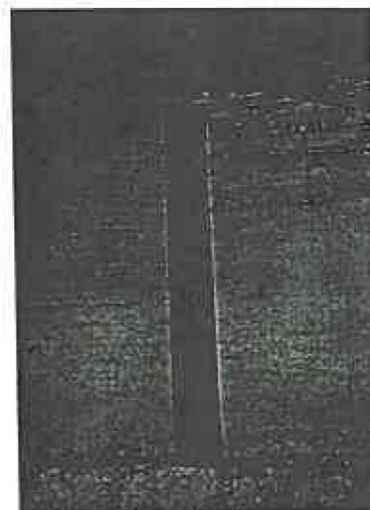
In the curved portions of the first floor, the floor joists are bearing partially on the exterior brick walls and partially on 2x6 wood posts that are supported by the granite foundation. These 2x6 wood posts are not connected to the floor joists or the granite foundation.

Curved area floor joist support

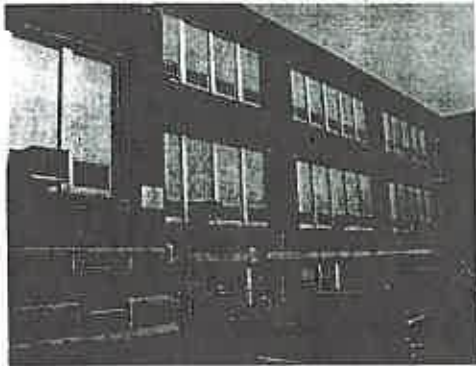
Vertical resisting elements consist of the perimeter unreinforced brick walls, the ground floor brick corridor walls, and the brick stair towers. These elements would only resist lateral forces, assuming there were adequate diaphragms in place. Based on the lack of reinforcing, it is anticipated that the vertical resisting elements would not have sufficient strength to resist the maximum design lateral forces.

Horizontal and vertical brick elements

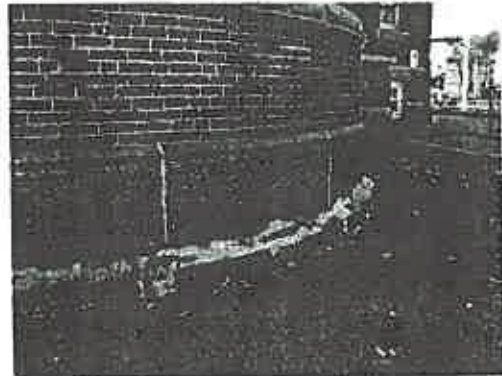
The foundation systems for both the original construction and the addition consist of granite blocks of varying sizes. Visual inspections did not indicate any evidence of failure or differential settlement.

Granite foundation

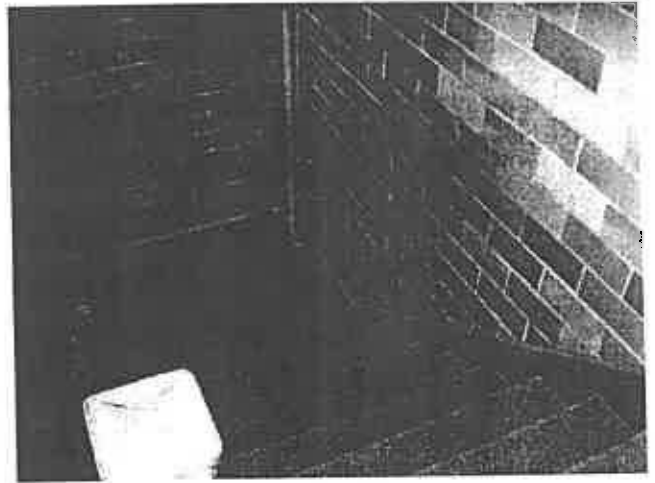
Egress stairs in the building are missing handrails or existing handrails do not meet building code or ADA requirements. Additionally, existing guards are below the 44-inch code requirements. All existing handrails and guards should be replaced or, if missing, be provided on each side of egress stairs: **\$9,000**

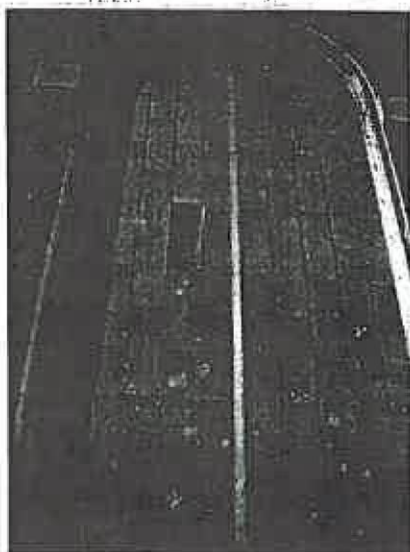
The existing windows are nearing the end of their expected useful life. The glazing used in the awning windows has lost its transparency due to age, and the fiberglass panels have areas of damage.

This existing system is also less energy efficient than current designs. It is recommended that the windows be replaced with units that are energy efficient and with transparent glazing: \$320,000

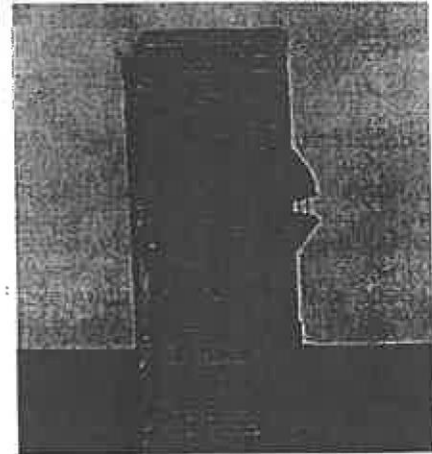
Chimney deterioration

The brick chimney above the original portion of the building is visibly in poor condition where it extends above the sloped roof. The chimney should be repointed in the immediate future to prevent further deterioration: \$3,500

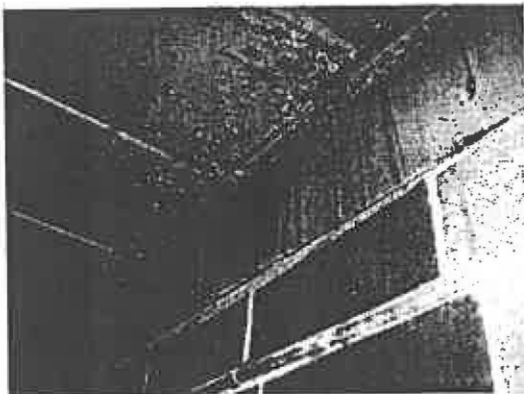
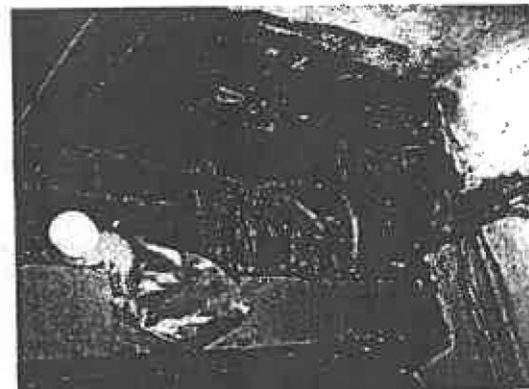
Corroded beam

Replace corroded beams located in the stair tower. Provide temporary support of existing structure while work is completed: \$10,000

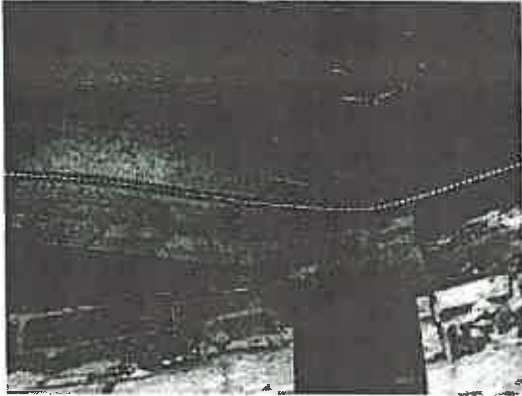
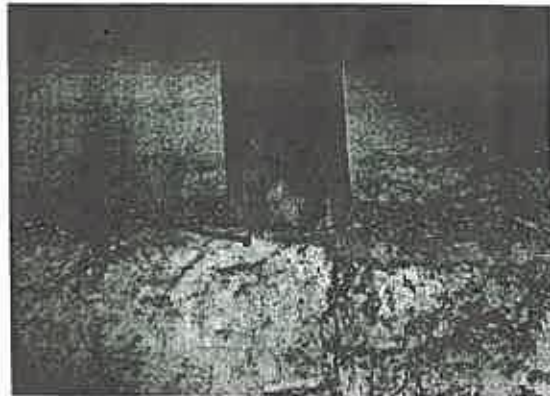
Top of floor joist support

Base of floor joist support

Provide connections of the first floor joist support posts to the first floor framing and the granite foundation: \$3,000

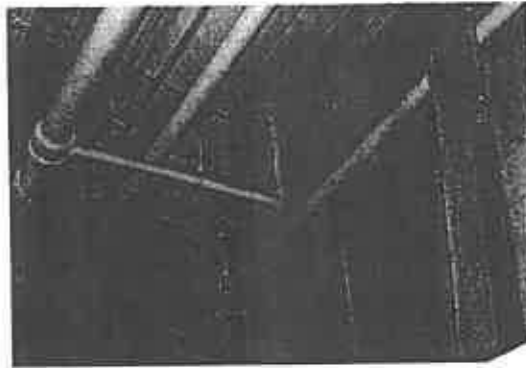
In the corner storage room, located off of the gymnasium on the Clark Street side of the building, there is a lintel supporting balcony framing that has lateral displacement and distortion. The lintel is a structural steel channel member located above a window opening. The lintel is supporting a built-up channel beam that supports the balcony. The built-up channel beam is connected to the lintel by a structural steel WT-section. The WT is connected to both the channel beam and the lintel by non-strength bolts. The lintel is currently displaced 1-3/4 inches from the wall. Further analysis is required to determine the cause of the lintel displacement and distortion and to determine the appropriate modifications needed.

Lintel lateral displacement and distortion

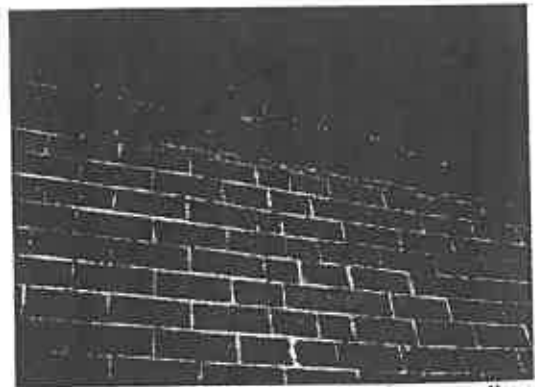
No lateral force transfer connections

Provide connections to transfer lateral forces from wind and seismic loads from the horizontal lateral resisting elements to the vertical lateral resisting elements: \$30,000

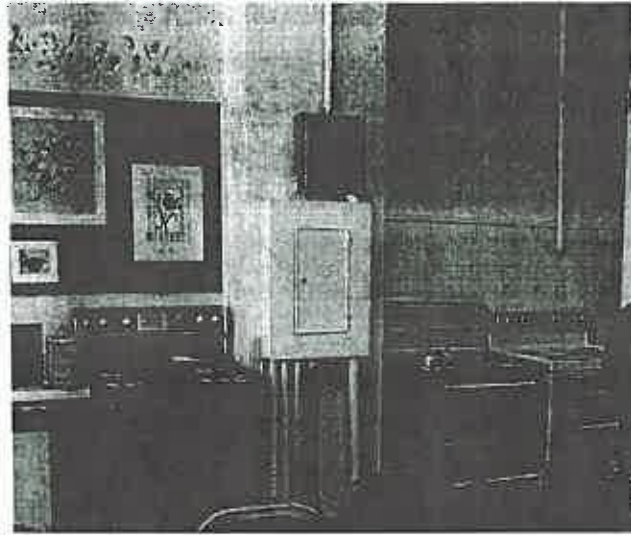
There are three rooms which have residential-style electric ranges (cooktops and ovens), totaling six ranges. None of these is equipped with a commercial kitchen hood exhaust system with fire suppression. Neither are any of the ranges equipped with a light-duty residential style fire suppression system, which is sometimes substituted for commercial-grade equipment for cooking equipment in educational environments. NFPA 96, The Standard for Ventilation Control and Fire Protection of Commercial Cooking Operations, requires commercial hoods with fire suppression for residential-style appliances installed in commercial buildings, except in buildings of non-assembly occupancy. Since the building does contain some assembly spaces, compliance with the standard requires that the ranges be equipped with commercial grade exhaust hoods with fire suppression. This requirement may sometimes be waived by the Fire Marshal if operations are considered limited enough to not warrant such equipment. Estimate to provide six hoods with suppression: \$75,000

Unvented electric ranges in second floor life-skills room

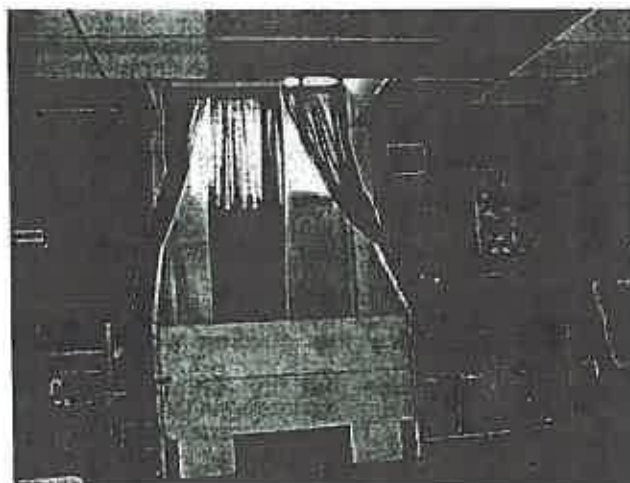
The building's sprinkler system appears to have originally covered the entire building. However, some partitions that have been added since have created spaces which are not protected, or in which sprinkler spacing and distances from walls may not be appropriate. Also, as already noted, some original building sprinklers, which are in excess of 50 years old, remain in use. In order to re-establish a condition of full coverage, a complete building survey by a qualified fire protection professional should be done, followed by work performed to eliminate unprotected and under-protected spaces. The remaining old sprinklers should be replaced with new. Estimate to do a complete building sprinkler inspection, change out remaining old sprinklers, and extend system to spaces currently lacking protection: \$8,000

Typical construction of storage pockets which have no sprinklers
