**Facility Assessment Report
For the City of Biddeford**

City of Biddeford
205 Main Street
Biddeford, Maine 04005

December 30, 2005

OAK POINT
ASSOCIATES

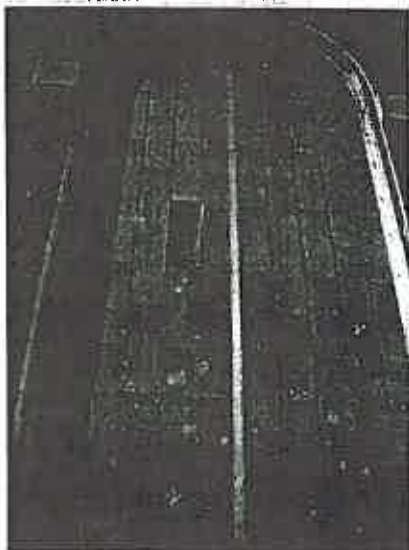
The existing windows are nearing the end of their expected useful life. The glazing used in the awning windows has lost its transparency due to age, and the fiberglass panels have areas of damage.

This existing system is also less energy efficient than current designs. It is recommended that the windows be replaced with units that are energy efficient and with transparent glazing: \$320,000
