**City of Biddeford**  
**Historic Preservation Commission**

April 9, 2025 at 4:00 PM  
City Hall Council Chambers & Zoom

**HPC MEETING**  
**March 12, 2025**  
**Meeting Minutes**  
**4:00**  
**DRAFT**

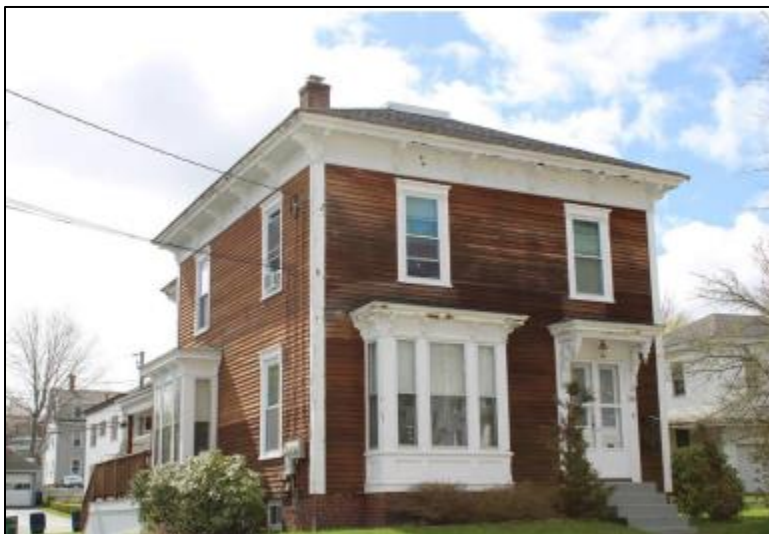
The building as it appeared in 2022 as part of the Kleinfelder Survey:

There is noticeable and significant wear to the existing wood siding on the East (rear) elevation of the building. The applicant proposes to replace the siding on the rear of the building only at this time.

The owner proposes to re-side the rear façade of the structure only (facing Quimby Street). The existing wood clapboard siding is in poor condition – see images above – and the applicant proposes Narrow Lap Siding by Everlast, with a 4-1/2" exposure. This siding is in a substitute material. According to the company's website, Everlast is made with a mixture of "granular stone and polymeric resin."

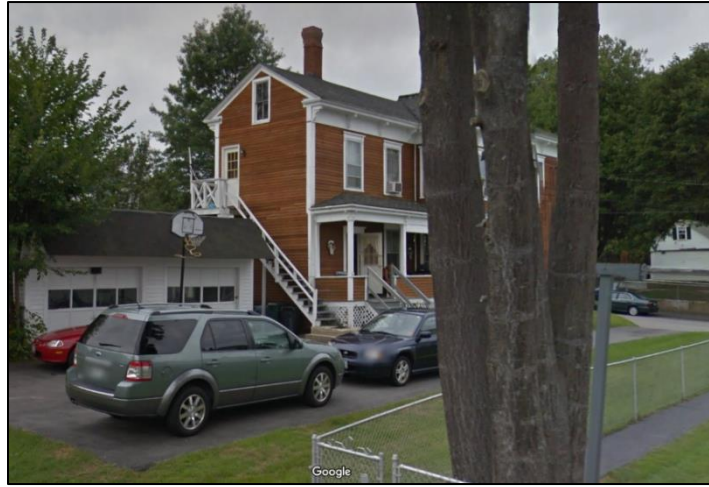
The rear of the building as seen from Quimby Street in a 2011 Google Street View image. (not the garage that partially obscures view of the house:

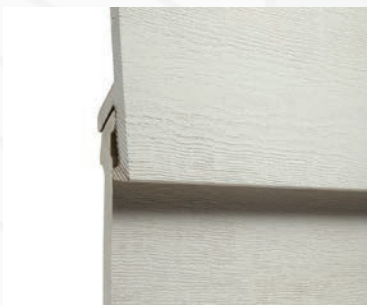
Everlast Lap Siding's EZStack interlocking joinery prevents siding from rattling in high wind conditions, while enhancing the siding's ability to withstand high wind forces, ensuring that your siding remains firmly affixed. EZStack joinery also assists installers by helping to ensure that your siding is perfectly level and spaced for optimal aesthetics.

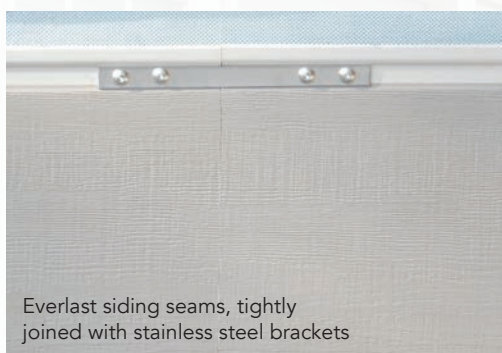
Everlast siding seams, tightly joined with stainless steel brackets

Each Everlast Lap Siding plank-to-plank seam is reinforced with a stainless steel bracket to produce the strongest, longest lasting, and best looking seams on the market. Even better, no caulking or flashing at seams is ever required.

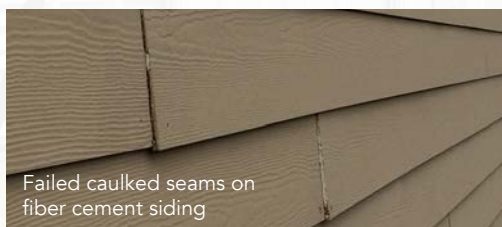
Failed caulked seams on fiber cement siding

With fiber cement and engineered wood, thermal expansion and contraction causes siding seams to open and close throughout the year. Caulking these seams only provides a temporary fix. And unsightly joint caps are no solution.

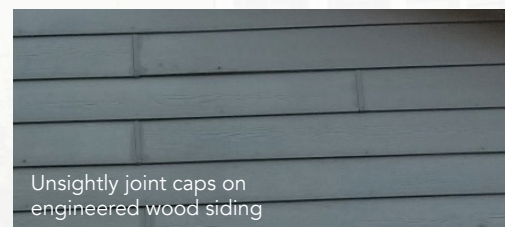
Unsightly joint caps on engineered wood siding

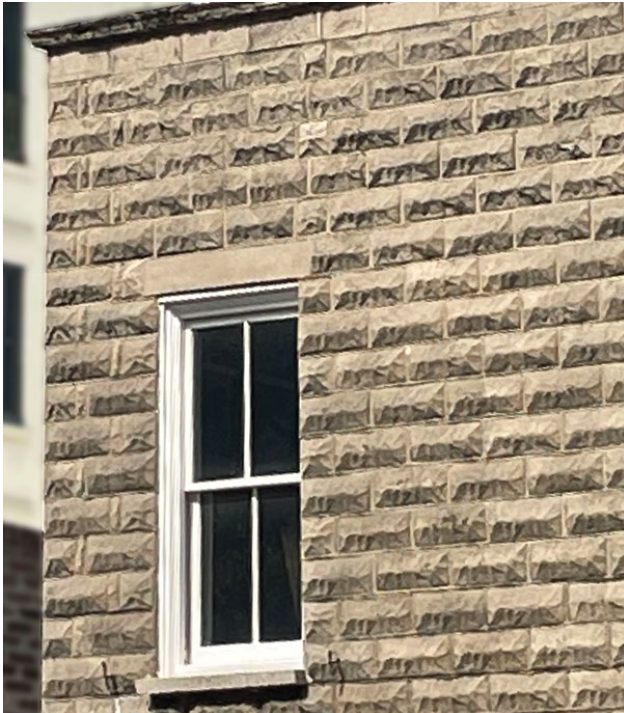
Figure 2a: Casting concrete blocks to mimic quarried stone was a popular late 19th- to mid 20th-century technique. Concrete masonry units could be completed by local craftsman, saving time and shipping costs. Photo: John Sandor, NPS.

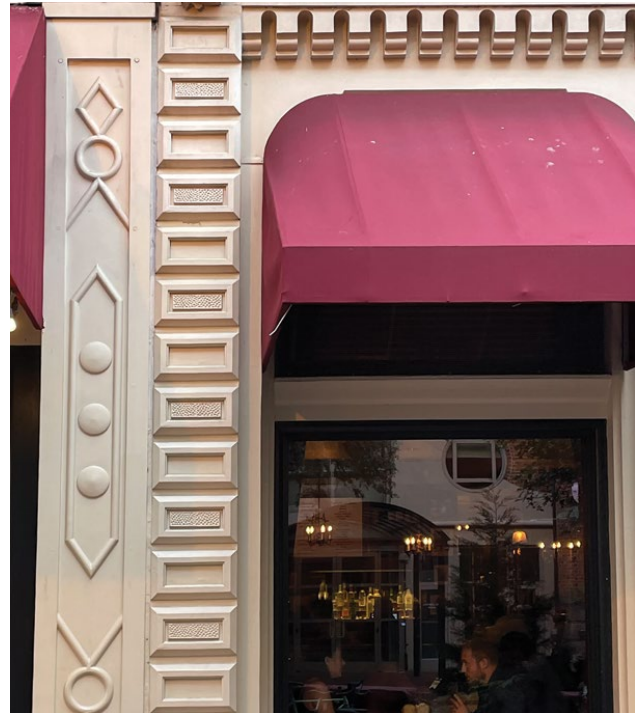
Figure 2b: The 19th century also produced a variety of metal products used to imitate other materials. Across the country, cast iron was used in storefronts to imitate stone. Photo: John Sandor, NPS.

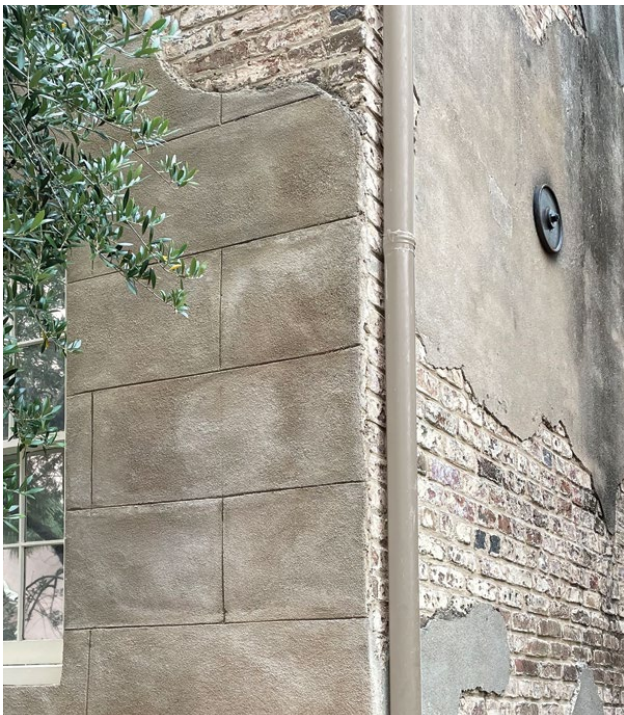
Figure 2c: Stucco has been used to imitate a number of building materials for many centuries. Seen here, stucco was applied to a brick structure and scored to represent a stone façade. Photo: John Sandor, NPS.

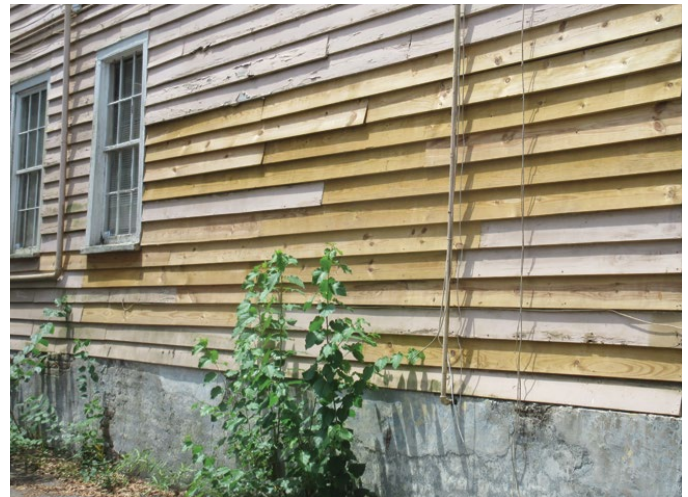
Figure 3: Incremental repair is best done using in-kind material to minimize differences in the performance characteristics that could negatively affect the overall assembly. Photo: NPS.

**Proposed siding material resembles the original historic material and will not destroy any distinguishing qualities or character. However, as stated on page 4, Figure 3 of Preservation Briefs 16, "Incremental repair is best done using in-kind material to minimize differences in the performance characteristics that could negatively affect the overall assembly."**

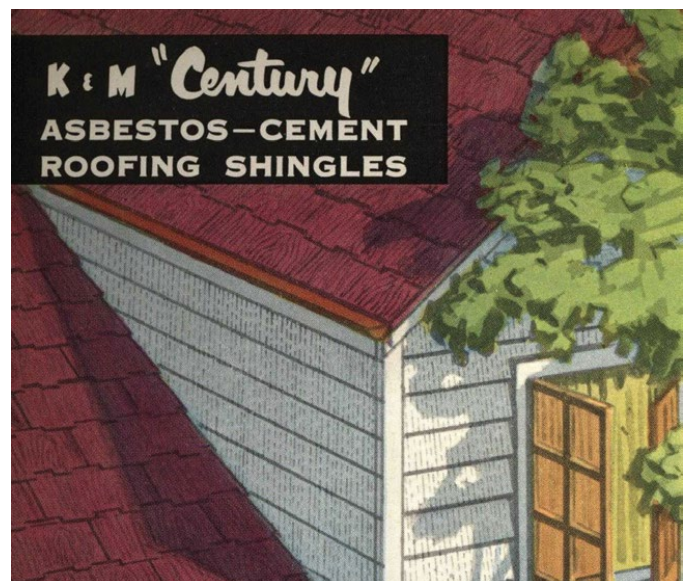
Figure 4. While occasionally used to imitate other materials such as wood or slate shingle, many asbestos shingles and siding materials had their own distinct shape and profile. No longer manufactured today, alternative materials must be found to replace these materials when they are distinctive features on a historic structure. Drawing: Association for Preservation Technology, Building Technology Heritage Library.

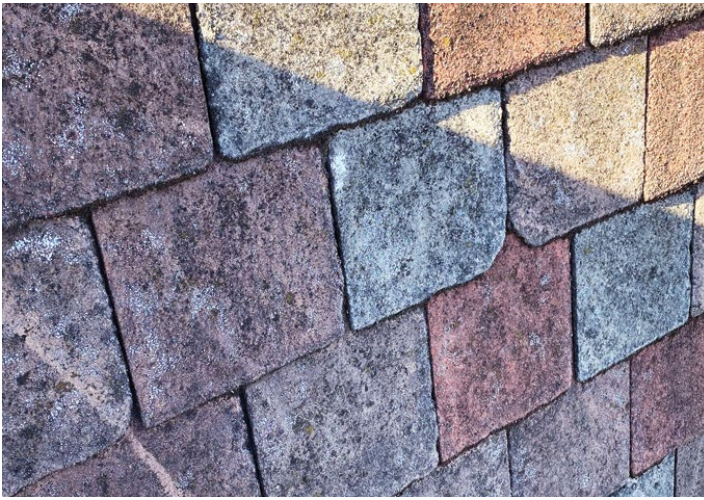
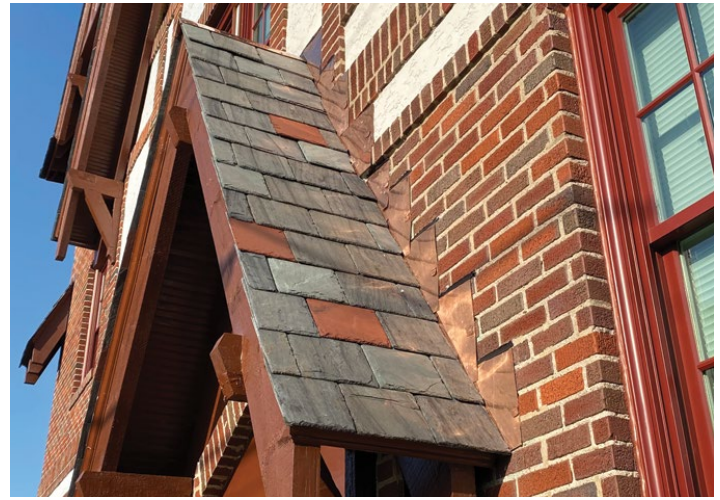
Figure 5. (Left) Asbestos shingles were often used as a substitute for traditional slate roof shingles. The historic asbestos roof on this rehabilitation project had reached the end of its lifespan and required complete replacement. (Right) Given the limited replacement materials available to match the historic asbestos shingles, utilizing natural slate was determined to be the best visual match for the original shingles and design intent in this instance. Photos: Crosskey Architects.

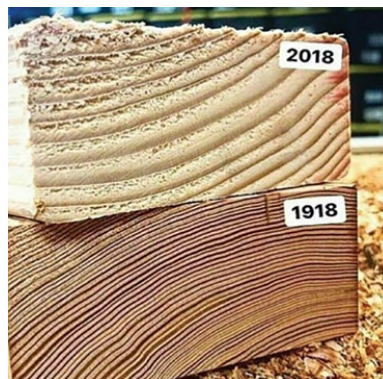
*Figure 6. The dramatic difference in the number of growth rings between old-growth wood and wood that was recently harvested from second- or third-growth forests is indicative of the diminished dimensional stability and durability of most lumber currently available. Photo: Zachary Dettmore.*

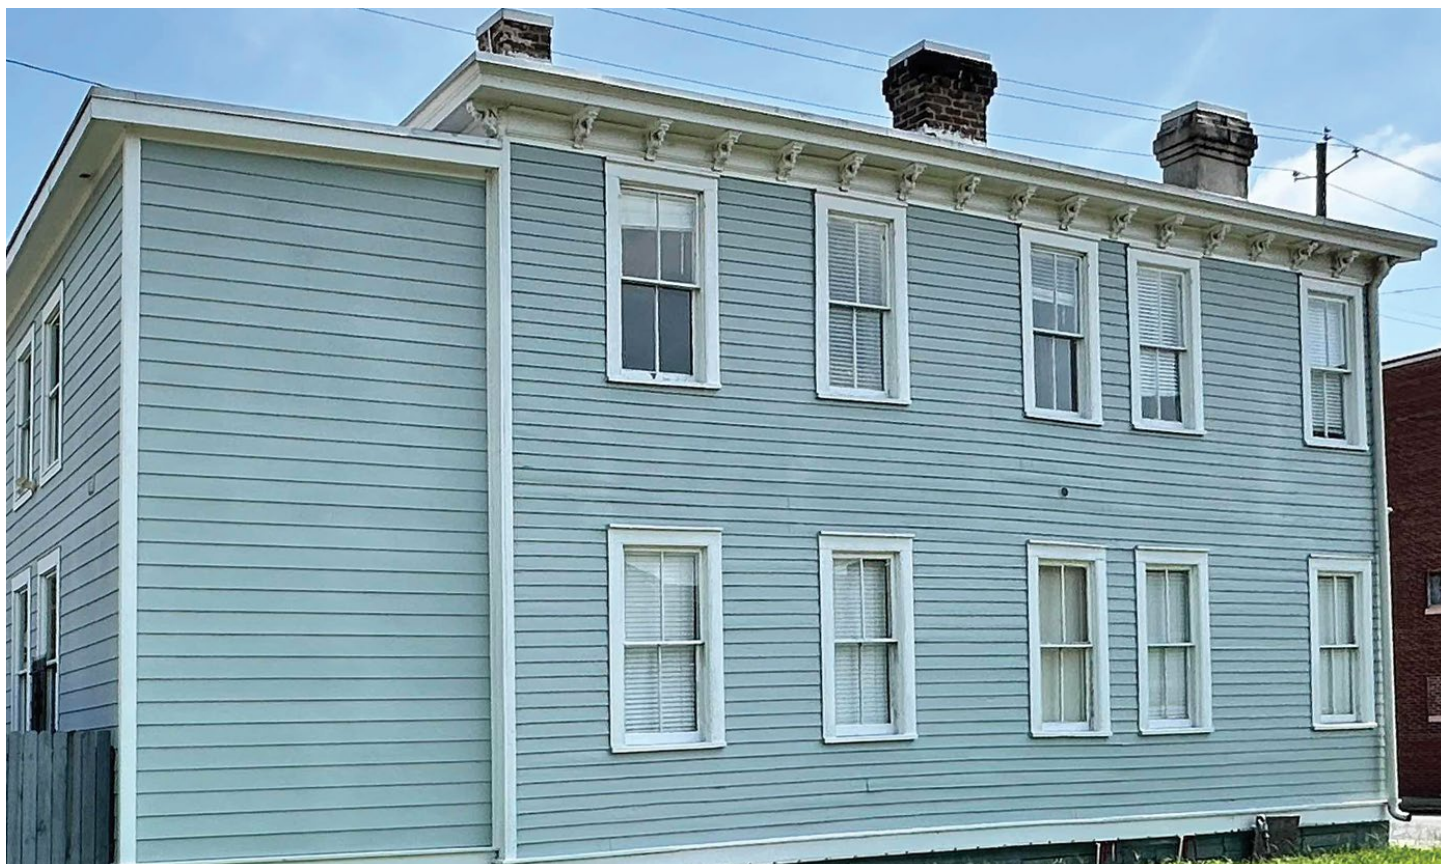
*Figure 7. A new addition replaced non-historic construction on the rear elevation of this building. Fiber cement gives the addition a compatible appearance without replicating the exposure for thickness of the historic siding. Photo: Ward Architecture + Preservation.*

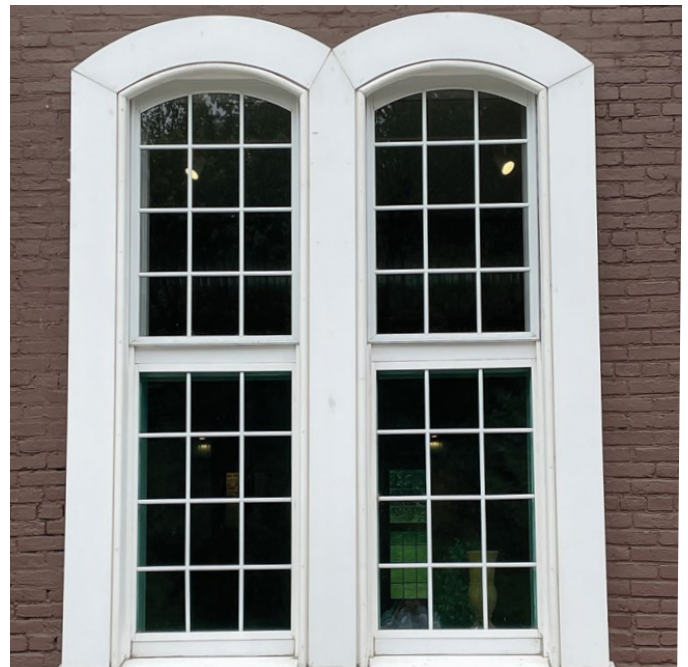
*Figure 9. Previously bricked-in openings below the flood line were reopened and new aluminum windows installed with cellular PVC trim detailed to hold back moderate flood waters and survive exposure to water. Photo: John Sandor, NPS.*

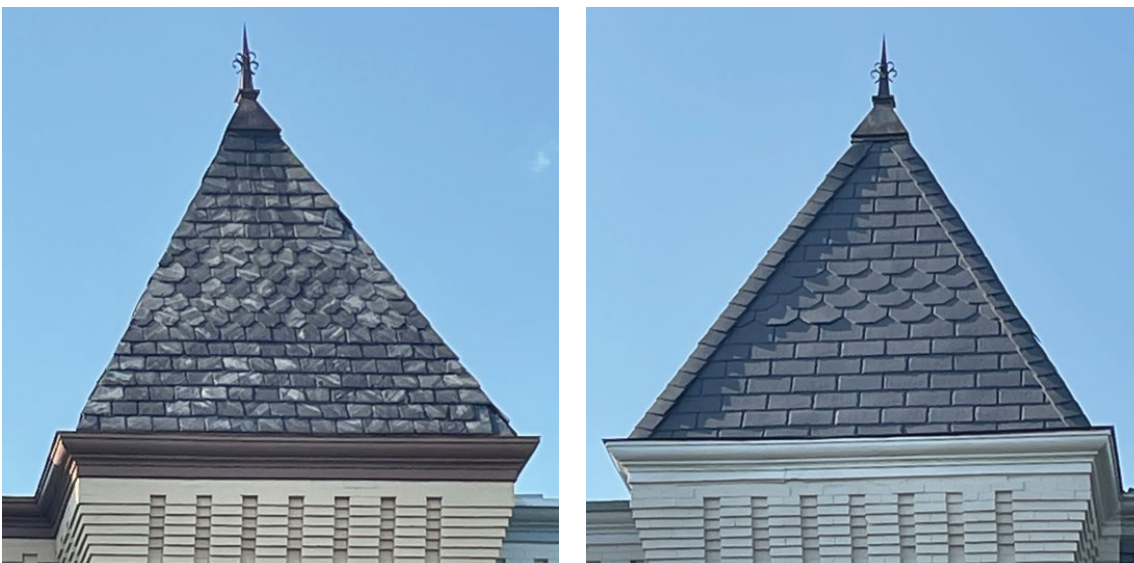
*Figure 10. Polymer slates offer a choice of shapes but not sizes, limiting their ability to achieve a good visual match for some historic slate. With the size of the polymer slates (right) being nearly twice that of the historic slates (left), the scale of the entire feature is incompatibly altered. The molded edges of this material, which contribute to its ability to replicate slate, would be lost if each shingle was resized by cutting. Photo: John Sandor, NPS.*

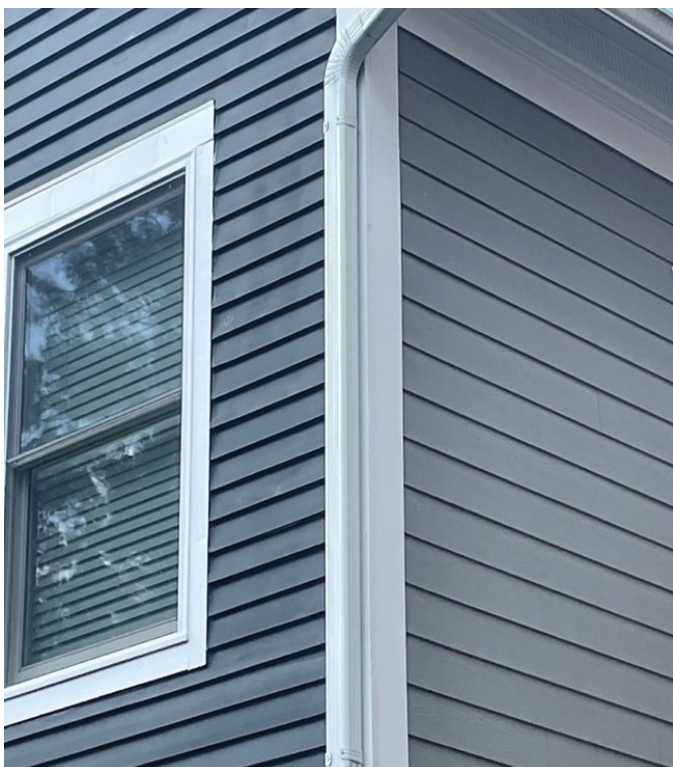
*Figure 11. The thickness of the wood siding on the front (left) creates a deeper shadow line than is achieved with the fiber cement siding used on the side (right) elevation. While the exposure can be adjusted, fiber cement siding is not available in a matching thickness. Photo: John Sandor, NPS.*

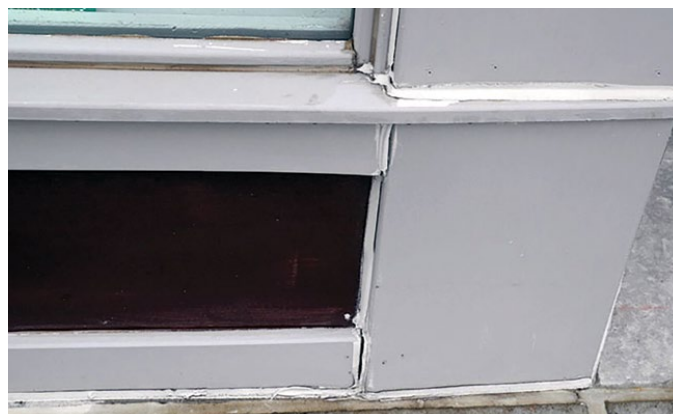
*Figure 12. Cellulose composite materials, like wood, expand and contract with moisture. Here it was used to reconstruct a missing storefront. Unlike solid wood that is dimensionally stable parallel to the grain, this composite moves equally in all dimensions, resulting in gaps that were not adequately anticipated in the design. Photo: John Sandor, NPS.*

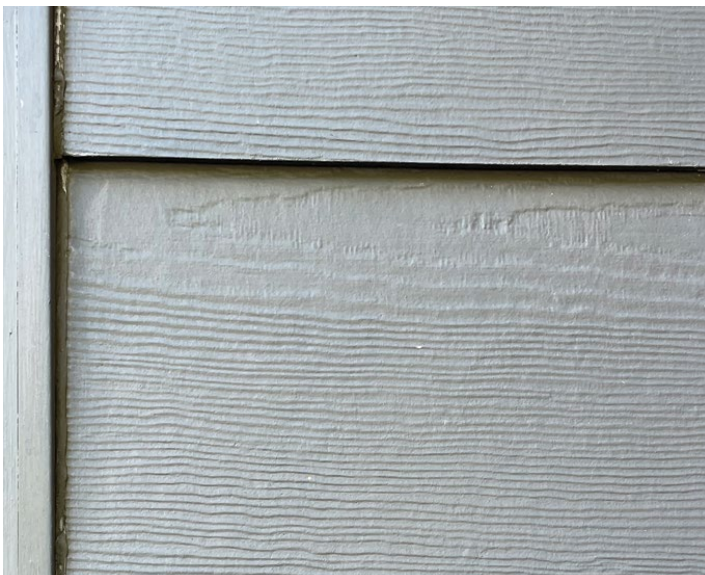
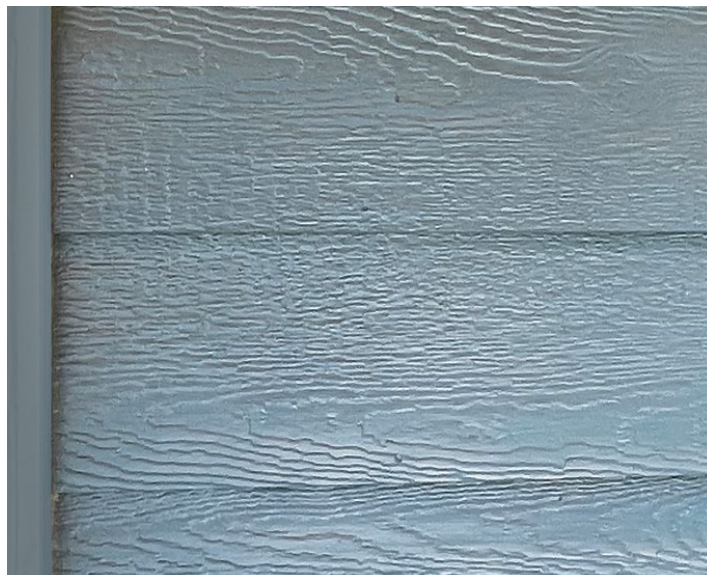
Figure 14. Surface texture is an important aspect in matching the appearance of a historic material, especially when a material is viewed at close range. As seen in these two images, many of the substitute materials produced for siding and trim have an embossed wood grain, making them incompatible for replacing historic wood that was typically planed to a smooth surface. Some substitute products are available with a smooth surface as well. Photos: John Sandor, NPS.

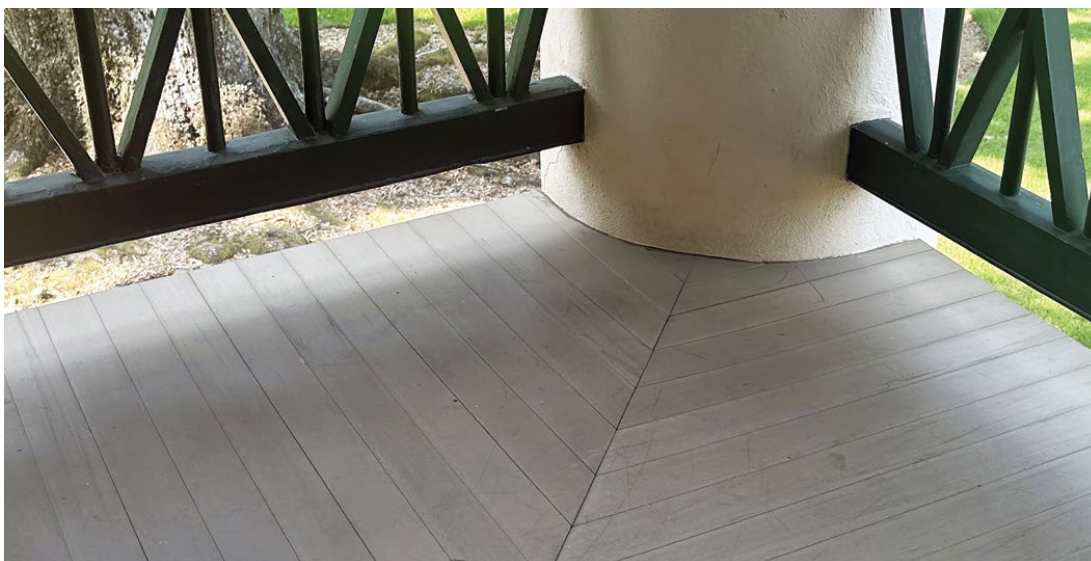
*Figure 15. Tongue-and-groove porch flooring is manufactured in several different substitute materials. Each type has different properties, though most are more moisture-resistant than wood. The prefinished product shown can be painted when worn, but repainting is not recommended for some product choices. Photo: Oak Alley Foundation.*

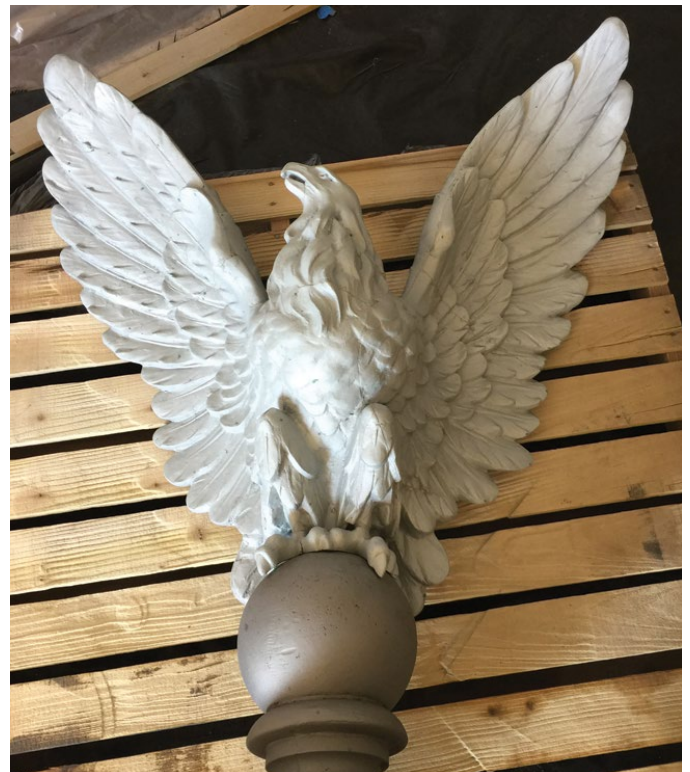
*Figure 16. Aluminum is a highly corrosion-resistant metal that is commonly used as a substitute material for cast iron. Aluminum can be a more affordable and lightweight alternative to cast iron that retains a similar texture, shape, and maintenance cycle. Photo: NPS.*

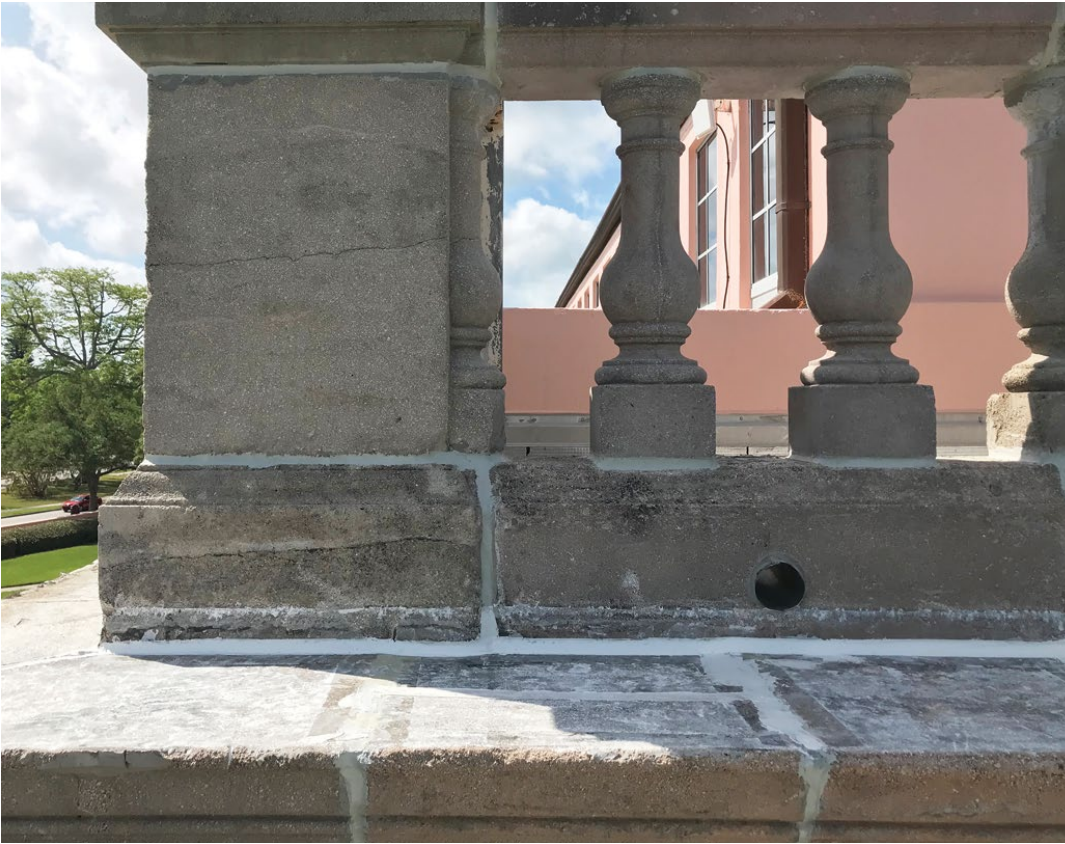
*Figure 17. The balustrade consists of multiple prior campaigns of using cast stone to replace the natural stone. The effective match for the surface texture and color of the original stone allowed individual elements to be incrementally replaced only when they had failed, thus retaining the maximum amount of original material as long as possible. Photo: EverGreene Architectural Arts.*

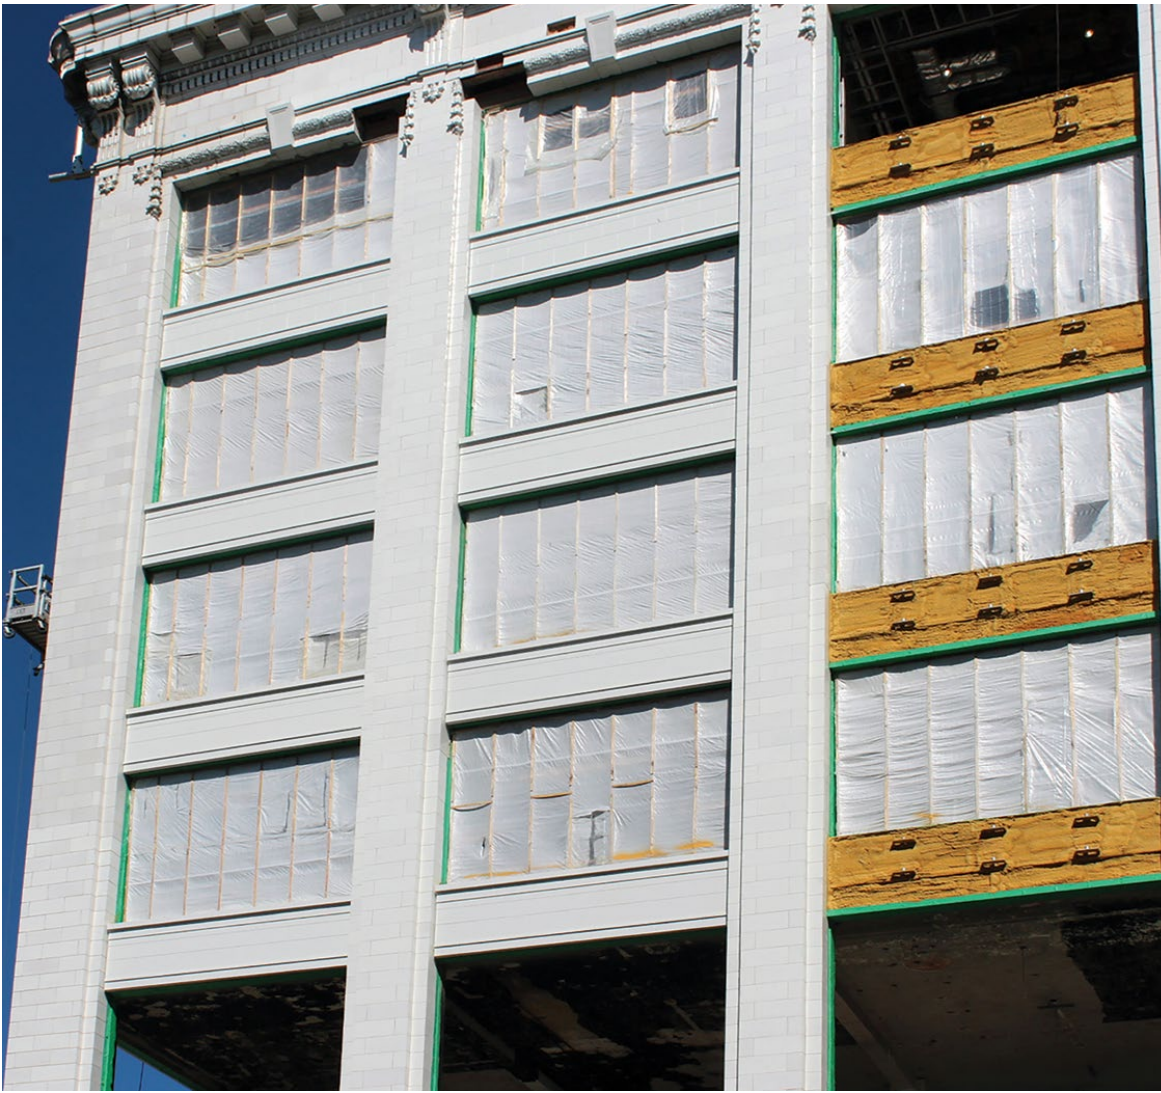
*Figure 18. Missing historic terra cotta spandrel panels on all floor levels were recreated utilizing glass fiber reinforced concrete (GFRC) replacements. New spandrels were fabricated as individual components and attached with metal clips between historic terra cotta piers. Photo: Kris Frail, Dewberry.*

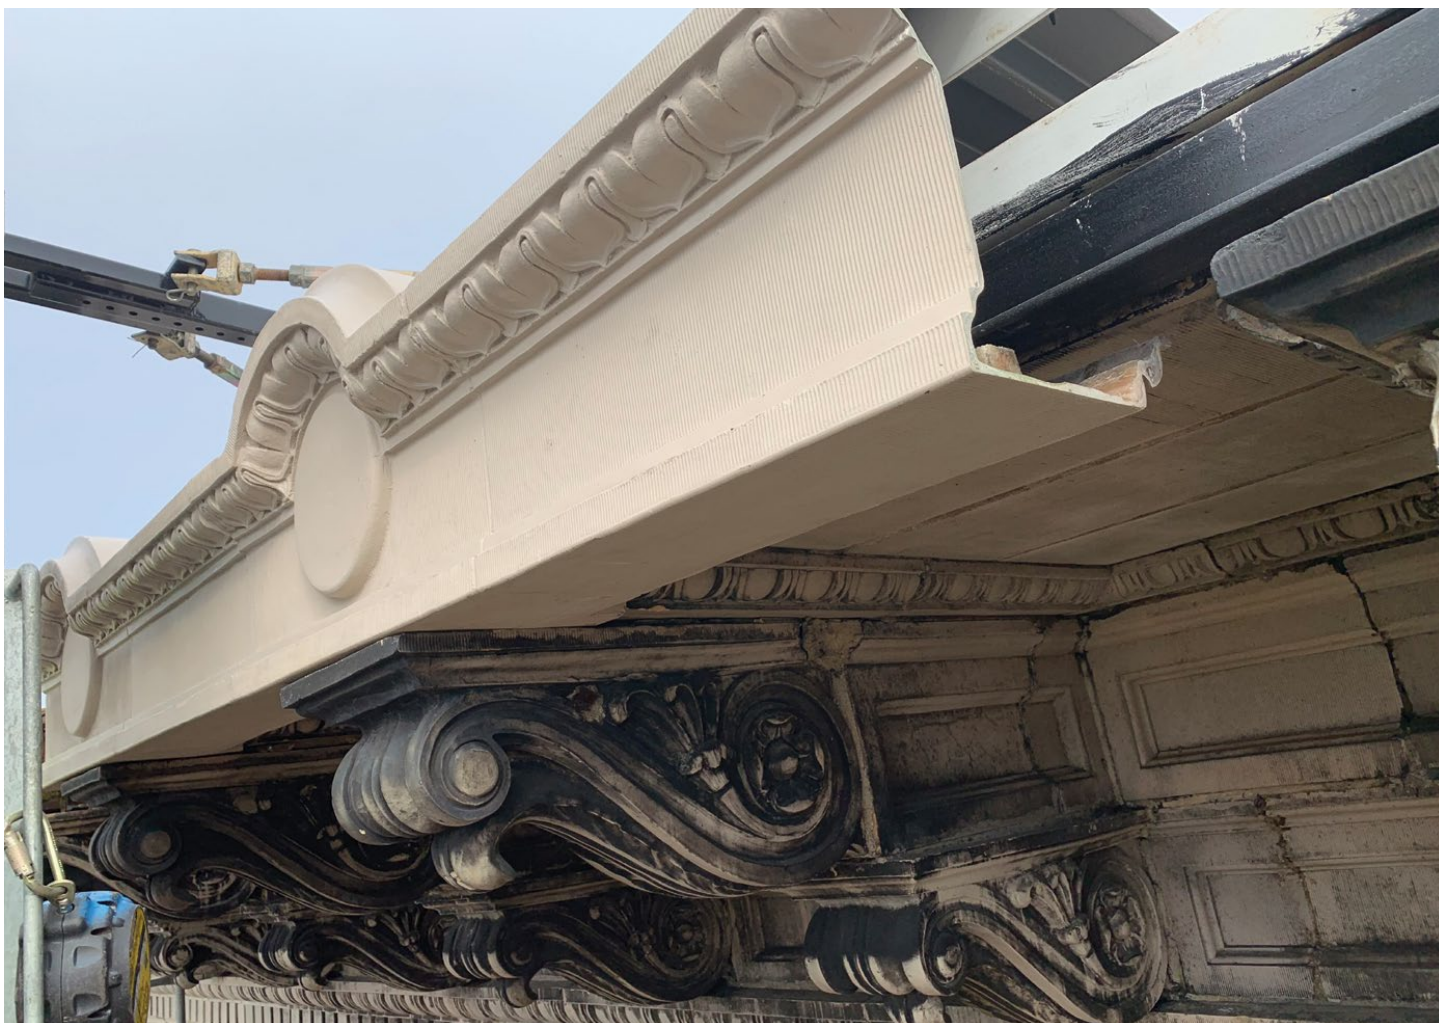
Figure 19. A new, lightweight fiber reinforced polymer is attached to a new metal armature to replicate damaged and missing elements of a terra cotta cornice. Photo: Quinn Evans.

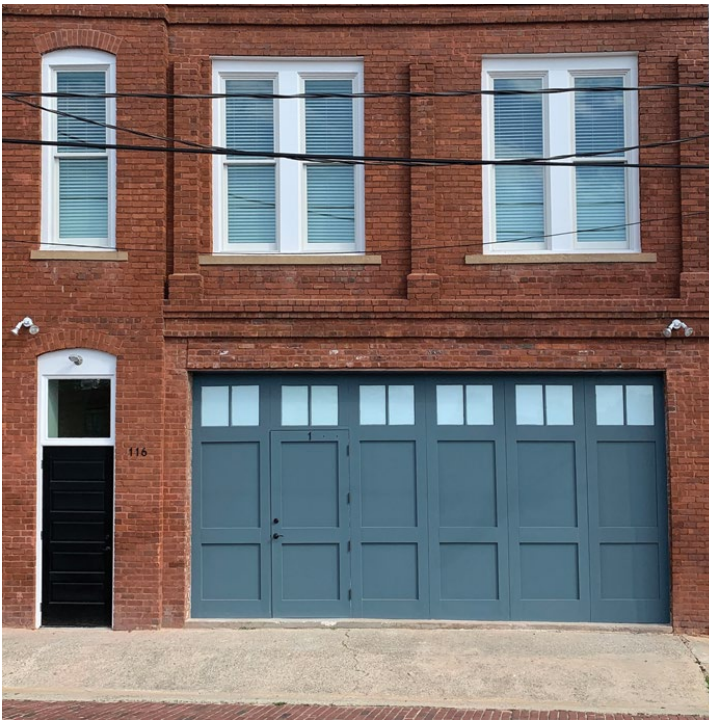
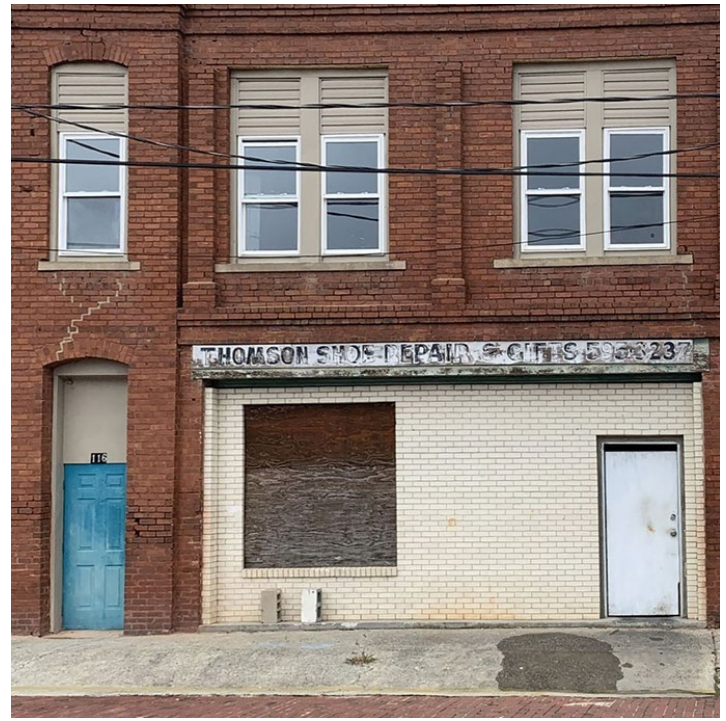
Figure 20. Cement board was used to replace a non-historic infill and mimics the configuration of a typical vehicular door of the period.  
Photos: Historic Augusta.

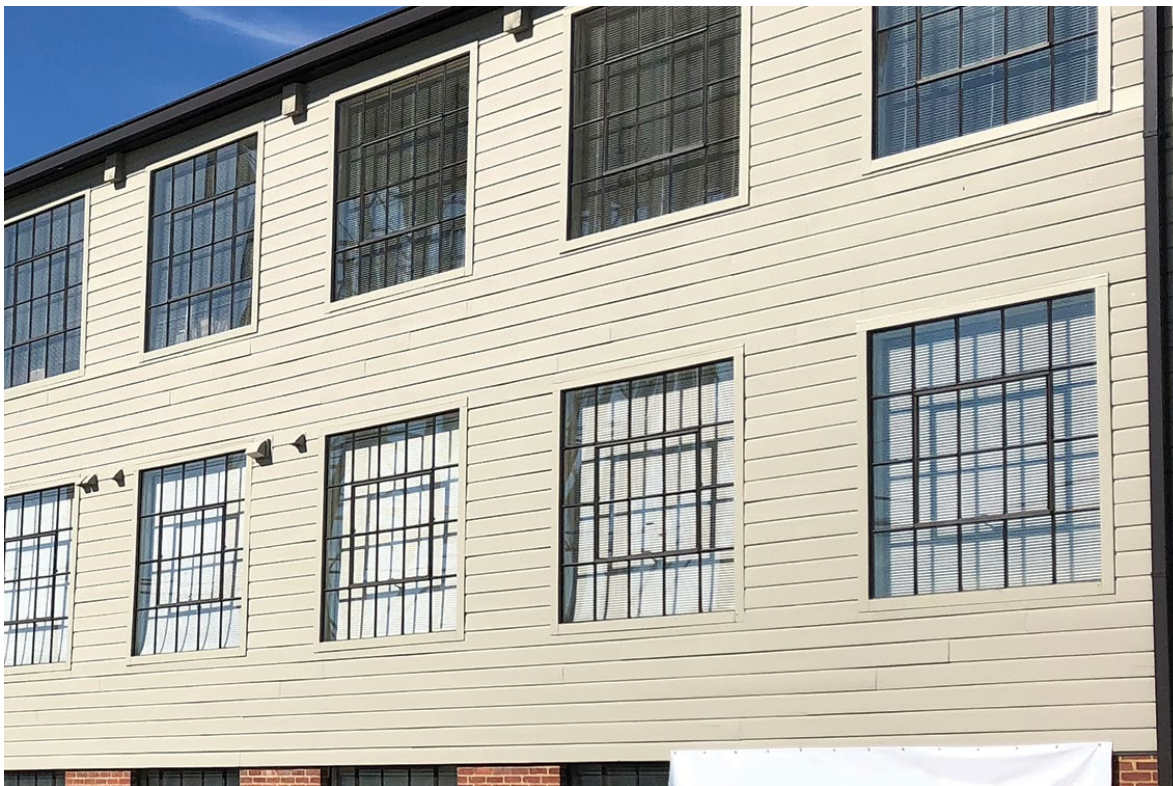
*Figure 21. A mineral polymer composite siding was available in the profile very similar to the historic siding. The replacement siding was used where the original material was almost completely missing beneath a more modern covering. Areas where the original wood was largely intact were replaced with matching wood to sustain more of the material integrity of the building. Photo: Belk Architecture.*

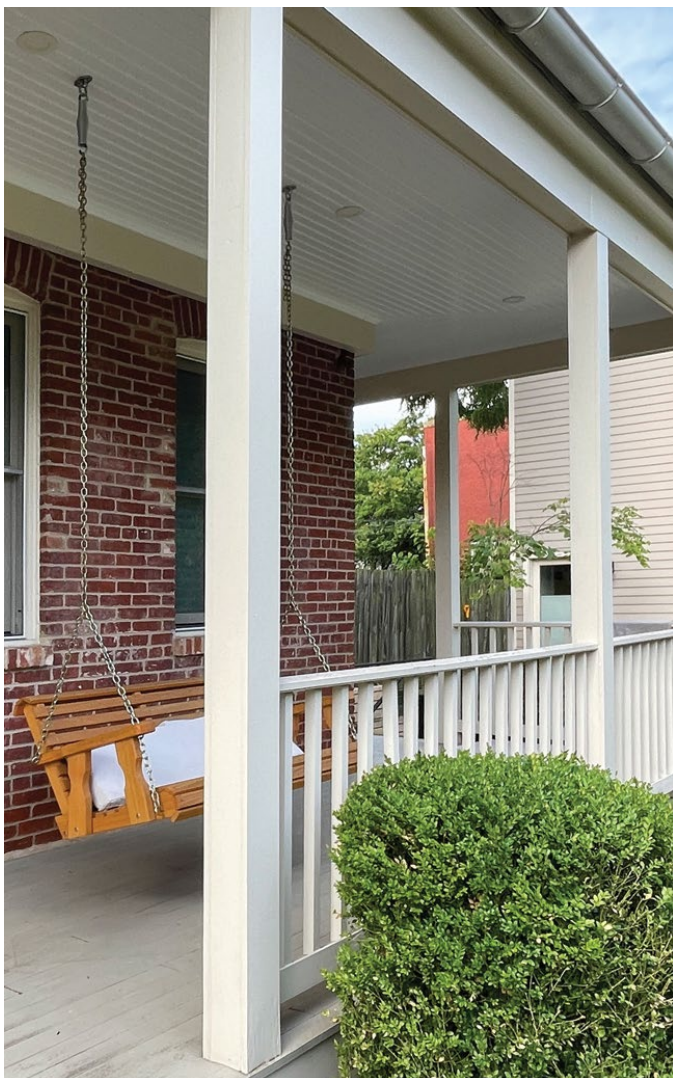
*Figure 22. A porch was reconstructed using posts fabricated on site from a smooth-surface cellulose/polymer composite material. Though the face of the posts are painted, the lack of paint on the bottom at the cut ends is not consistent with manufacturers' recommendations. This treatment will allow moisture to be absorbed, shortening the life of the new replacement feature. Photo: John Sandor, NPS.*

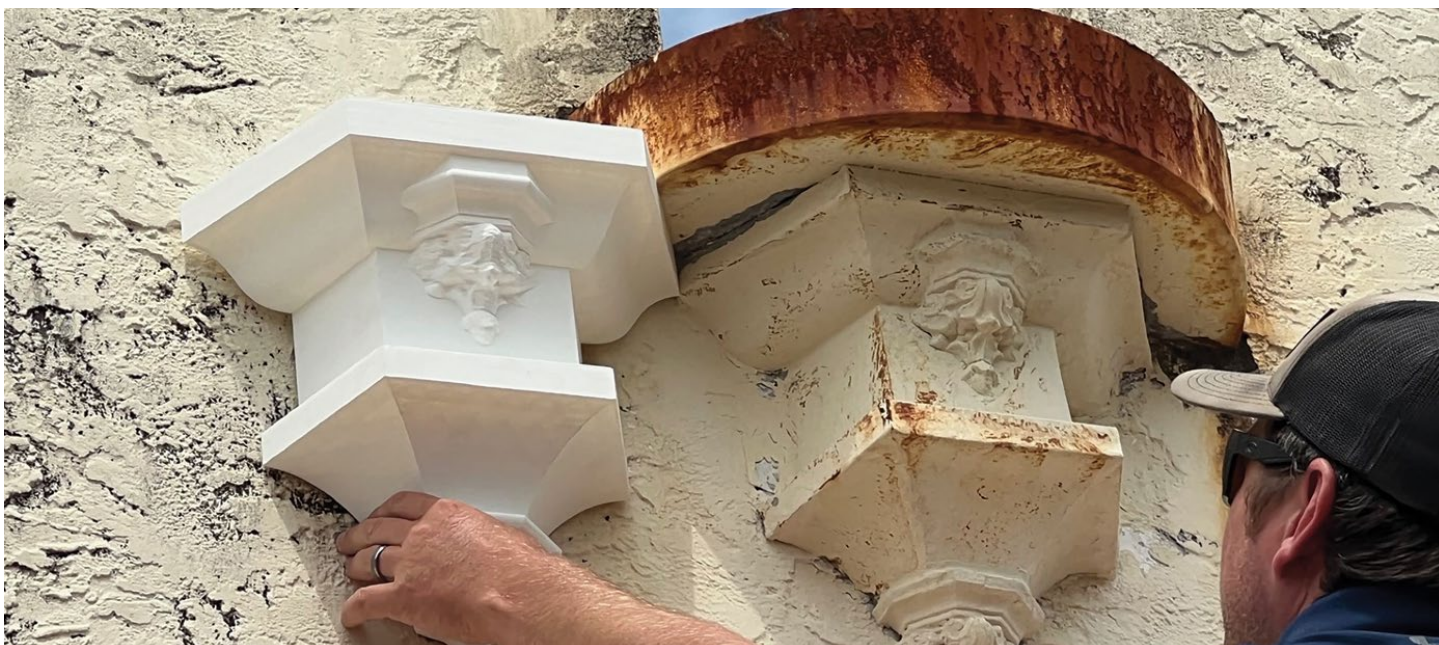
Figure 23. 3-D printing using various polymers is occasionally used to replicate missing metal or wood features. This new application is continually being refined, but the application can be successful when a painted, lightweight feature needs to be replicated. Photo: NPS.

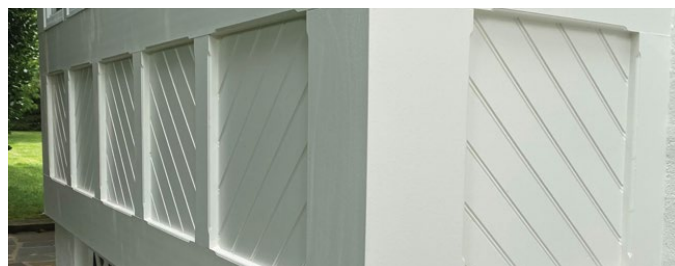
*Figure 24. Cellular PVC when painted can be used to replace deteriorated wood features. This beadboard set in a wood frame was not historically designed to shed water effectively and had deteriorated. Cellular PVC was able to match the appearance of the wood details, while its properties were well matched to the shady location, painted finish, and limited size and configuration within the overall assembly; thus, it should provide a long-lasting solution for this application. Photo: Jennifer Balson Alvarez, NPS.*

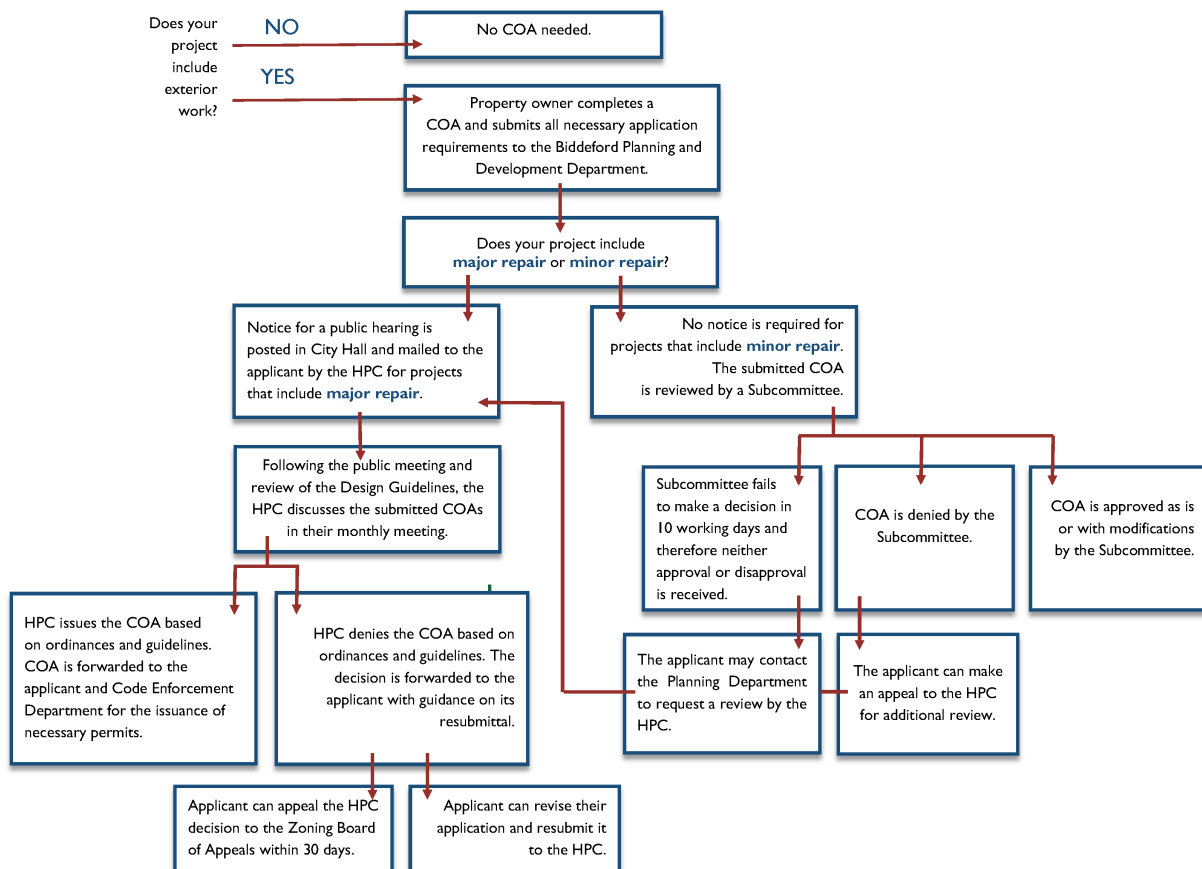
Figure 7: Flow chart outlining the Design Review Process in Biddeford.

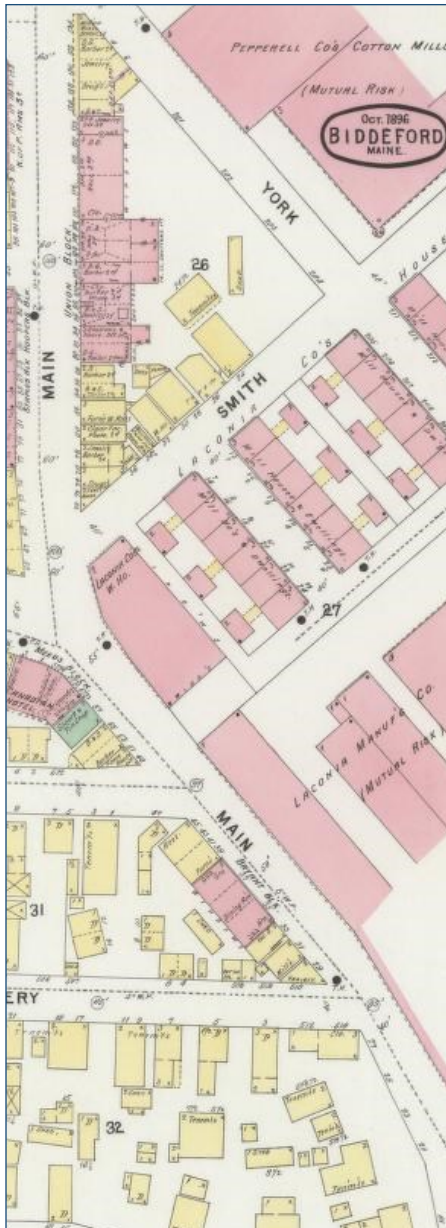
Figure 8: This 1896 fire insurance map, published by the Sanborn Company, illustrates Biddeford along Main Street in that year.

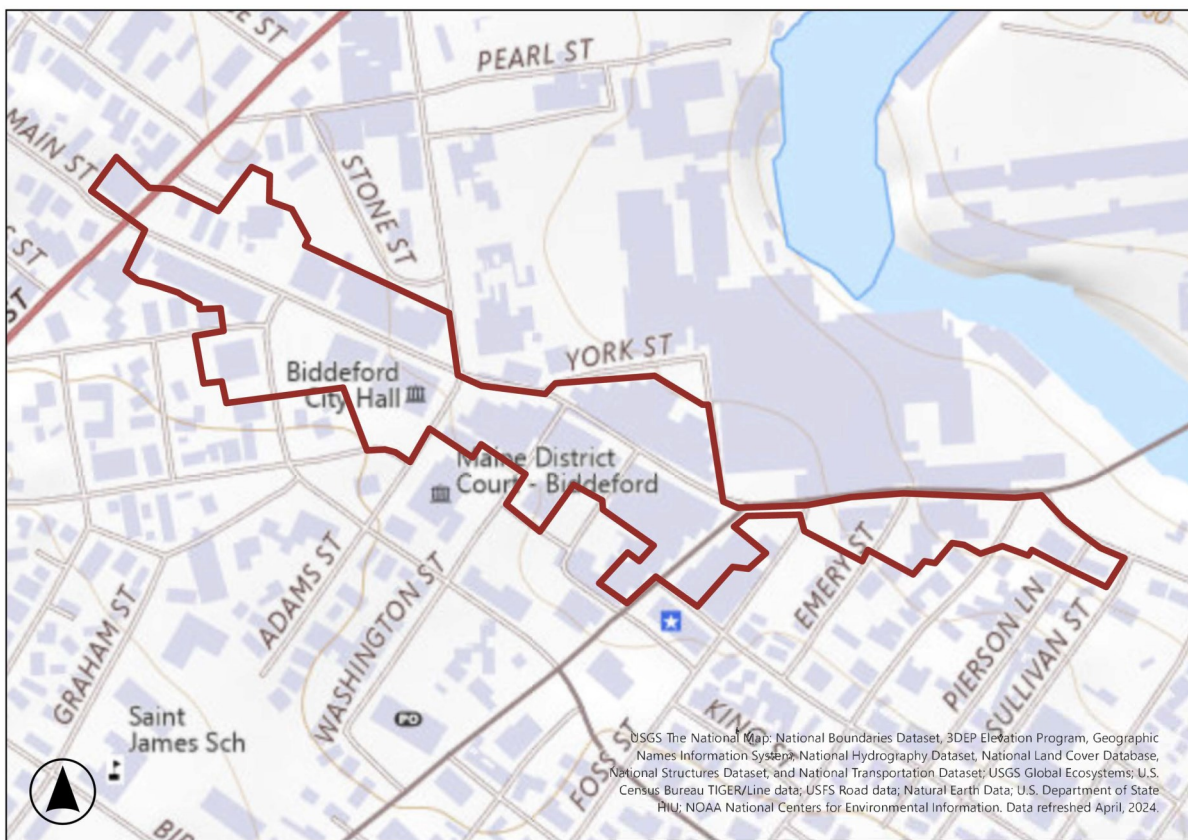
Biddeford Main Street Historic District Boundary

Figure 14: Map of the Biddeford Main Street Historic District.

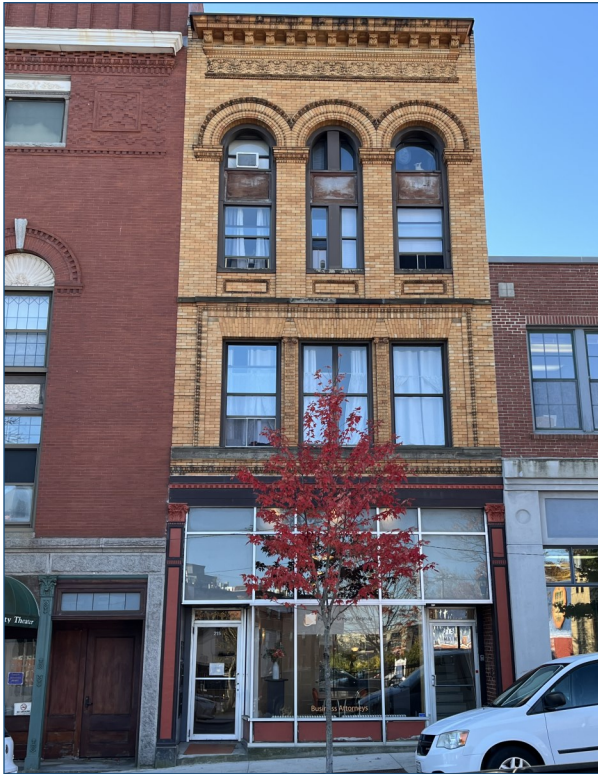
Figure 15: Italianate commercial building located at 215 Main Street.

The district includes mainly two- to four-story brick or frame buildings with first-floor storefronts and upper-story office or residential uses. The most prominent stylistic influence is Italianate, although Greek Revival, Romanesque Revival, Art Deco, and Classical Revival are also represented. Common details include segmental arch windows and pressed metal cornices with decorative brackets. The storefronts are visually separated from the upper stories and usually have display windows and recessed entrances. The civic and religious buildings follow many of the same stylistic principles, with notable details that discern them from the commercial buildings, such as the tower on City Hall. Several of the commercial buildings are distinguished by materials, such as the Marble Block, or through design, such as the Egyptian Revival J.K. Paquin Building.
