**City of Biddeford**  
**Historic Preservation Commission**

April 9, 2025 at 4:00 PM  
City Hall Council Chambers & Zoom

**HPC MEETING**  
**March 12, 2025**  
**Meeting Minutes**  
**4:00**  
**DRAFT**

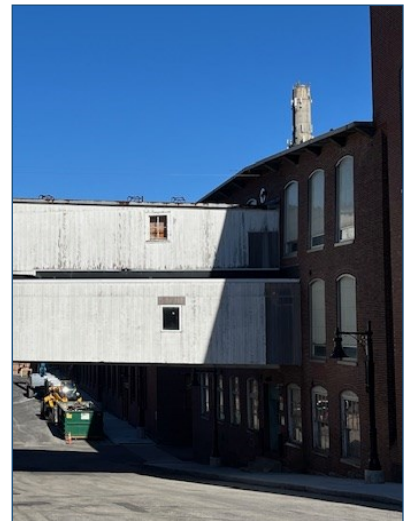
Figure 20: Wooden enclosed bridges can be found throughout the Biddeford / Saco Mills Historic District. The bridges connect the former mill buildings.

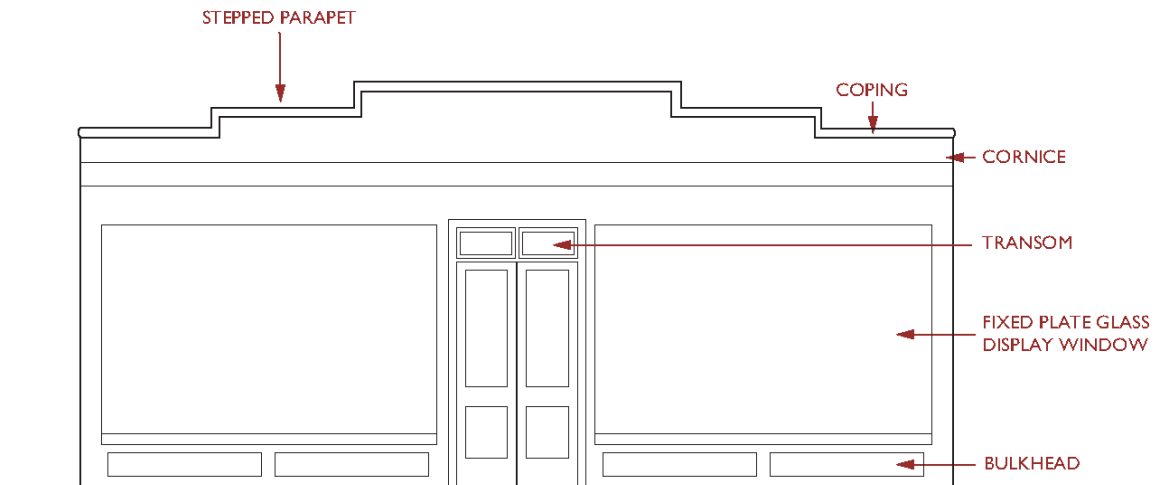
Figure 24: One-Part Commercial Block diagram.

This building type is a single story and was typically constructed in urban settings to house retail shops, banks, or restaurants. These buildings tend to be wider than they are tall and feature large windows to display the goods provided inside. One-part commercial block type buildings often feature recessed entrances, and decorative cornices or parapets on the façade. This type is not as common in Biddeford but is still represented.

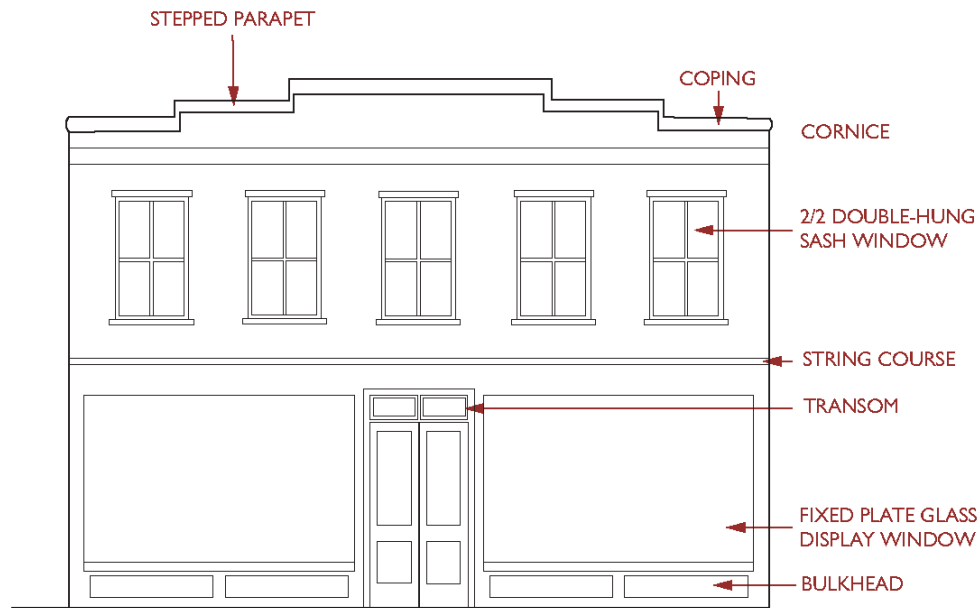
Figure 25: Two-Part Commercial Block diagram.

This building type is common throughout the United States. These buildings are two to four stories in height and divided into two distinct parts based on interior uses. Public spaces such as storefronts, lobbies, or restaurants, are located at ground level, with private spaces, such as apartments or offices on the upper stories.

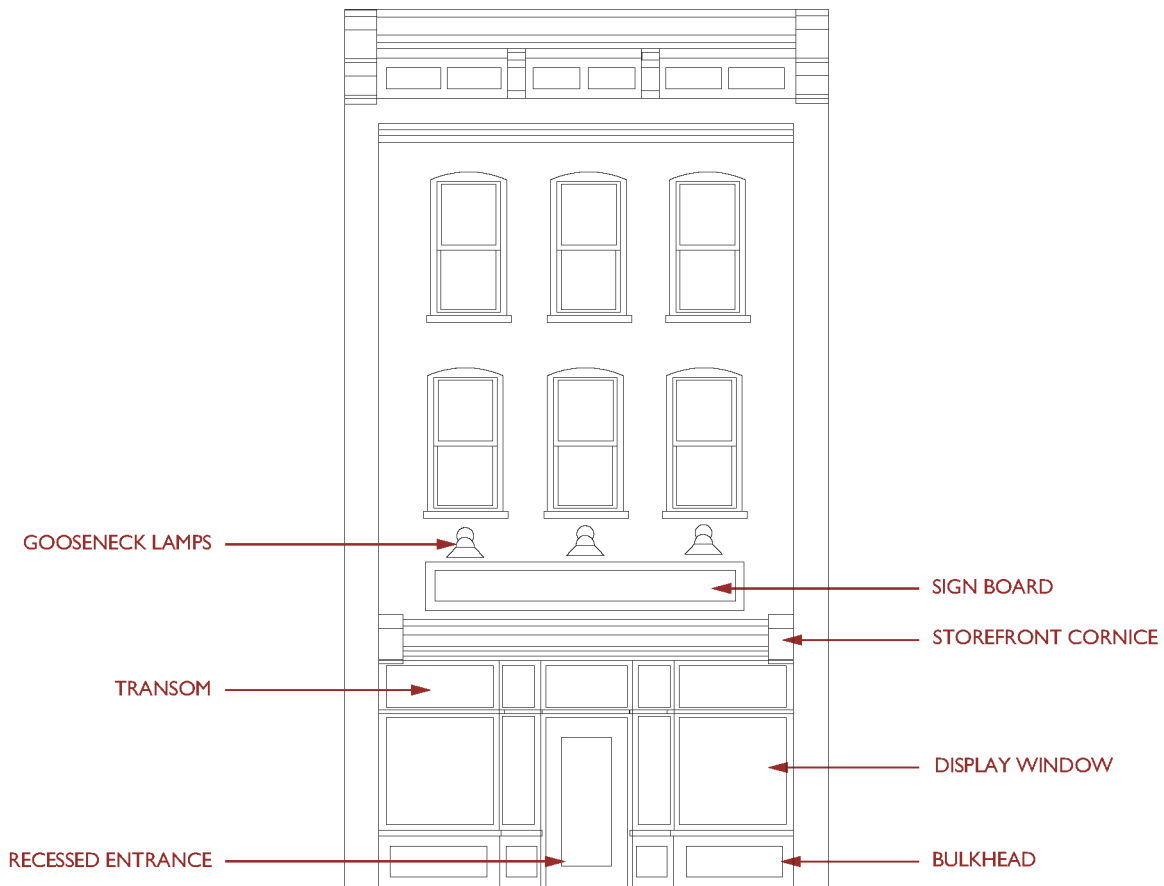
Figure 26: Vernacular Storefront diagram.

The vernacular commercial storefront of the late 19th and early 20th centuries commonly appears as the first-floor level of the one- and two-part commercial block building types. These storefronts feature large windows for the display of goods and a recessed main entrance which may be centered or aligned to one side of the building. The majority of Biddeford's historic commercial buildings feature vernacular storefronts.

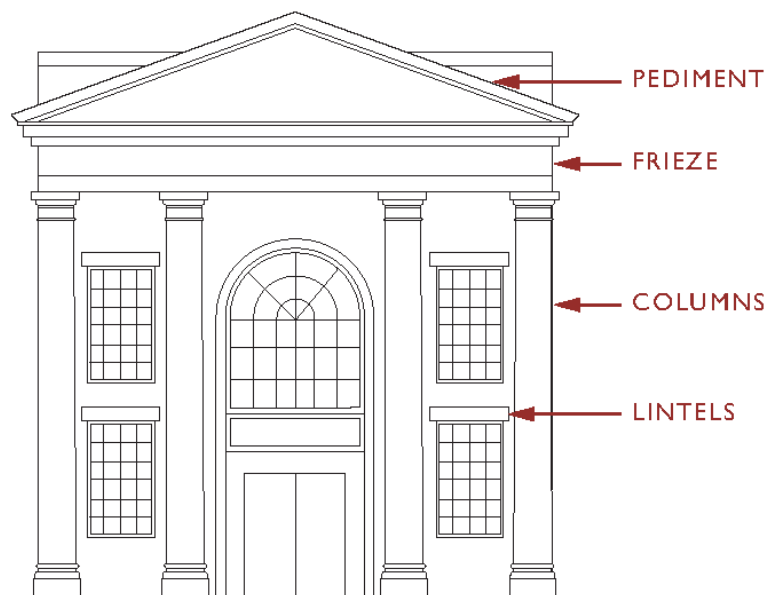
Figure 27: Temple Front diagram.

Temple front buildings have facades which mimic the temples of Greek and Roman antiquity. Rather than having been developed for commercial use as the other building types listed here, the temple front was most often used on religious, civic, and institutional buildings. A common exception is bank buildings, which, prior to the mid-19th century often had little in common with other commercial buildings in terms of appearance.

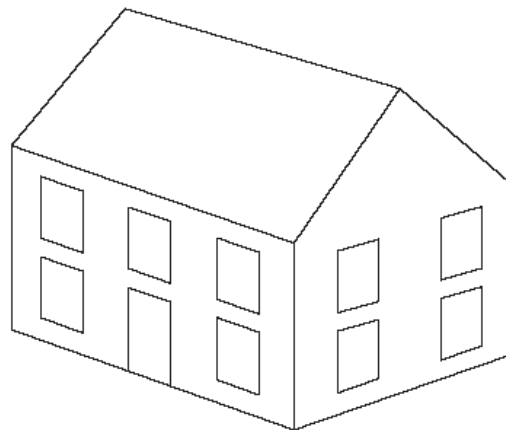
Figure 29: Double Pile diagram.

The Double Pile house, like the I-House, is typically three to five bays wide and two stories tall with a rectilinear shape and side-gable roofline. The Double Pile house is defined by its two-room depth. It follows one of the most common domestic floor plans found in the United States, the “Hall and Parlor” plan, in which a central hall with staircase is flanked by pairs of rooms on each side. The double pile form is most closely associated with the Georgian and Federal styles but was also commonly ornamented with Greek Revival, Gothic Revival, Italianate, Colonial Revival, and Classical Revival style details. It is also commonly found in its simple vernacular form with little stylistic detail.

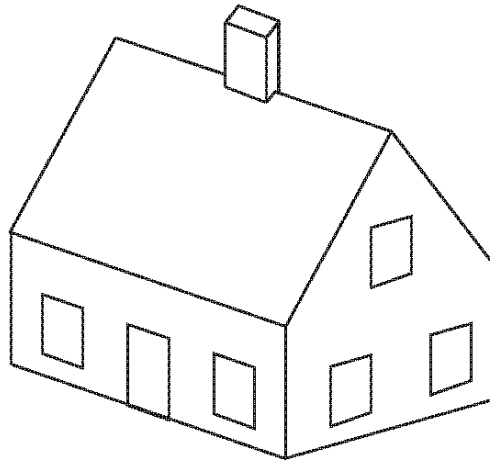
Figure 30: Cape Cod diagram.

The Cape Cod house is a common vernacular, early New England folk-house form. The Cape Cod style is traditionally five bays wide, two bays deep, and one-and-a-half stories tall with a side-gabled, steep roof. It has a symmetrical façade with a central chimney. This style can also feature partial-width front porches over the centered front door or dormers on the roof. It was also a popular building form because it was typically inexpensive to build and the simple form made it is easier to add on and configure the house.

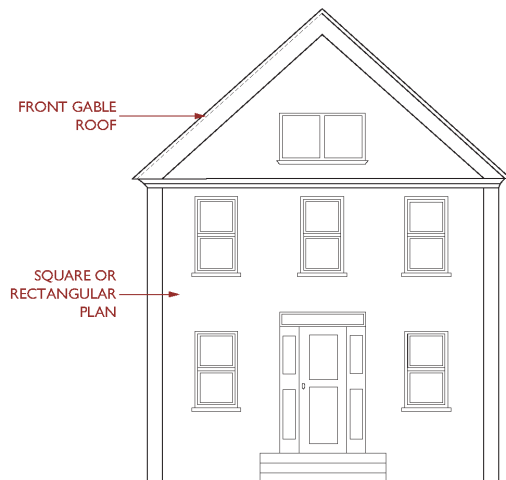
Figure 31: Gable-Front diagram.

The Gable-front house is another common vernacular form. Characterized by its simple, front-gabled roof, the Gable-front house type is typically rectangular or square in form. The narrow form of the gable-front type was well suited to narrow lots and the type is commonly found in urban neighborhoods and towns. Like other vernacular forms, this type may be found unornamented or with applied ornamentation from a variety of architectural styles.

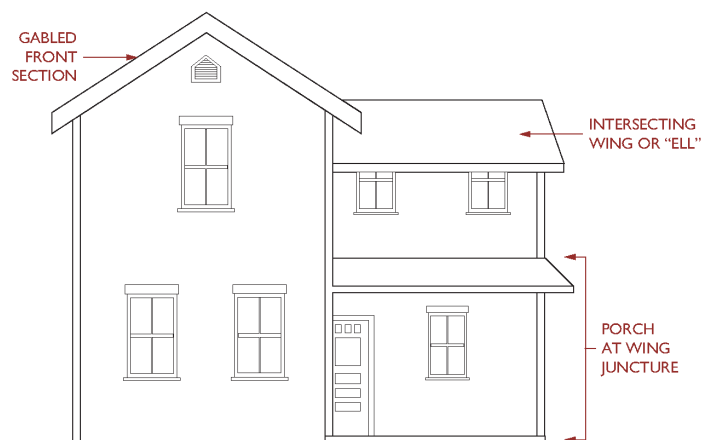
Figure 32: Gable-Ell diagram.

The Gable-Ell house is typically two stories and is characterized by a gable-front central mass with an intersecting wing (the “ell”) placed perpendicularly, creating an L shaped plan. The long side of the ell is typically oriented towards the street, and a porch is often located at the juncture of the two wings. Like the other building types mentioned, the gabled ell house was often ornamented with Victorian-era details, and the porch was commonly updated to reflect changing tastes and architectural fashions.

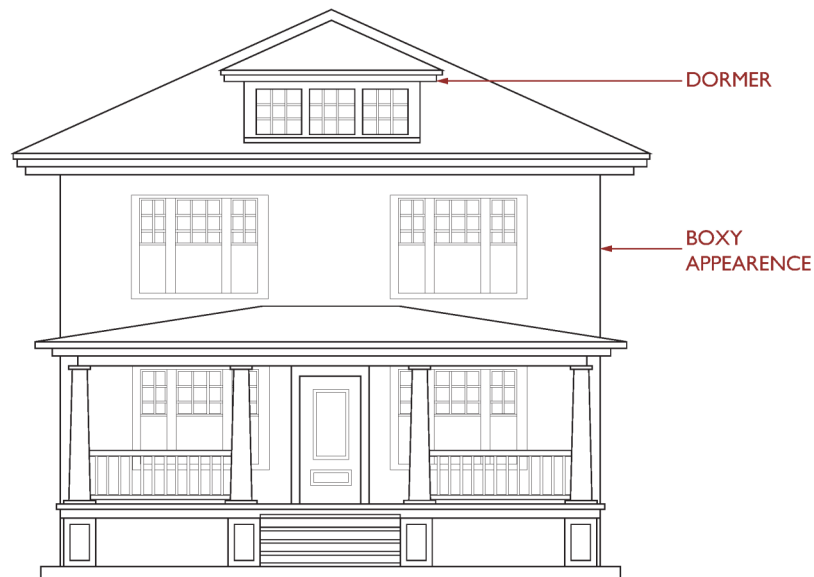
Figure 33: American Foursquare diagram.

The American Foursquare is characterized by its boxy appearance, square or rectangular plan, and hipped or pyramidal roof. They are two-and-a-half stories high, and many have hipped or shed dormers. Dormers were typically centered over the front façade or placed on all four sides of the hipped roof. The form was ubiquitously popular on farms, in suburbs, and in more urban areas with larger lot sizes. These houses were popularized by their appearance in pattern books. Prefabricated versions were also available for purchase. These houses commonly incorporated Craftsman style elements but can be found with stylistic details from a variety of architectural styles, including Mediterranean Revival style barrel tile roofs or Colonial Revival style porches.

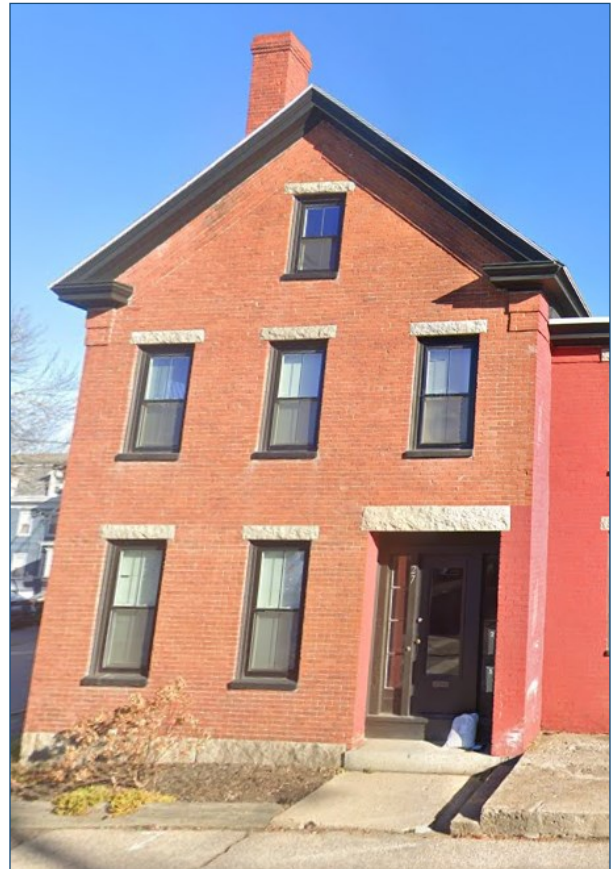
Figure 40: Residence with Greek Revival elements such as general symmetry, pronounced lintels over windows and doors, and a decorative cornice with a gable return.

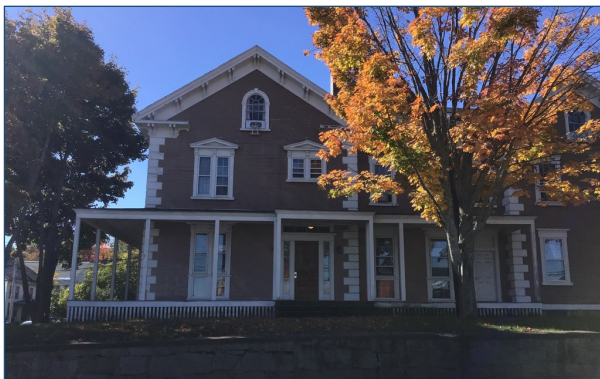
Figure 43: Italianate style residence that features quoins at the corners and prominent hoods over the windows.

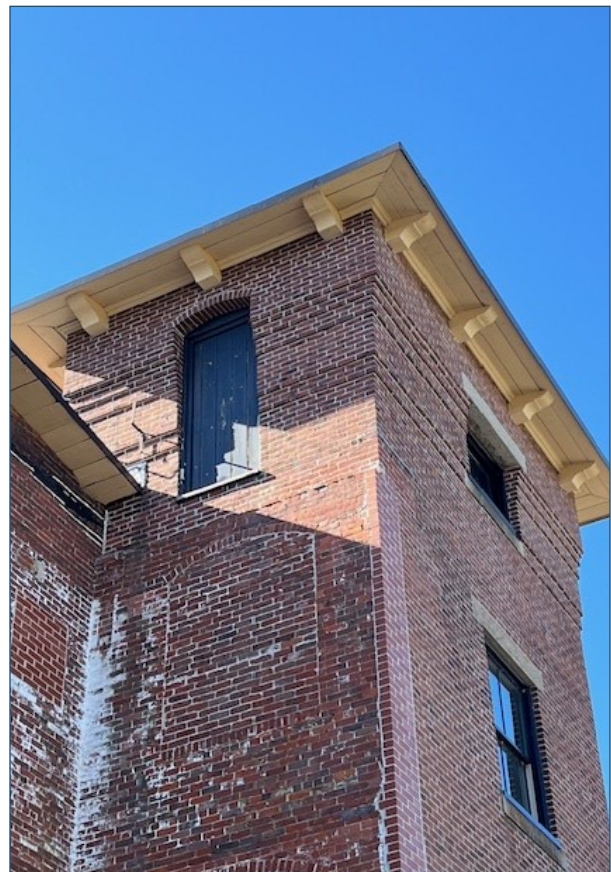
Figure 45: Stair tower on one of the mill buildings within the Biddeford / Saco Mill Historic District that features Italianate elements in the roof.

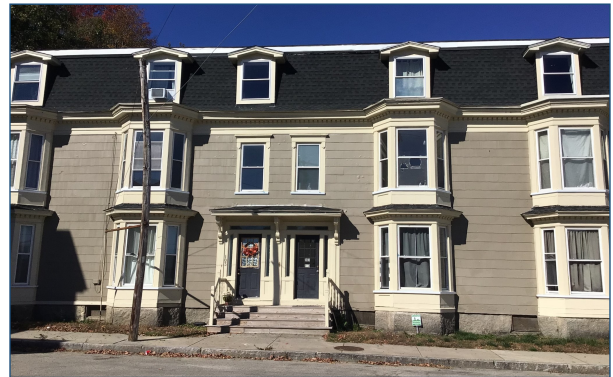
Figure 47: Example of a Second Empire style multi-family residence.

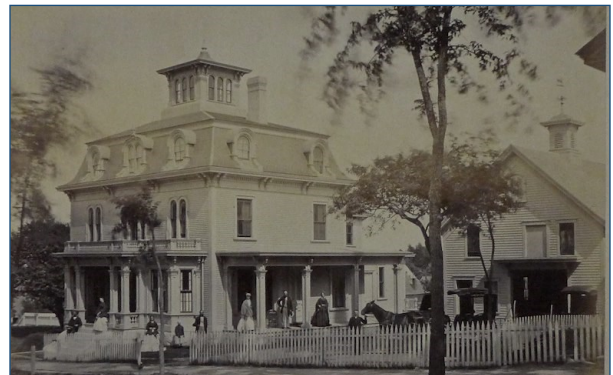
Figure 48: Historic photo of a high-style Second Empire style residence. Source: Biddeford Historical Society.

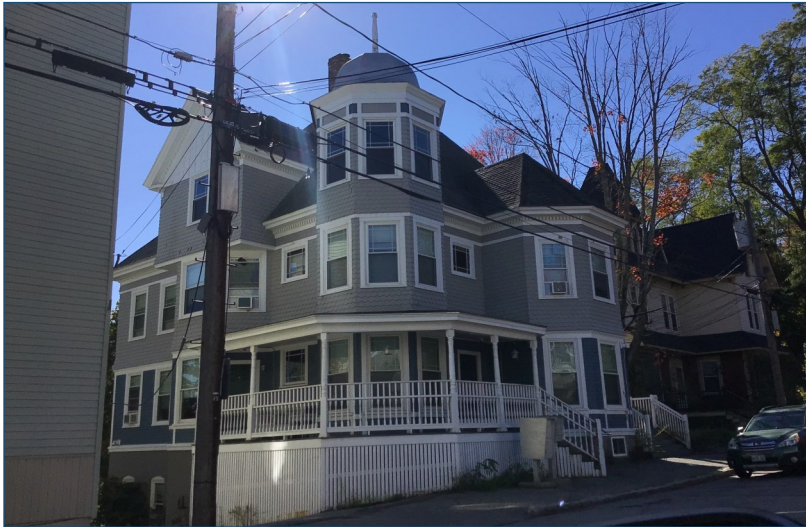
Figure 49: Queen Anne style residences are typically constructed larger in size and so many have later been converted to multi-family homes.

The Queen Anne style was successfully adapted to residential, commercial, and institutional uses. Queen Anne buildings are typically asymmetrical in plan, and feature turrets, window bays, towers, complex rooflines, decorated chimneys, and large and ornate porches. A variety of materials with contrasting textures, including brick, wood stone, slate, and tile were often combined to create a picturesque effect.

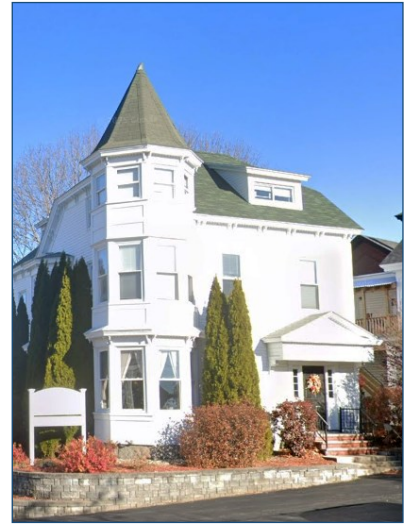
Figure 50: Queen Anne style buildings were typically constructed as residences.

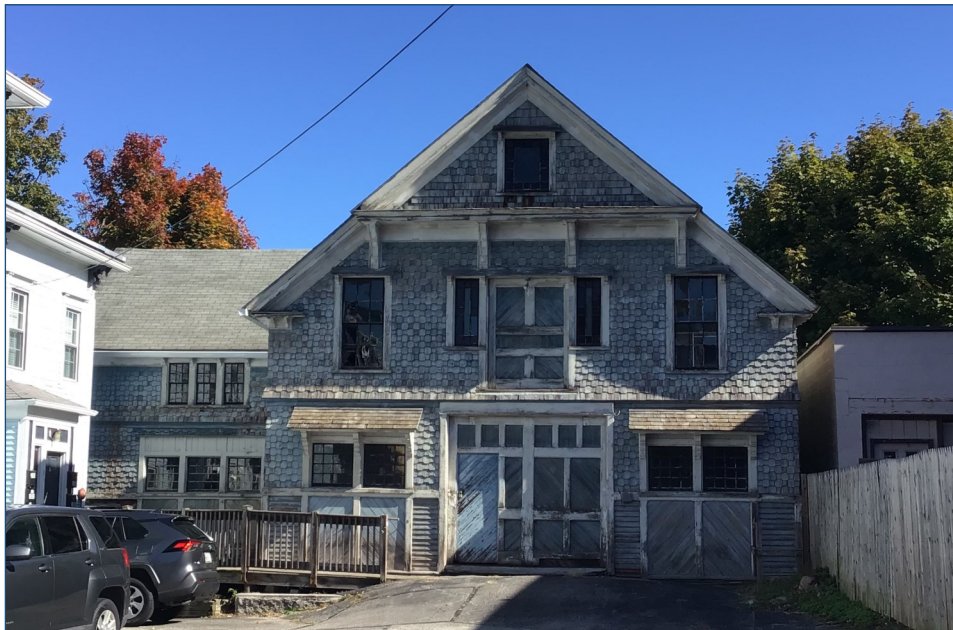
Figure 51: Shingle style carriage barn outbuilding that retains wood clapboard siding, a variety of shingles, and multi-light double-hung wood windows.

The Shingle style features wall cladding and roofing of continuous wood shingles; uninterrupted shingle walls (no corner boards); an asymmetrical façade; irregular, steeply pitched roof lines; roofs with intersecting cross gables and multi-level eaves; and extensive porches.

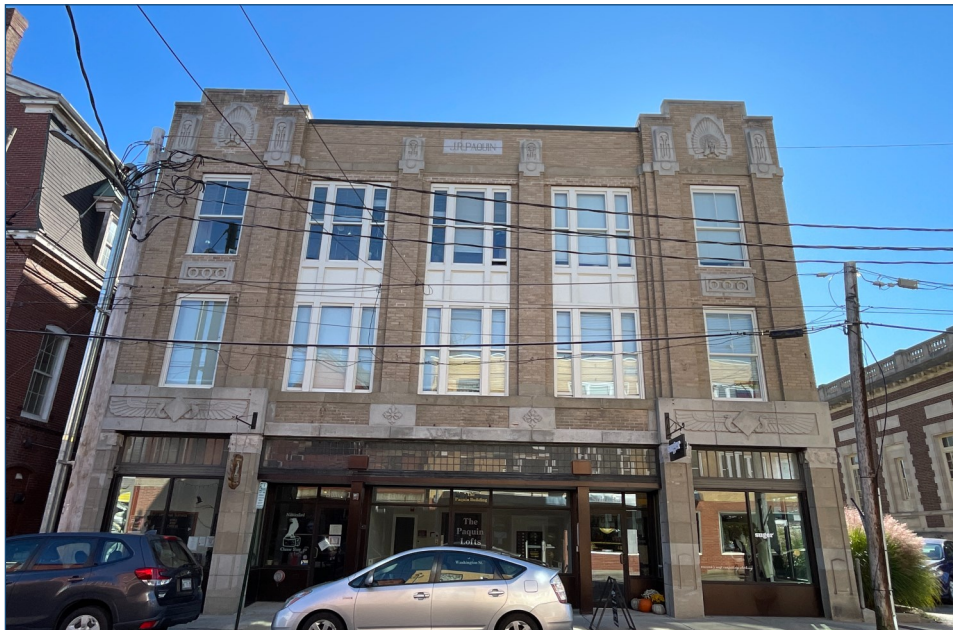
Figure 52: Art Deco style commercial building located within the Biddeford Main Street Historic District.

The Art Deco style emerged in the 1920s and was popular throughout the 1930s. The style reflected a rejection of historic styles and emphasized modernity. It features highly stylized ornament based on geometric forms. Stylized floral motifs and repetitive geometric forms incorporating sharp angles and segments of circles, zigzags, chevrons and diamond patterns are typical and often are applied as decorative moldings or masonry patterns, often in low-relief, and concentrated around doors, windows, and parapets. The style emphasized verticality and Art Deco buildings often feature rounded or angular corner windows and building entrances embellished with geometric motifs. Surface finishes emphasized modernity and smooth concrete, shiny steel, glazed tiles, mirrors, and glass were common.

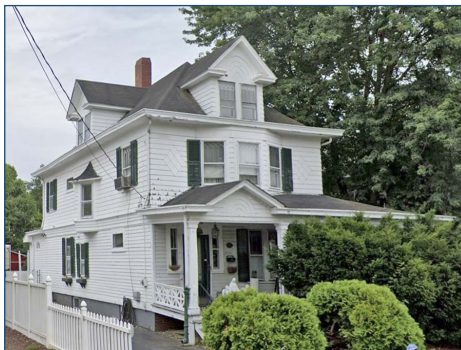
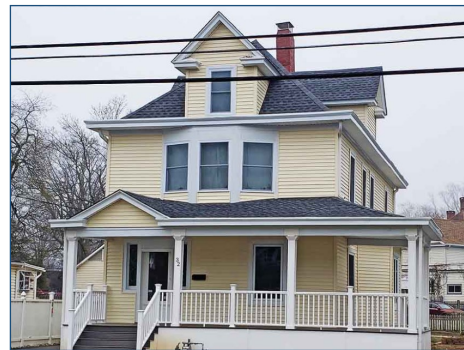
Figure 53: Before (left) and after (right) example of how a loss of architectural interest found in the original decorative siding, porch railing, and window shutters damages the character of a historic building.

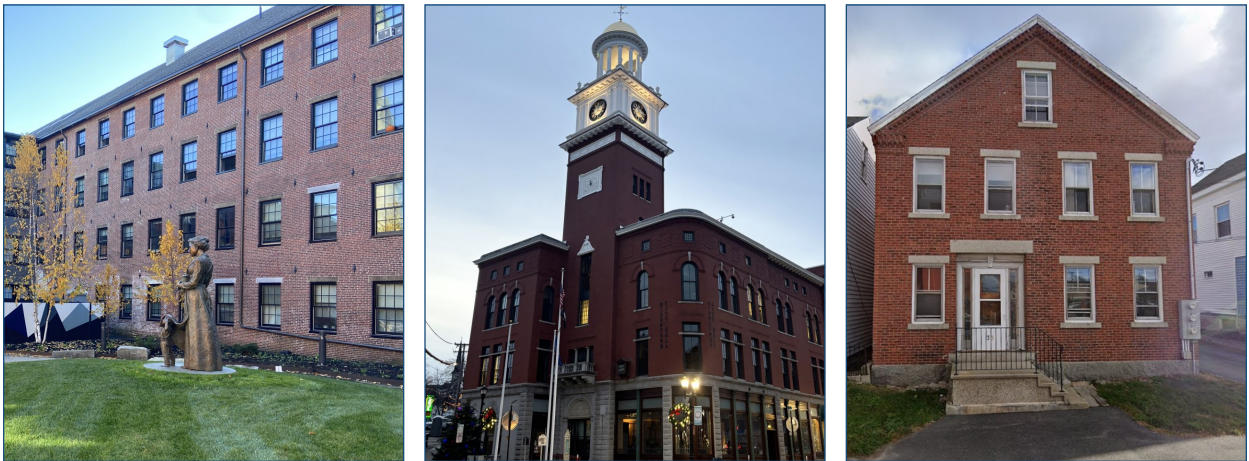
Figure 54: These examples of properties with high historic integrity have all retained their form, materials, and stylistic details.

A property with high integrity is one where the original design and historic materials remain largely intact. Preservation of the historic appearance is the preferred approach for treating properties with high integrity, however, rehabilitation may also be appropriate when some original features need repair or replacement.

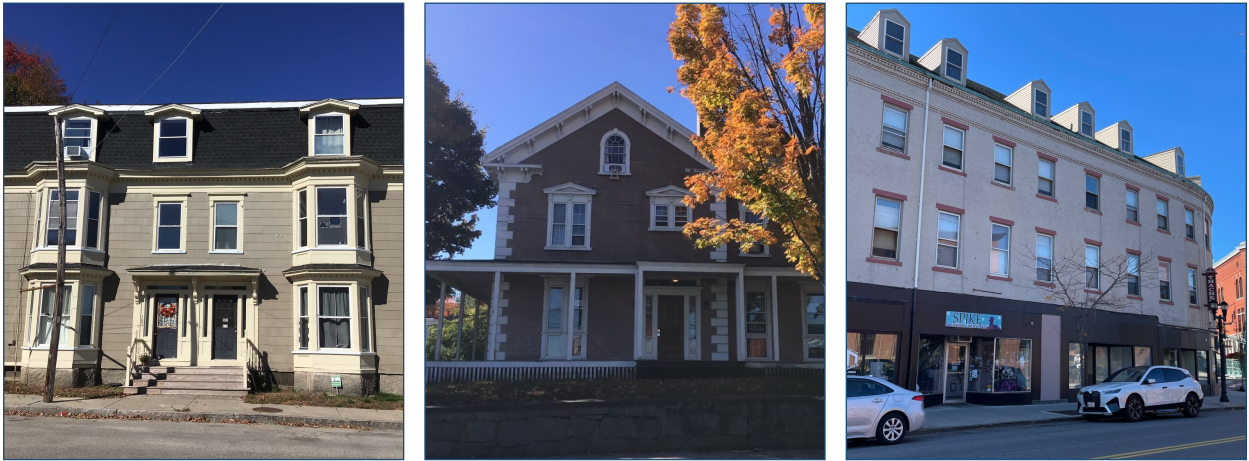
Figure 55: These examples of properties with moderate historic integrity have all retained their form, but some materials and stylistic details have been lost or changed.

A property with moderate integrity is one that has only been partially altered but retains many of its historic features. A good example of a property with moderate integrity would be a commercial property where the first-floor storefront was modernized in later periods, but the historic appearance of the upper floors remains intact. Another example would be a residence whose roof and siding have been replaced with modern materials but whose windows, doors, and other architectural details remain in place.

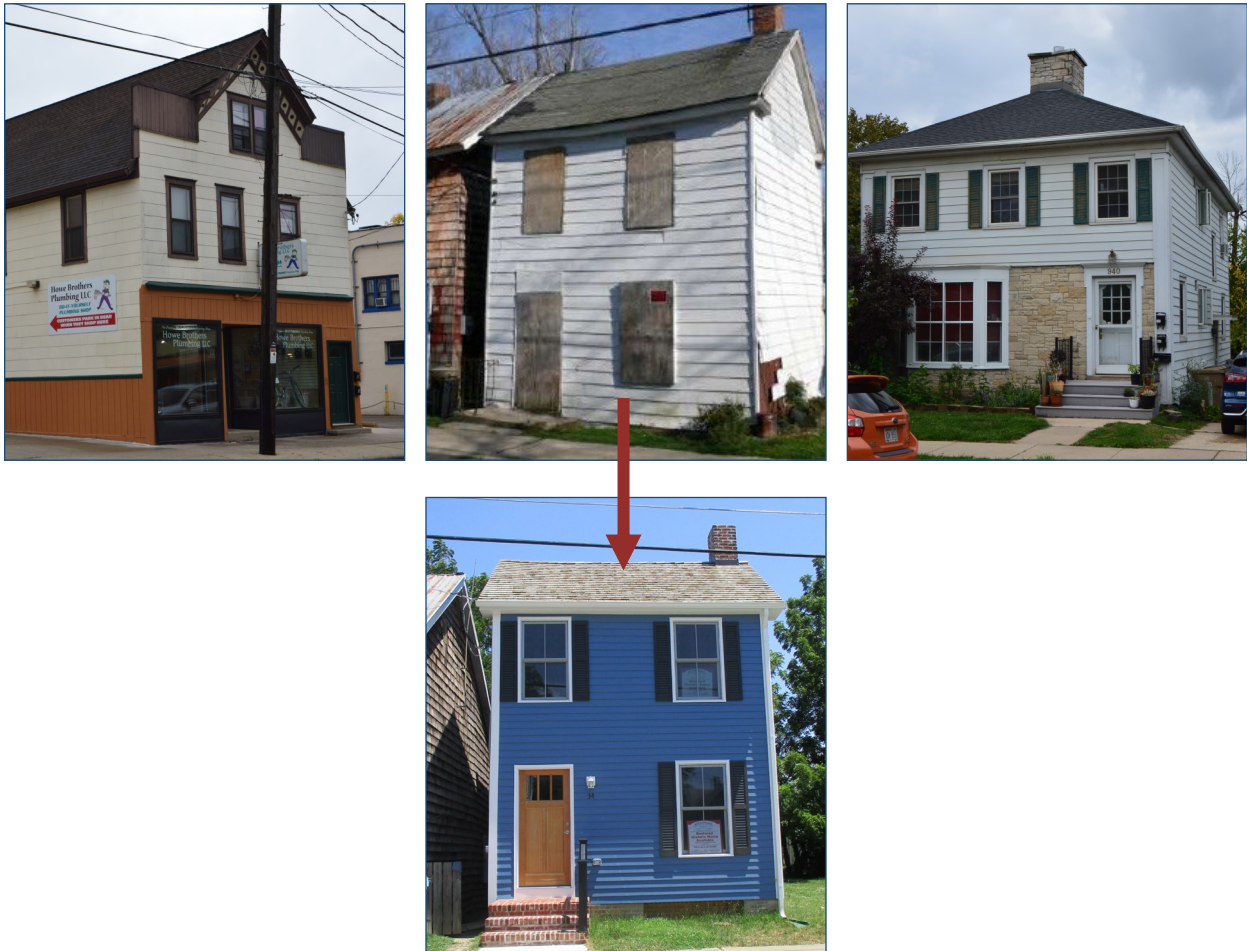
Figure 56: These examples of properties with low historic integrity have lost most of their original historic features, including materials and design elements. When low integrity buildings are rehabilitated, the historic appearance may be restored, or a new design that is compatible with the surrounding district may be utilized.

In a property with low integrity, the building's form may be the only recognizable historic feature, as most materials and details have been lost, altered, covered, or replaced. An example would be a historic Foursquare whose roof, siding, porch, windows, doors, and siding have all been replaced with modern materials.

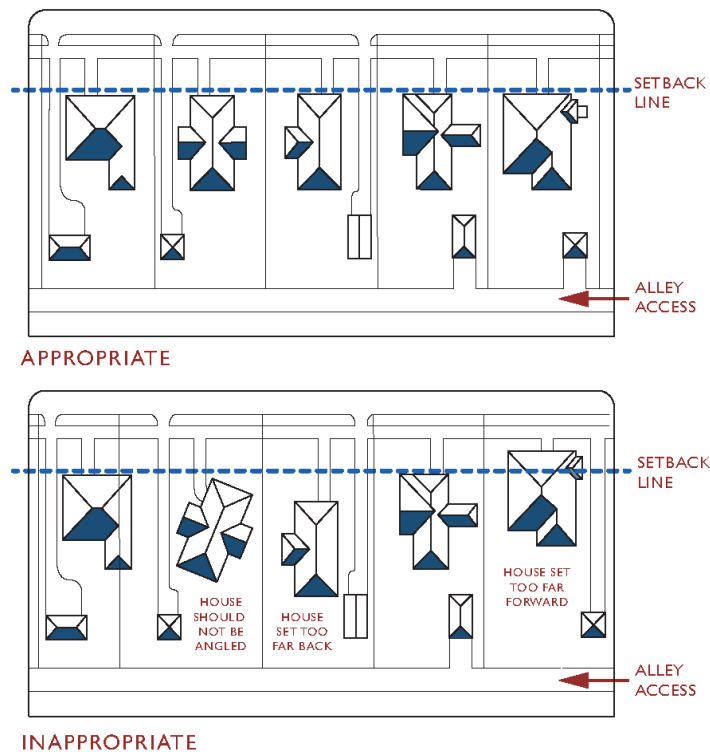
Figure 57: Diagram representing alignment, setback, and orientation within a residential neighborhood.

Setback describes the distance between a building and its property line. For the purposes of this document, it generally refers to the setback from the street-adjacent property boundary. For example, many residential properties are set back approximately 25 feet from the property line, creating an open space between the front of the house and the street, forming a front yard. Many commercial properties, however, have little to no setback.

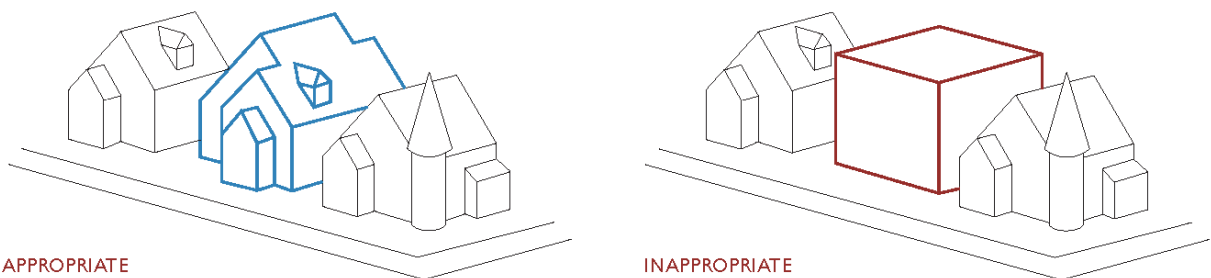
Figure 58: Diagram demonstrating appropriate and inappropriate massing of new construction.

Scale is the size of a building in relation to the surrounding buildings. Scale can be expressed through the size of a building itself (the height and width, number of stories, etc.) as well as through the size of building elements (the doors, windows, columns, staircases, etc.). Most buildings are described as being “human in scale,” however, many civic buildings are “monumental” in scale. Buildings that are “human in scale” have features, such as windows and doors, sized to comfortably support human use, while buildings that are “monumental” in scale typically have over-sized features designed to impart a symbolic sense of importance.

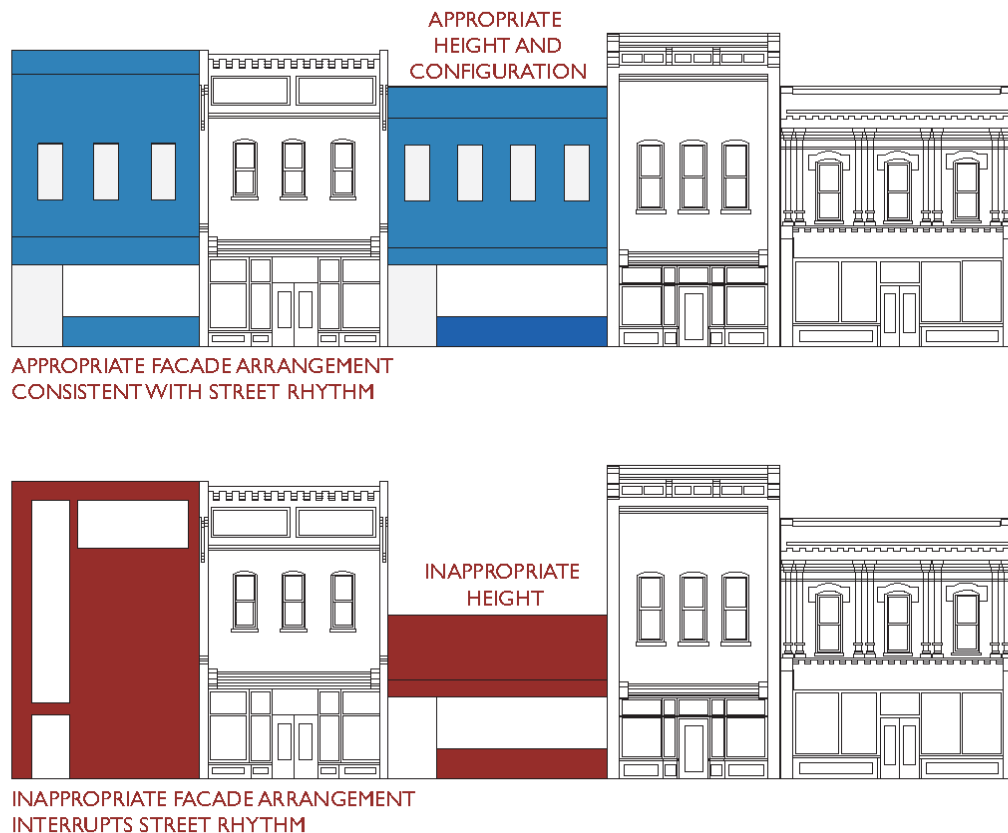
Figure 59: Diagram demonstrating appropriate and inappropriate height and rhythm of new construction within a historic district.

Rhythm is the repetition of architectural forms along a streetscape. Width, height, spacing, setback, and orientation, as well as the placement of architectural features such as cornice lines, windows, and doorways contribute to the rhythm of the street. Demolition of existing historic structures, or the construction of new buildings which are incongruous with height, spacing, or other rhythm-defining elements can disrupt the historic rhythm of the street and alter the overall character of the historic district.

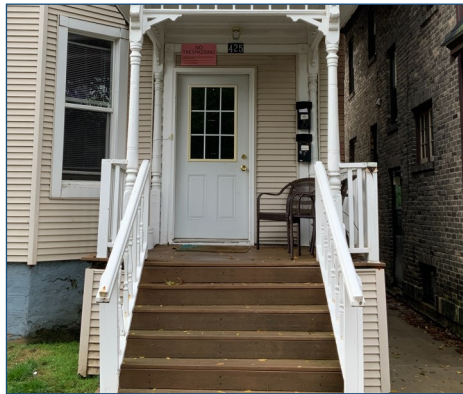
Figure 60: Porch flooring and steps replaced with compatible substitute material similar in visual qualities.

- d) Substitute materials should only be used if they do not cause damage or change the character of the historic resource. The new material should match the form, color, and texture of the historic feature (for additional information on substituting historic materials, see [Chapter 7. Replacement Materials](#)).

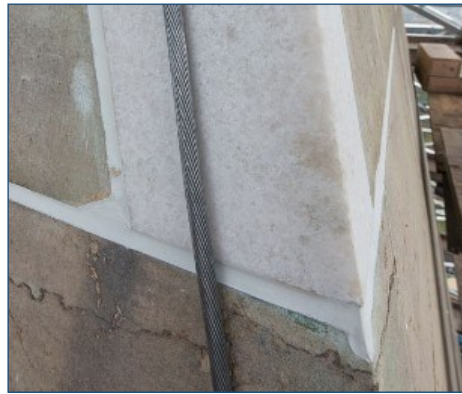
Figure 61: Appropriate dutchman replacement on masonry.

- a) Replace as little historic material as possible. This may include patching, splicing, or piecing-in replacement materials such as individual roofing tiles, shingles, or siding, masonry patches, or dutchman repairs for stone or wood elements. A dutchman repair refers to any new or salvaged material (stone or wood) fitted into the existing facade material. This new material is chosen and installed to match existing.

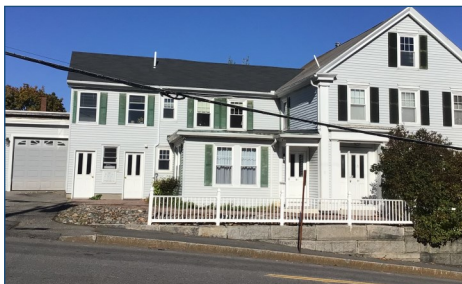
Figure 66: Example of fencing and a retaining wall along the front of a residence.

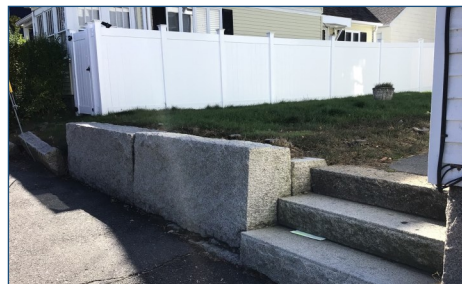
Figure 67: Historic fences and retaining walls should be maintained or replaced in-kind as needed.

- a) Retain existing historic perimeter walls and fences.
- b) Repair or restore damaged or deteriorated historic perimeter walls and fences. Where repair is not possible due to the severity of the deterioration, replace historic walls or fences in-kind using the same material as the original and matching in size, shape, height, profile, texture, and color. If use of the same material is not feasible, the substitute material should approximate the original as closely as possible.

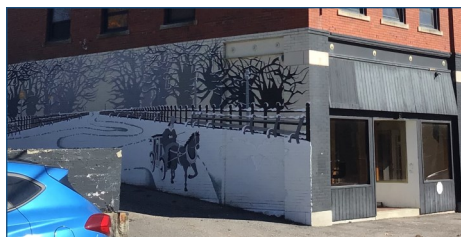
Figure 75: Mural on the side elevation of a previously painted masonry building.

| | 70 | Figure 75 | It would be helpful to clarify the mural was painted on previously painted brick. ..on a side elevation of a previously painted masonry... | Clarified | | Julie | SS |

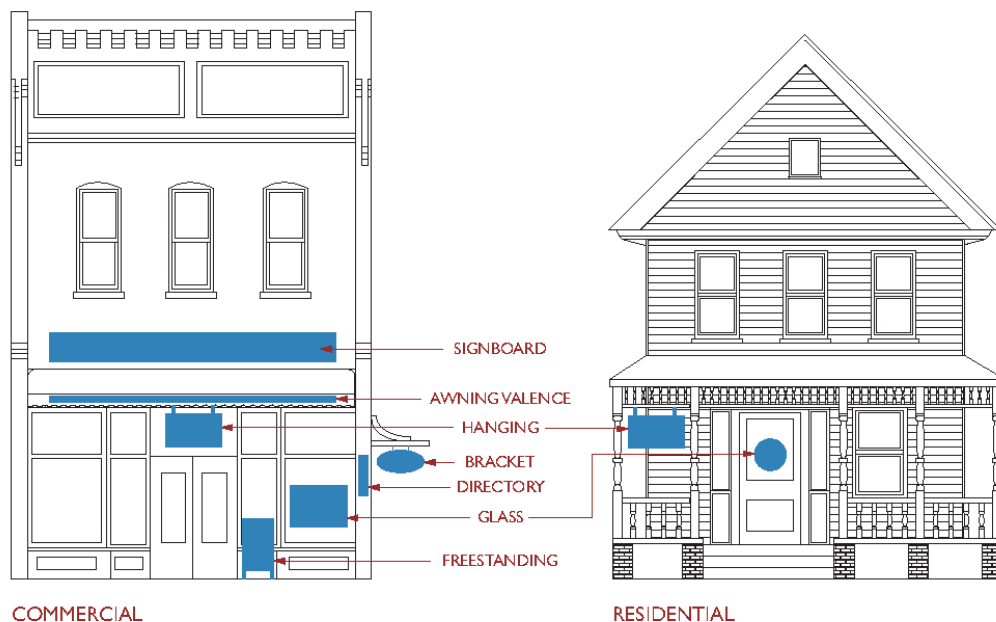
Figure 79: Types of signage and their locations on commercial and residential properties.

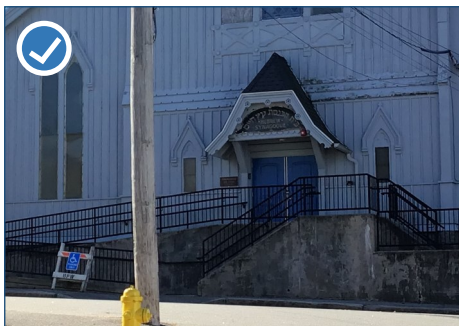
Figure 87: Appropriate ramp on the front façade of a public building.

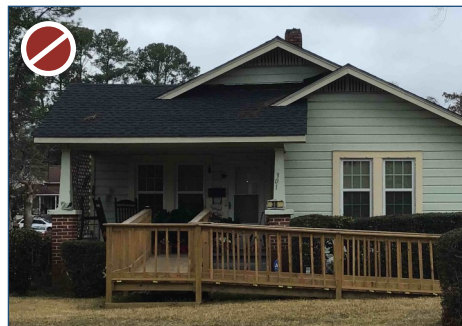
Figure 88: Inappropriate ramp installation on the front façade of a residential building.

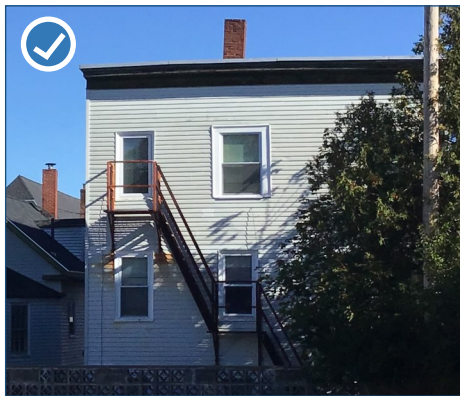
Figure 89: Appropriate fire escape obscured on a side elevation in a residential area.

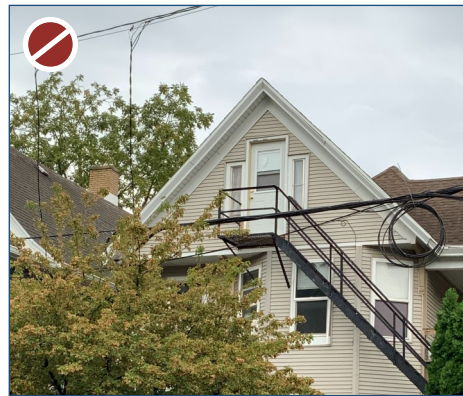
Figure 90: Inappropriate fire escape on the front façade of a residence.

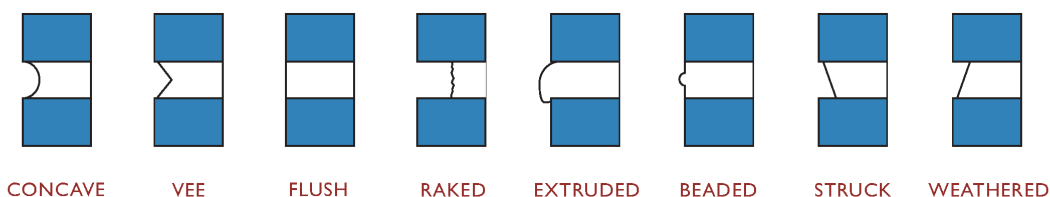
Figure 91: Diagram of types of mortar joints.

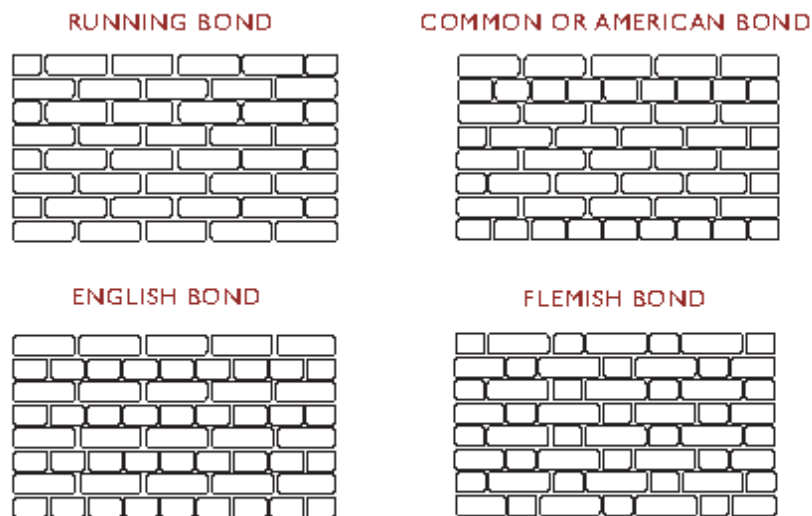
Figure 92: Diagram of typical brick bonds.

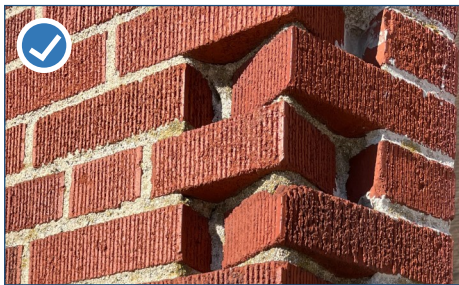
Figure 93: Appropriate brick and mortar pairing within Biddeford.

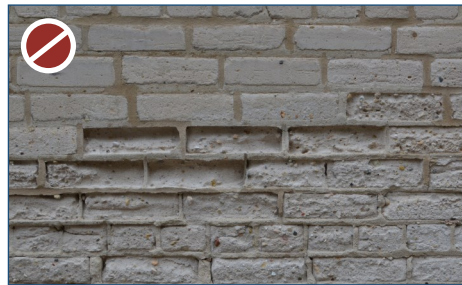
Figure 94: Inappropriate modern mortar replacement on a historic building resulting in damaged bricks.

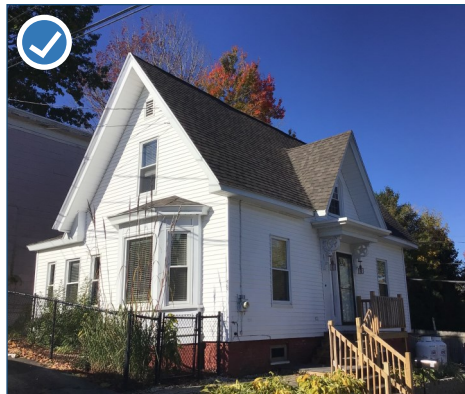
Figure 96: Appropriate replacement siding on a historic residence.

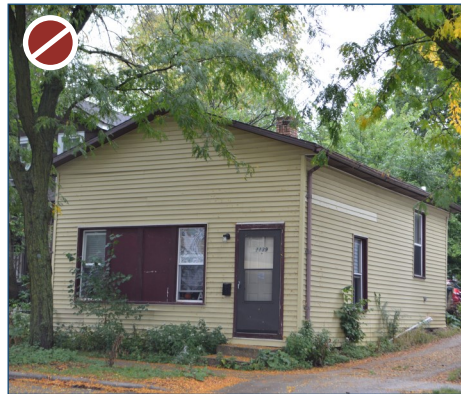
Figure 97: Inappropriate siding replacement that has resulted in a loss of historic integrity for the residence.

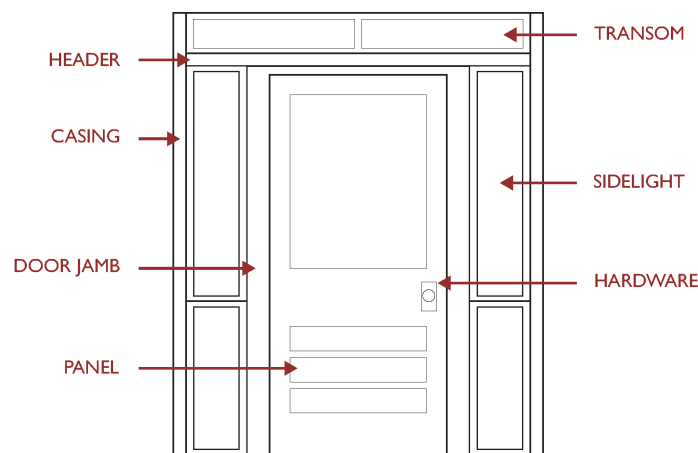
Figure 100: Diagram of typical door parts.

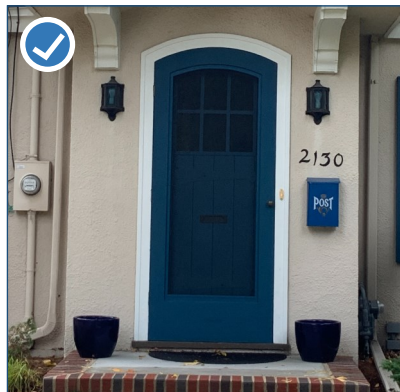
Figure 101: Appropriate and compatible storm door that does not obscure the historic door.

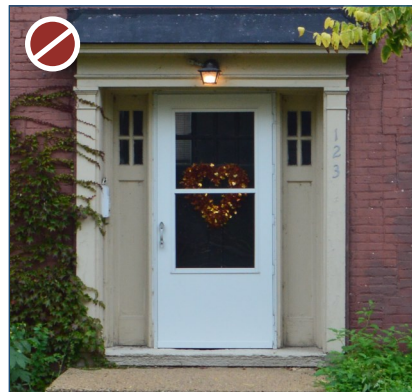
Figure 102: Inappropriate storm door over historic door.

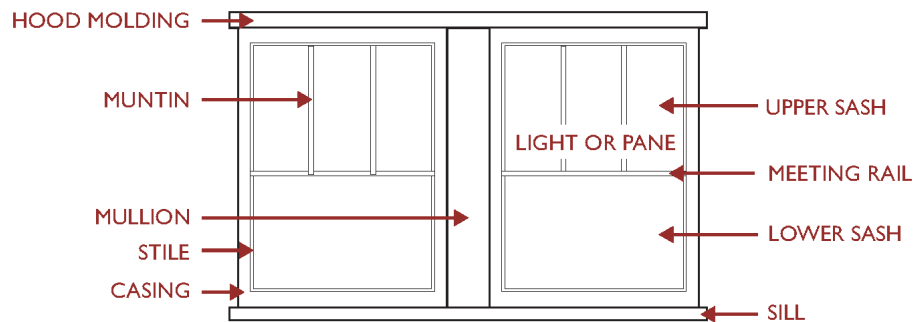
Figure 105: Diagram of typical window parts.

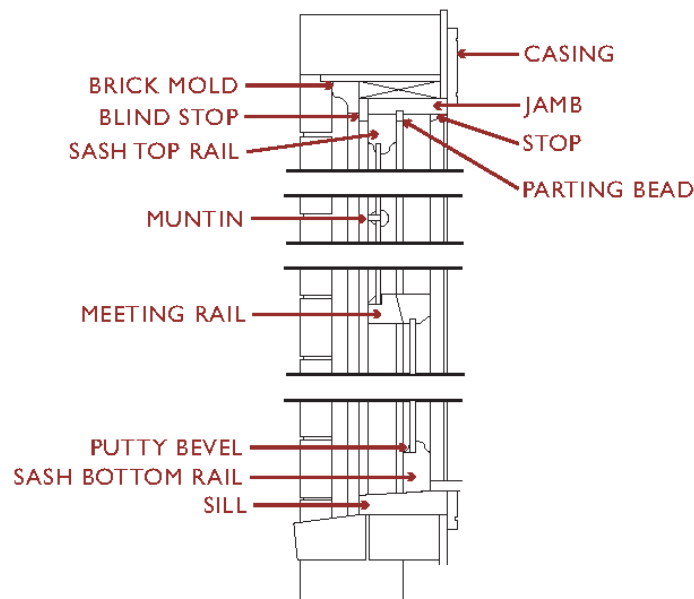
Figure 106: Diagram of typical wood window section.

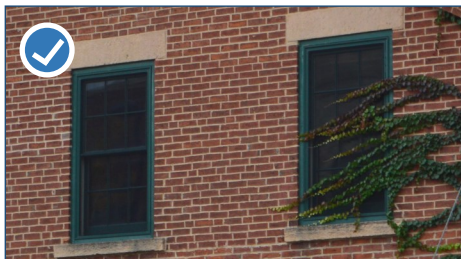
Figure 107: Appropriate storm windows compatible with the existing windows.

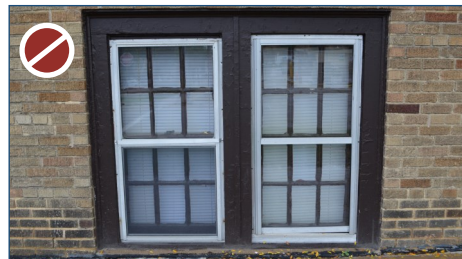
Figure 108: Inappropriate storm windows that obscure the original windows.

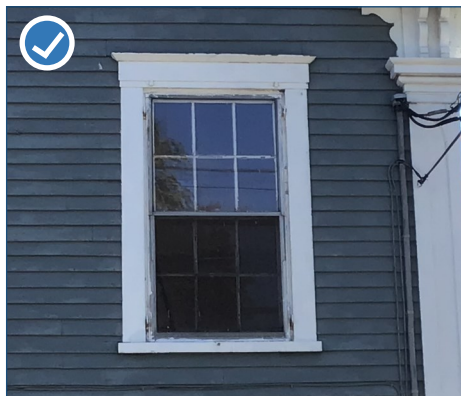
Figure 109: Original wood window in good condition but needing basic maintenance.

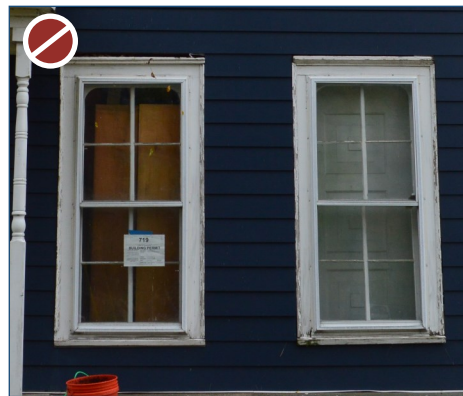
Figure 110: Inappropriate replacement windows that don't fit in the historic casing.

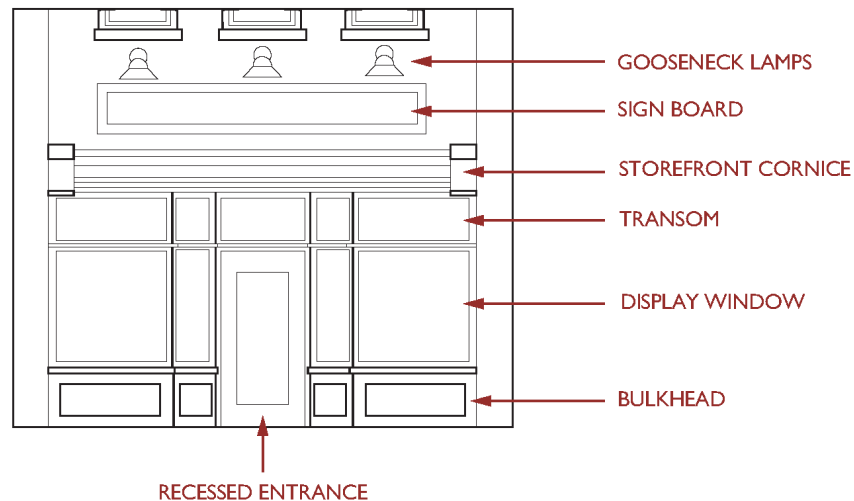
Figure 111: Diagram of typical storefront features.

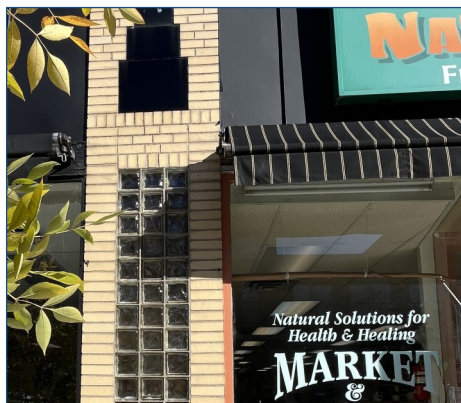
Figure 113: Sloped, retractable awnings within Biddeford's commercial area.
