**City of Biddeford**  
**Historic Preservation Commission**

April 9, 2025 at 4:00 PM  
City Hall Council Chambers & Zoom

**HPC MEETING**  
**March 12, 2025**  
**Meeting Minutes**  
**4:00**  
**DRAFT**

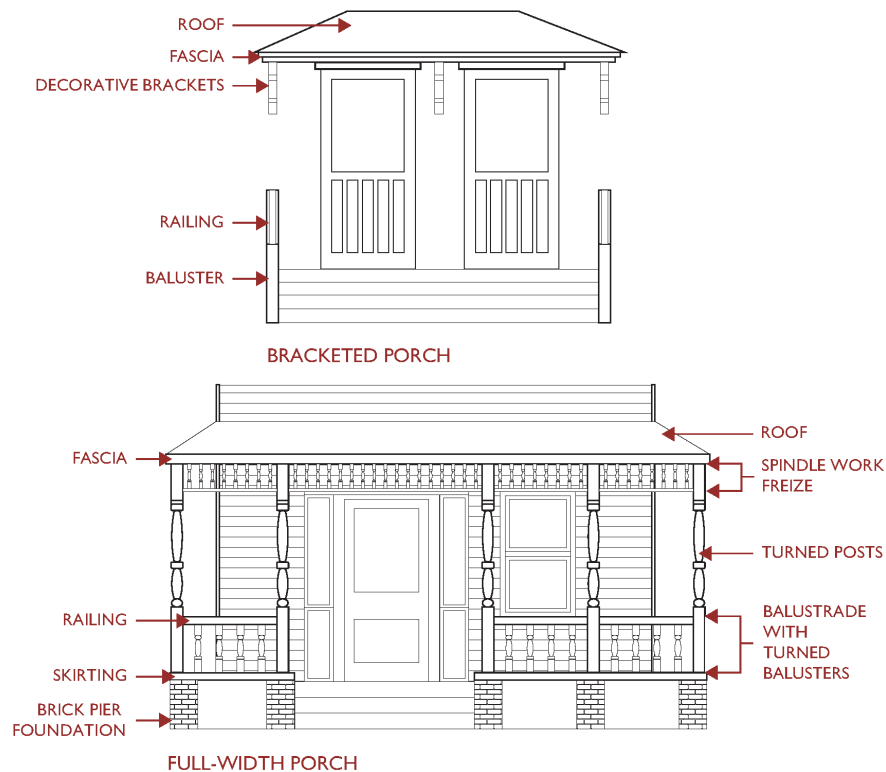
Figure 117: Diagram of typical porch parts of a full-width and bracketed porch.

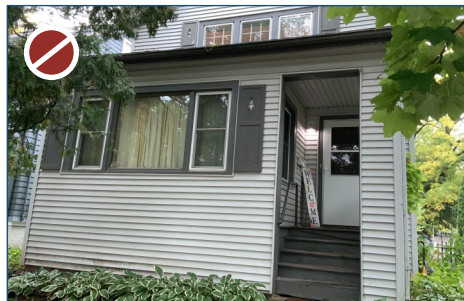
Figure 119: Inappropriately enclosed front porch.

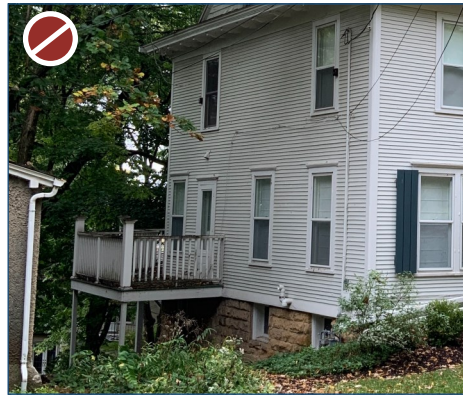
Figure 121: Inappropriate side deck addition.

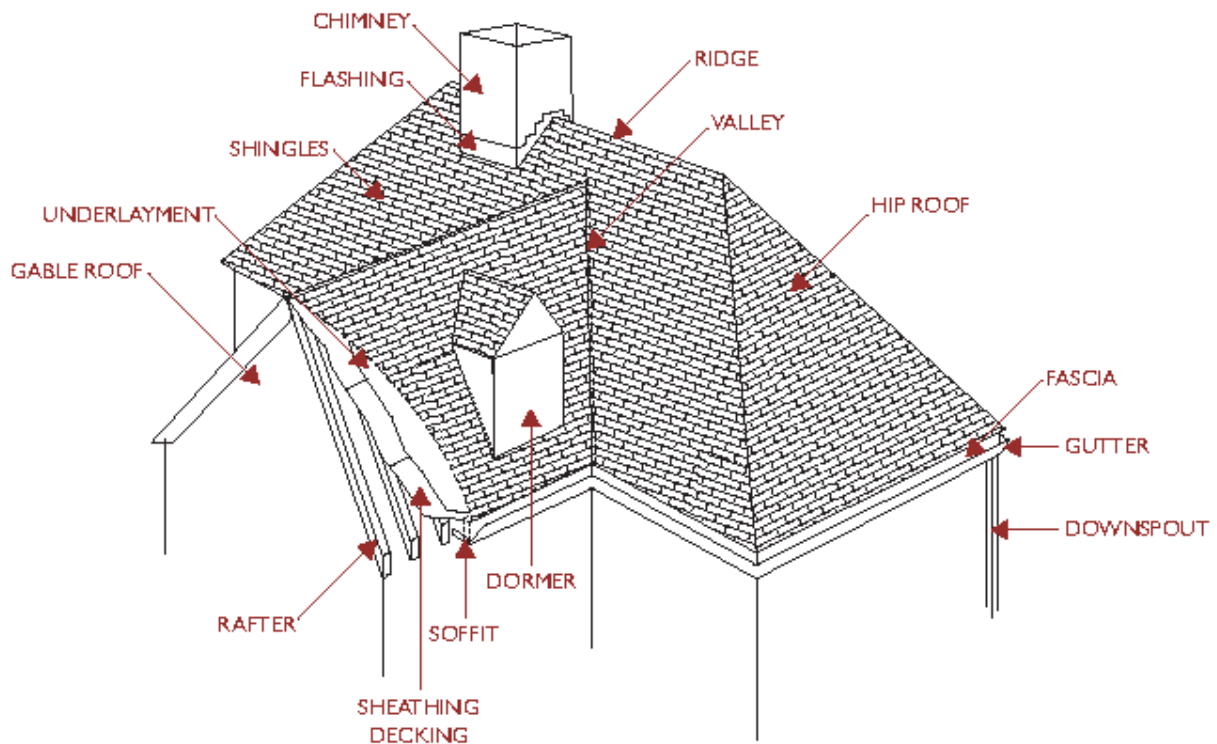
Figure 122: Diagram of typical roof parts.

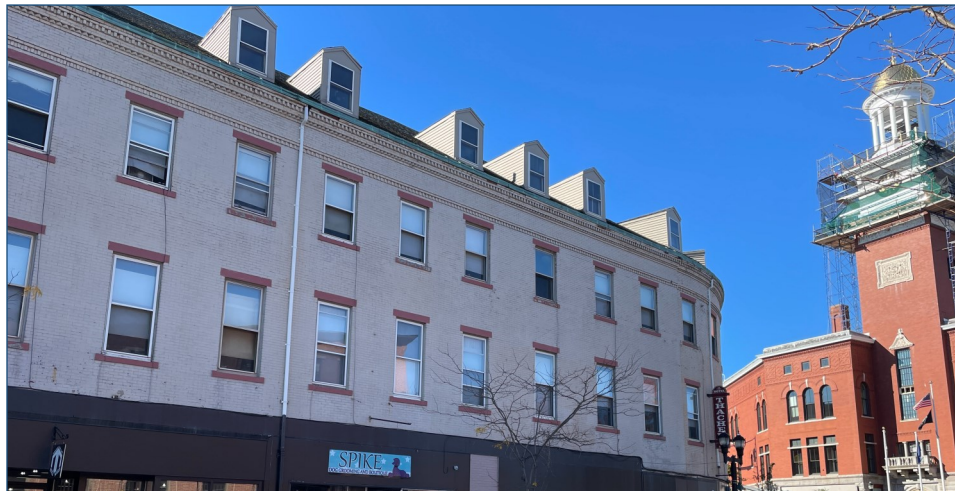
Figure 123: A variety of roof shapes can be found throughout the HPC Review Area as well as a variety of roof appurtenances.

| | 110 | Figure 123 | Is it possible to clip the photo to eliminate the 80s era arched window, which is not an appropriate alteration | Figure photo replaced with more appropriate | | Julie | SS |

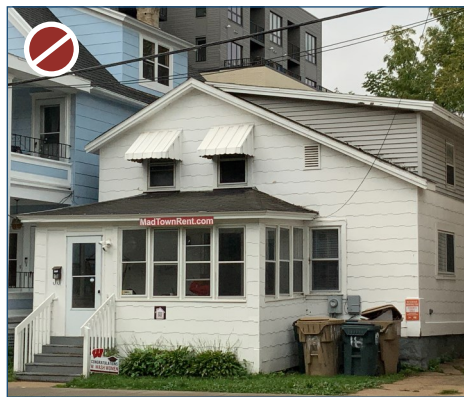
Figure 125: Inappropriate dormer addition that changes the roof shape of the residence.

| | 111 | Figure 125 | Photo is very dark and hard to read at this scale. If you know the local address, can we substitute a better picture – or can the photo be brightened? | Photo brightened and highlighted with a callout box | | Julie | SS |

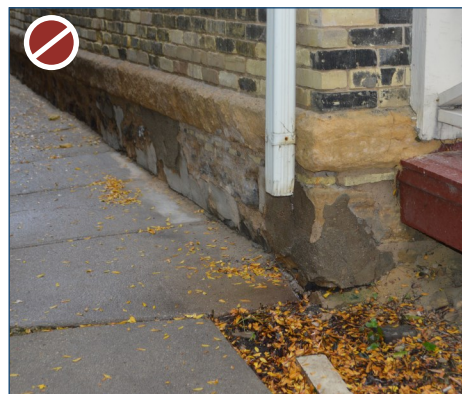
Figure 127: Improper drainage gutter system resulting in deterioration of foundation walls.

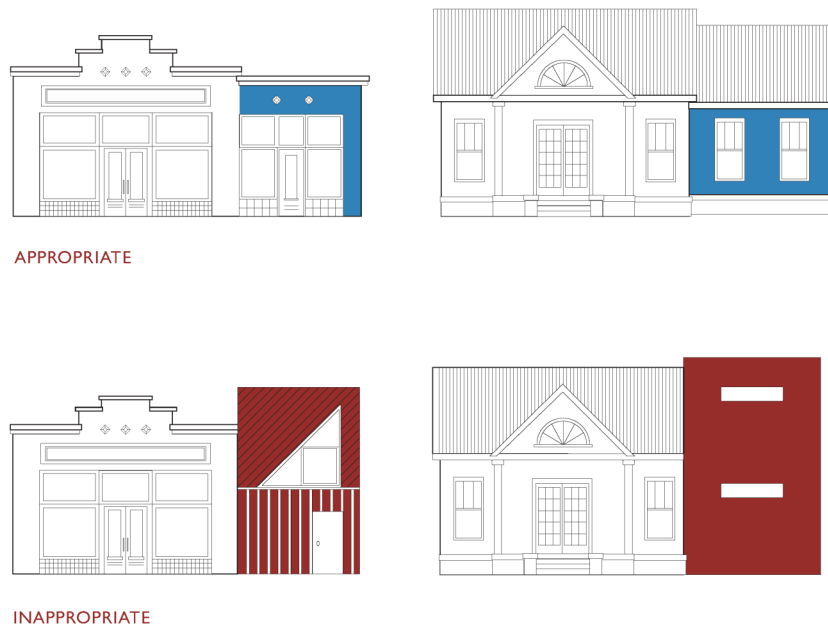
Figure 140: Diagram of the appropriate and inappropriate scale and fenestration of side additions.

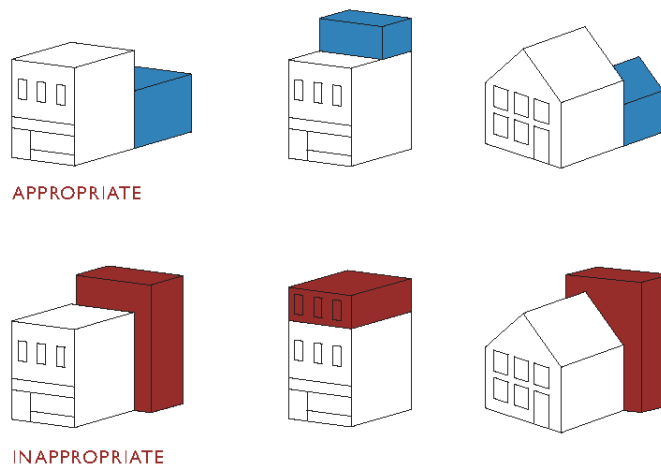
Figure 141: Diagram of the appropriate and inappropriate location of rear and rooftop additions on commercial and residential buildings.

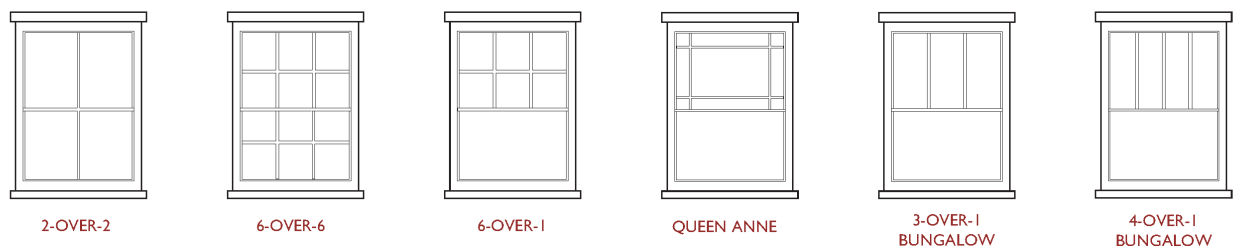
Figure 145: Diagram of types of typical window types.

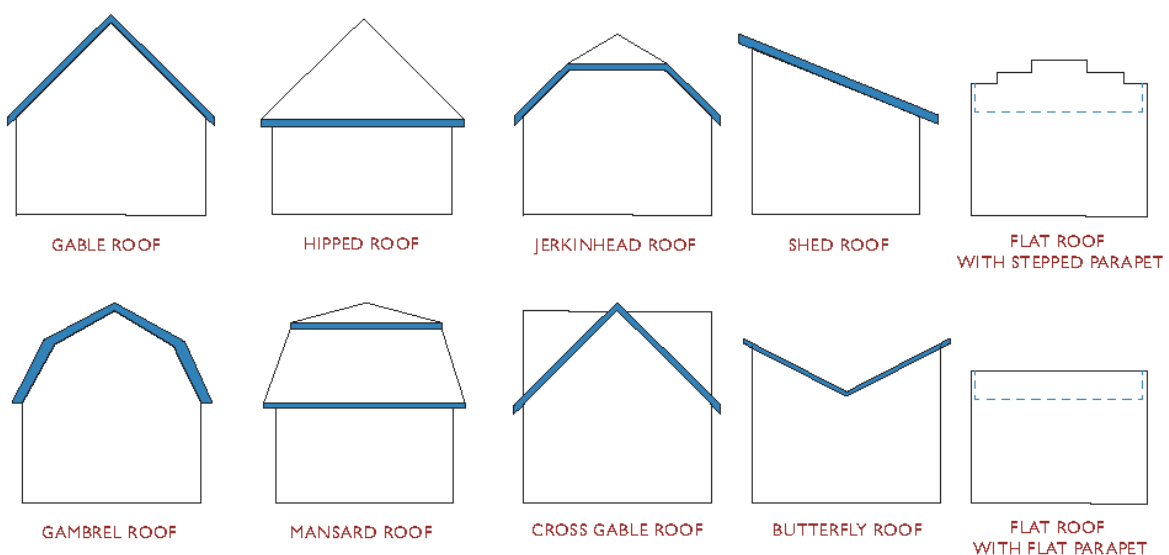
Figure 147: Diagram of typical roof shapes.

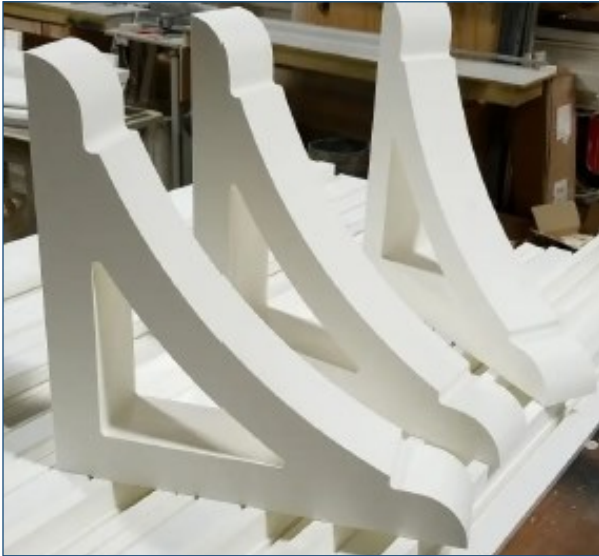
Figure 149: Substitute material brackets. Source: Executive Architectural Millwork.

High-quality synthetics may be an appropriate replacement for wood or plaster details where the profile, size, and dimension of the element can be accurately reproduced. Synthetic material use on architectural details and trim will be considered on a case-by-case basis by the HPC and all synthetics are subject to a painting requirement.

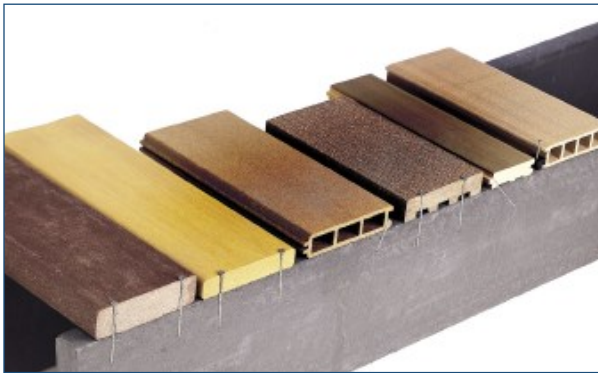
Figure 151: Substitute porch decking. Source: This Old House.

Composite materials are made from a mixture of plastic and wood fibers and are manufactured for use as floorboards and stair treads. These materials are formed into planks to imitate wood decking and are installed in a manner similar to traditional wood planks. The product is sometimes available in a paintable finish. Composite materials are appropriate for installations on non-visible sections of a property.

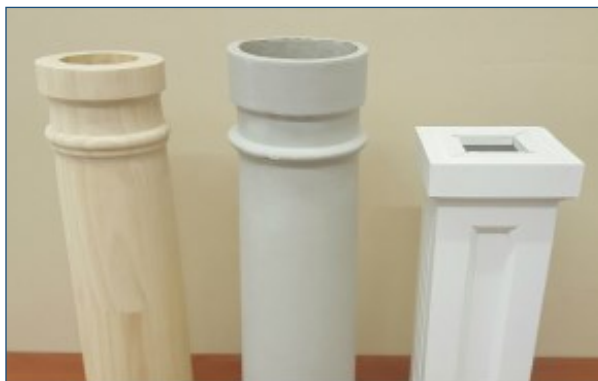
Figure 152: Substitute porch columns. Source: Worthington Millwork.

Fiberglass can be used to replicate decorative features, such as columns and balusters, and are available in a variety of shapes and sizes. Fiberglass products which mimic historic forms are commercially available. Fiberglass is typically more expensive than their wooden counterparts. A fiberglass replacement may be appropriate if it closely matches the design and proportion of the original elements.

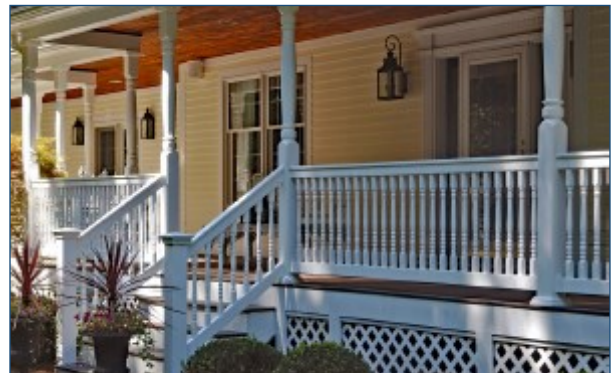
Figure 154: Pressure treated lumber porch railing. Source: Perfection Fence.

Pressure treated lumber is preserved through a process that uses high pressure to inject a preservative into the wood, adding years to the life of the material. Pressure treated lumber is not stronger than untreated wood, but pressure treated does withstand the elements better than untreated while still being susceptible to deterioration of checks (separation in wood fibers across the annual rings of a piece of wood), warping, and splitting. Pressure-treated wood can be effective when used for hidden structural elements such as posts, joists, and sills. It is not a good substitute for visible porch parts.

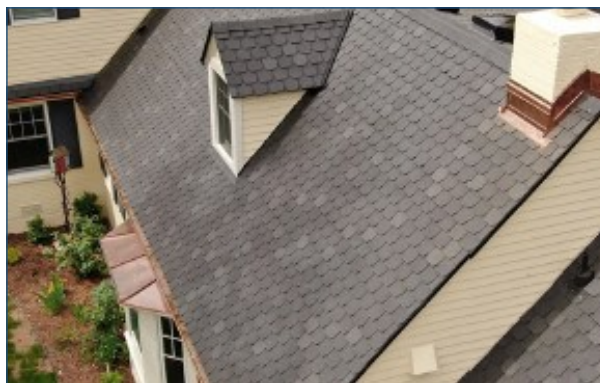
Figure 155: Asphalt shingles. Source: Refined Exteriors.

Asphalt shingles were first introduced in the late 19th century. While strip shingles, commonly known as “3-tab” shingles, are not appropriate on contributing or historic buildings in the Historic Preservation Commission Review Area, dimensional asphalt shingles are designed to have a more natural and irregular appearance and may be appropriate for some uses within the Review Area. Asphalt roll style covering are not historically appropriate on any building older than the mid-20th century. New asphalt roofs should be one color and compatible with the historic colors and style period of the building.

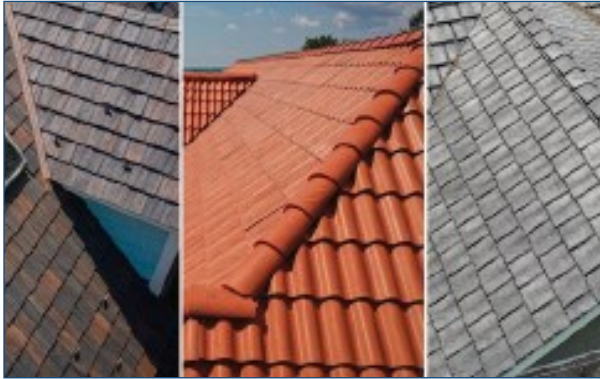
Figure 156: Composite and Synthetic roofing. Source: Brava Roof Tile.

Composition shingles are a heavy-duty asphalt product made with a fiberglass backing and a facing made from ceramic-coated mineral grains, suspended in an asphalt coating. Also known as laminated shingles, architectural shingles, or dimensional shingles, these differ from traditional asphalt tab shingles as they are more dimensional and provide a more irregular, natural looking pattern. Architectural shingles may be an appropriate replacement for severely deteriorated slate or timber shingle roofs, as well as existing tab-style asphalt shingles. Composition roofing may be determined to be appropriate for flat or low-pitched roofs to prevent structural damage.

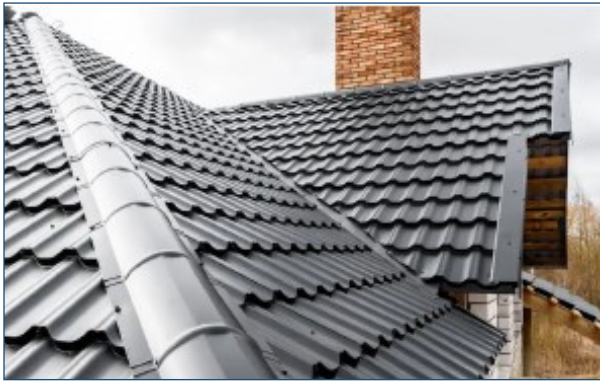
Figure 157: Metal roofing. Source: Gouge Quality Roofing.

Sheet metals – tin, copper, zinc, tin plate,terne plate, and galvanized iron – are common historic metal roofing materials. Corrosion, pitting, and streaking are common deteriorations to metal roofs. Metal roofs are only appropriate where a metal roof was part of the original structure and should be replaced with similar details and proportions.

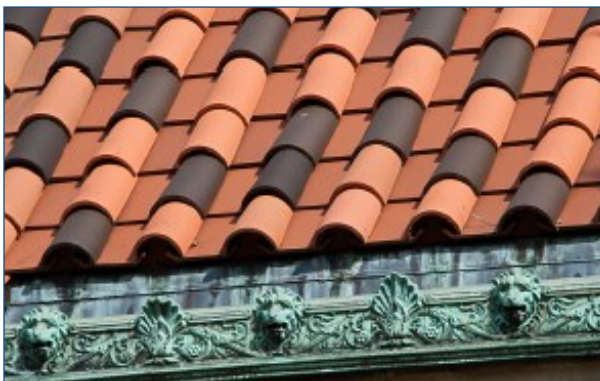
Figure 158: Clay tile. Source: Tile Roofing Industry Alliance.

Clay tile and slate were common historic roofing materials as well as some of the most durable. Tile and slate require a level of craftsmanship and specialization that is not attainable to mimic exactly. When feasible, it is preferred to replace a historic tile or slate roof in-kind. If a roof historically did not have clay tile, it would not be an appropriate material.

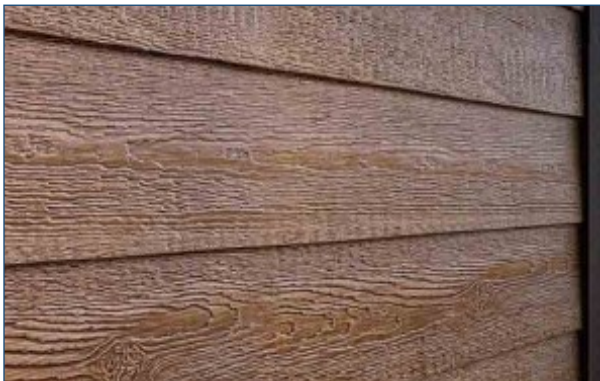
Figure 159: Engineered Wood siding

Engineered wood products, such as LP Smartsiding, can be an appropriate replacement siding for the rear, non-visible elevations of a building.

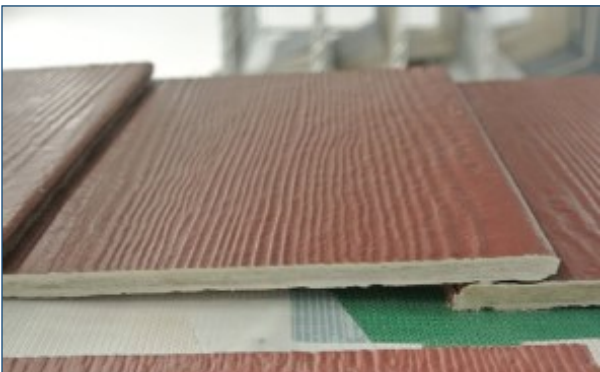
Figure 160: Fiber Cement Board.

Fiber cement board siding is made from combining wood pulp or cellulose with Portland cement, silica, and other products. It is commonly known as HardiPlank or Hardiboard. These products may be approved for repairing the rear, non-visible elevations of a building.

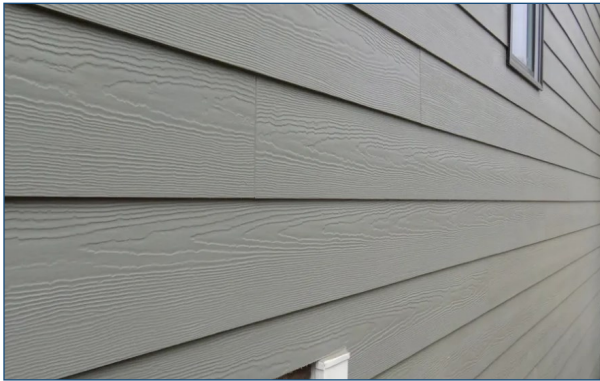
Figure 161: Synthetic Vinyl siding. Source: Urban Exteriors.

Synthetic siding, such as vinyl, is not an appropriate covering in the historic district. Asbestos cladding that is original to a dwelling should be kept stained or painted to avoid any health hazards. If the asbestos siding is deteriorating, it may be removed and replaced with wood or other substitute siding.

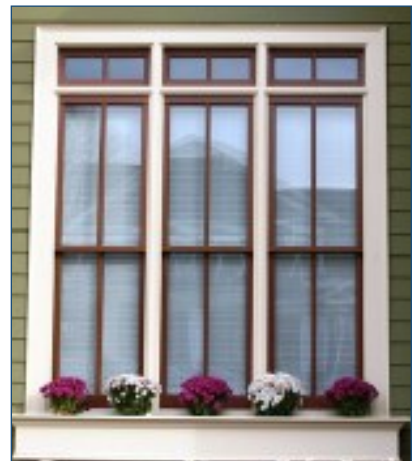
Figure 166: Composite windows.

Composite windows and doors are made from a mixture of materials, typically fiberglass and wood fibers. **Composite is paintable and is a good lower-cost option for residences in historic districts.** Composite windows may be appropriate if they can match the appearance of the historic windows.

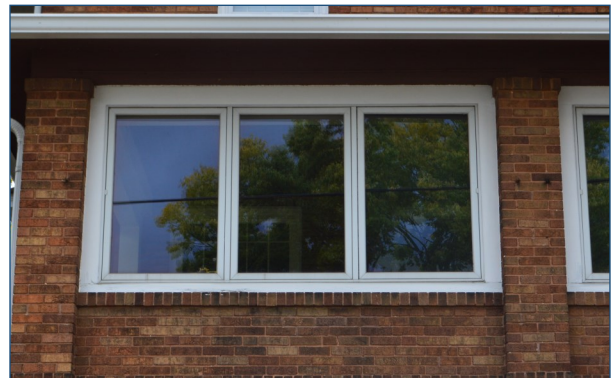
Figure 168: Vinyl windows.

Vinyl can either be used as a cladding on wood or composite materials in the same way as aluminum, or vinyl windows or doors can be completely constructed out of PVC. **Vinyl products are problematic for use in historic districts, as they are not typically available in proportions or finishes that are compatible with historic buildings.** Because of the way vinyl is manufactured, vinyl windows have narrow stiles and rails on the sashes which do not match the thicker proportions on historic window openings. **Vinyl windows and doors are not paintable and are the least durable option with a lifespan of 10 to 15 years.**
